Wisconsin Highway Research Program

Evaluation of Bridge Approach Settlement Mitigation Methods

Final Report

October, 2007

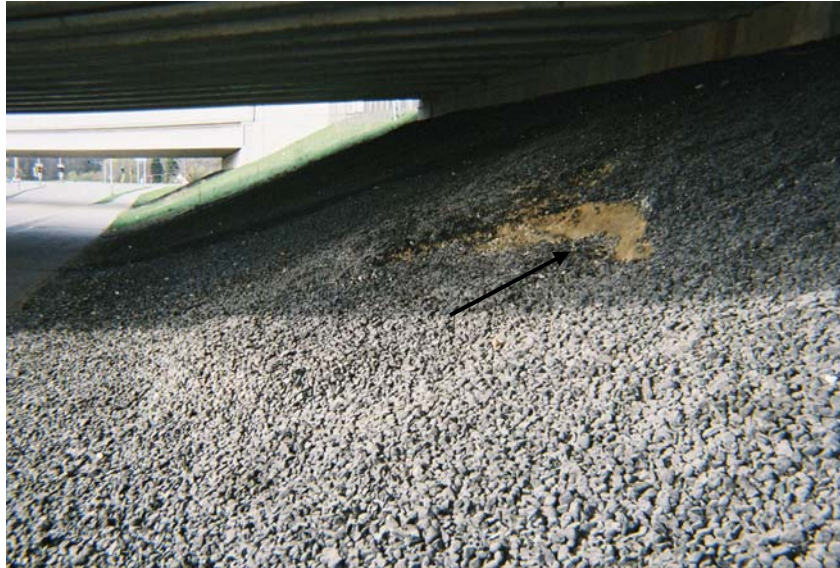
Foundation soil failure can be attributed to slope instability. Slope stability or rotation failure occurs when the shear strength of the foundation soil cannot resist applied loads. Slope stability failures will result in scarps or cracking at the top of embankments and/or slopes. A weak foundation soil, high or differential water table, and/or heavy embankment loads can cause failures. A schematic showing slope stability failure is illustrated in Figure 25, and a photograph of the scarp at the top of a failed embankment is shown in Figure 26.

Figure 26: Scarp of Slope Stability Failure

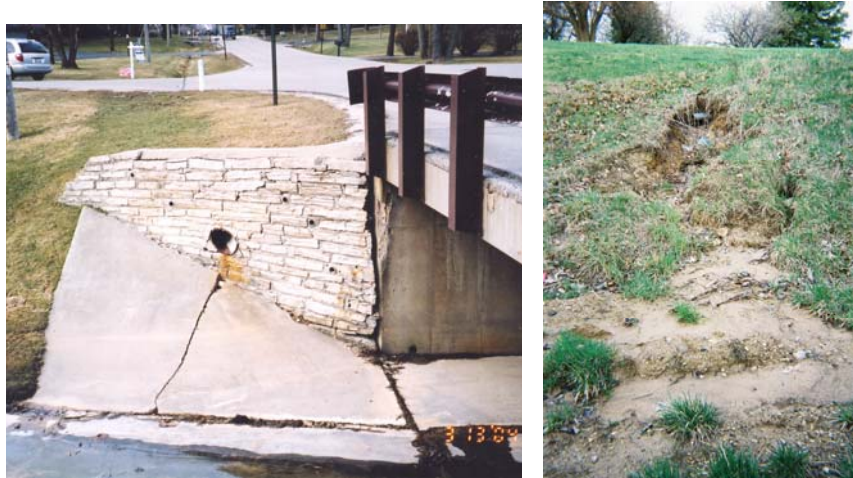
and undermining as result of erosion are shown in Figure 27. Figure 28 illustrates erosion and piping of material along the front slope.

Figure 27: Broken Slabs and Undermining of Soil due to Erosion of Slopes

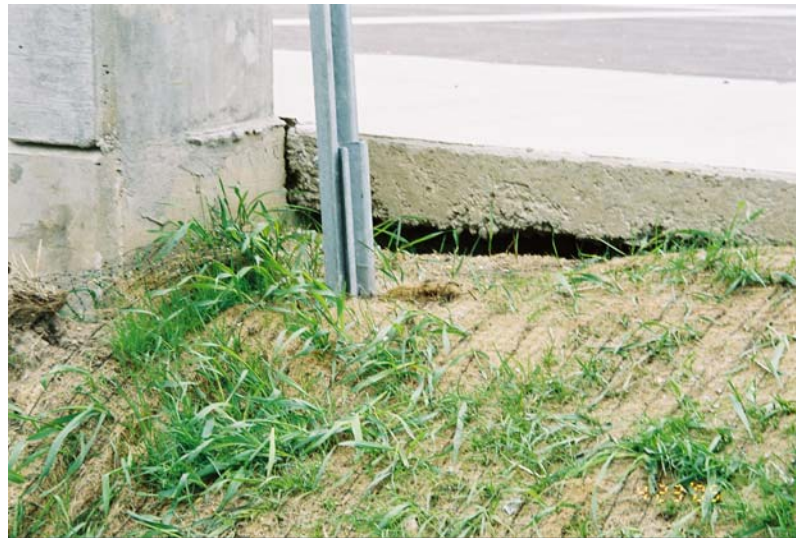
If erosion of material occurs near the top of the side slopes, soil from the backfill or embankment will tend to collapse or fill in the voids along the side slopes. This typically creates a void under the approach pavements and can cause faulting of concrete or cracking of asphalt. A void, and thus subsequent settlement, can also be created from the piping and undermining of the sleeper slab (Luna et al. 2003). Figure 29 presents the start of a void due to erosion of the side slopes.

Figure 29: Void beneath Concrete Curb along Side Slope

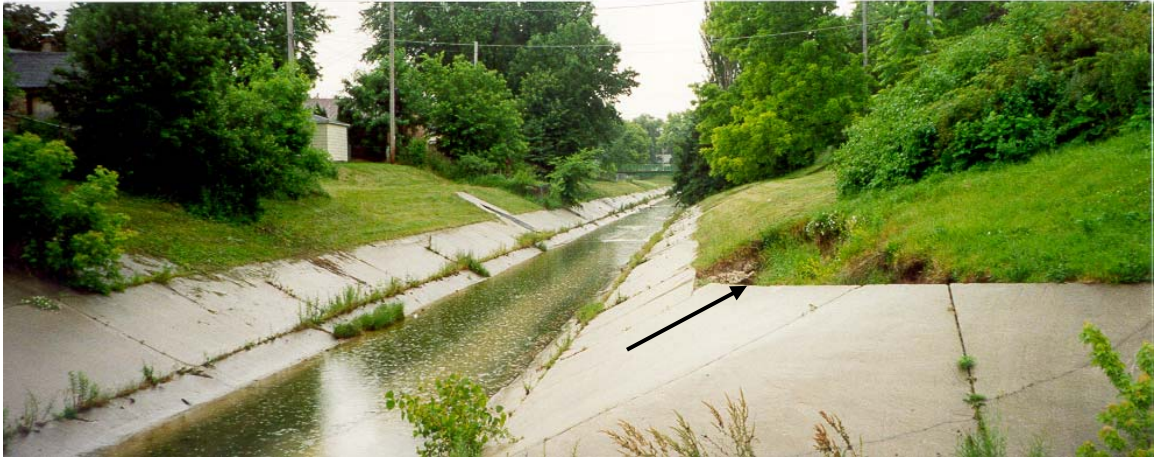
water table reduces the shear strength of soil. As described in Section 2.1.4, slope stability failures will cause cracking or sloughing at the top of the backfill or embankment, as shown in Figure 30.

Figure 30: Slope Stability Failure of an Embankment

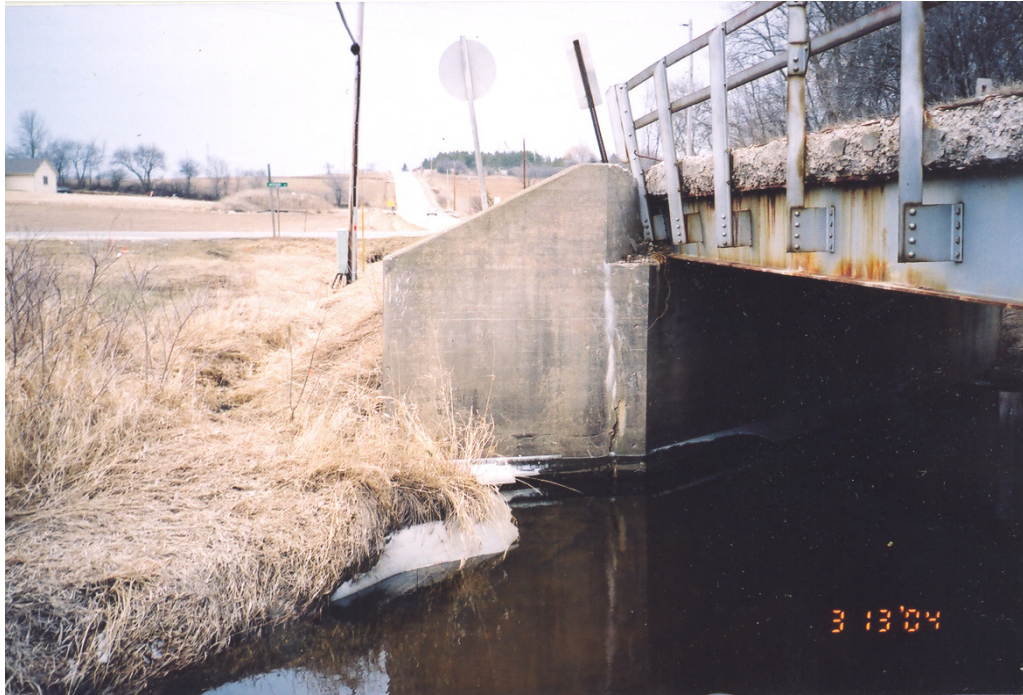
deflections were noted on the north side. Erosion was observed in a ditch located parallel to the embankment on the northeast side of the bridge.

Figure 43: Drainage Ditch on Northeast Side of Western Bridge

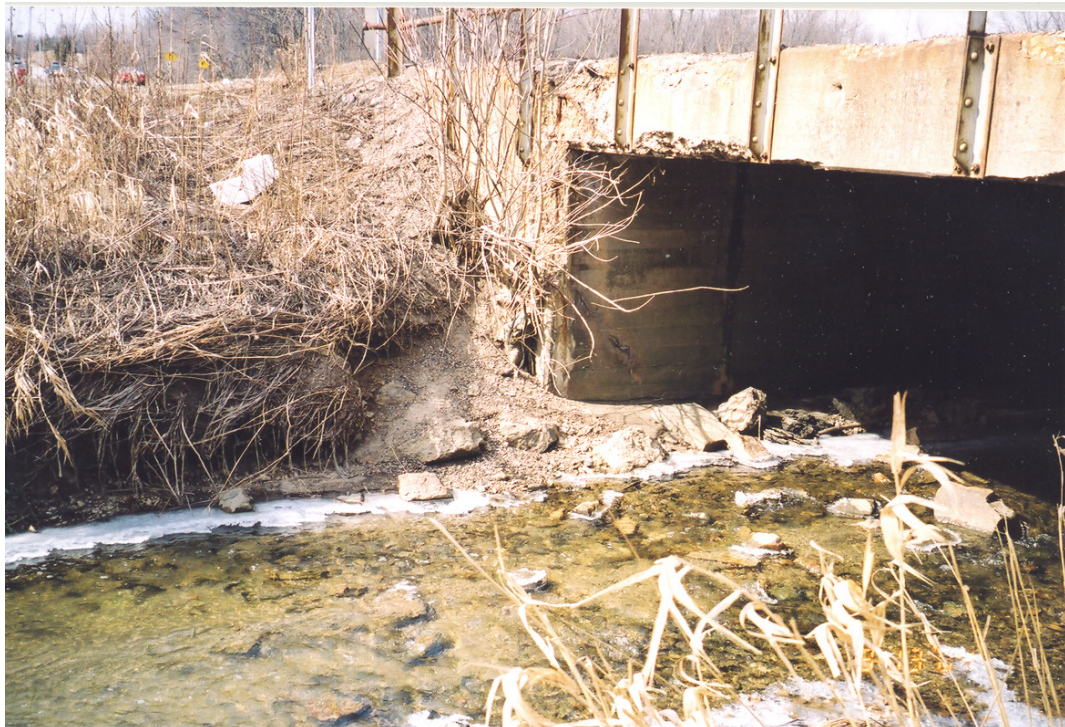
Based on a site visit and structure survey report by McMahon (2003), the bridge, substructure and approaches were observed to be in poor condition. Photos of the existing bridge taken in March 2004 are presented in Figures 48 to 51. As shown in the photos, the bridge had spalling concrete, exposed rebar, and distressed concrete. The eroding banks of the river appear to consist of silts and clays. The asphalt approaches indicated some transverse cracking. The shoulders were gravel, and steep embankments surrounded the bridge.

Figure 51: Erosion of banks at south side of Beloit Bridge

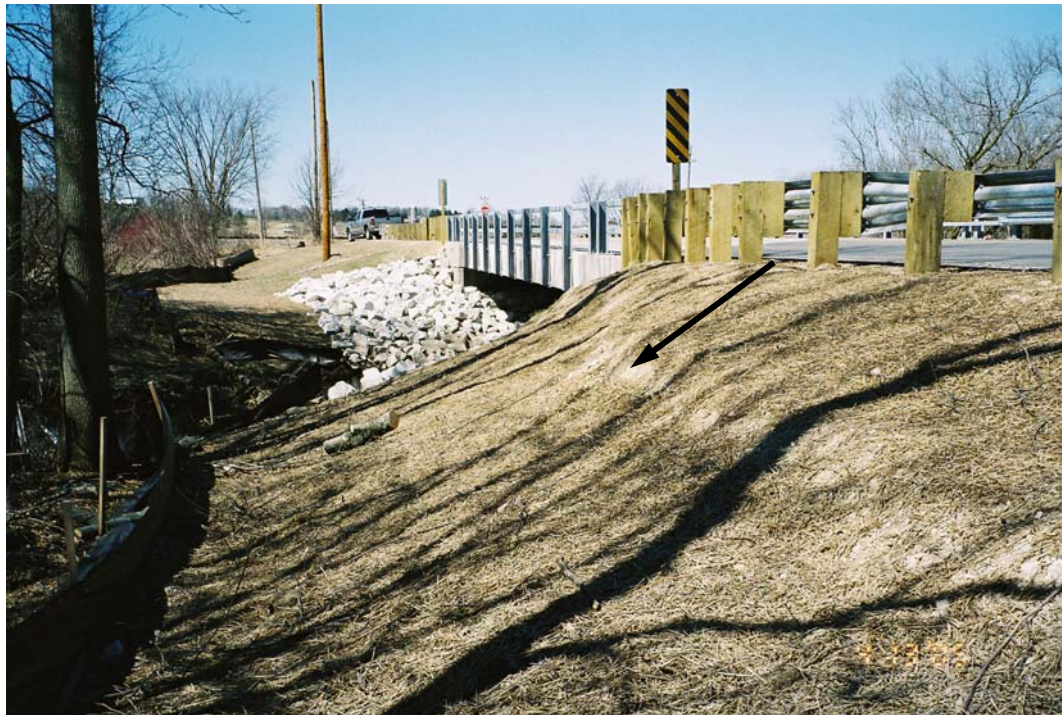
Figure 72: Slope instability along south side of Western Bridge

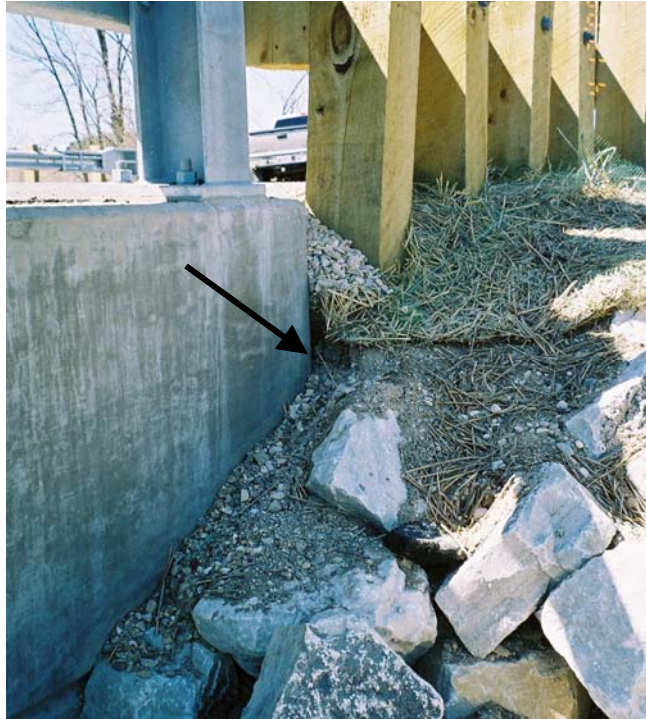
Figure 73: Erosion of fill at Northwest corner of Western Bridge

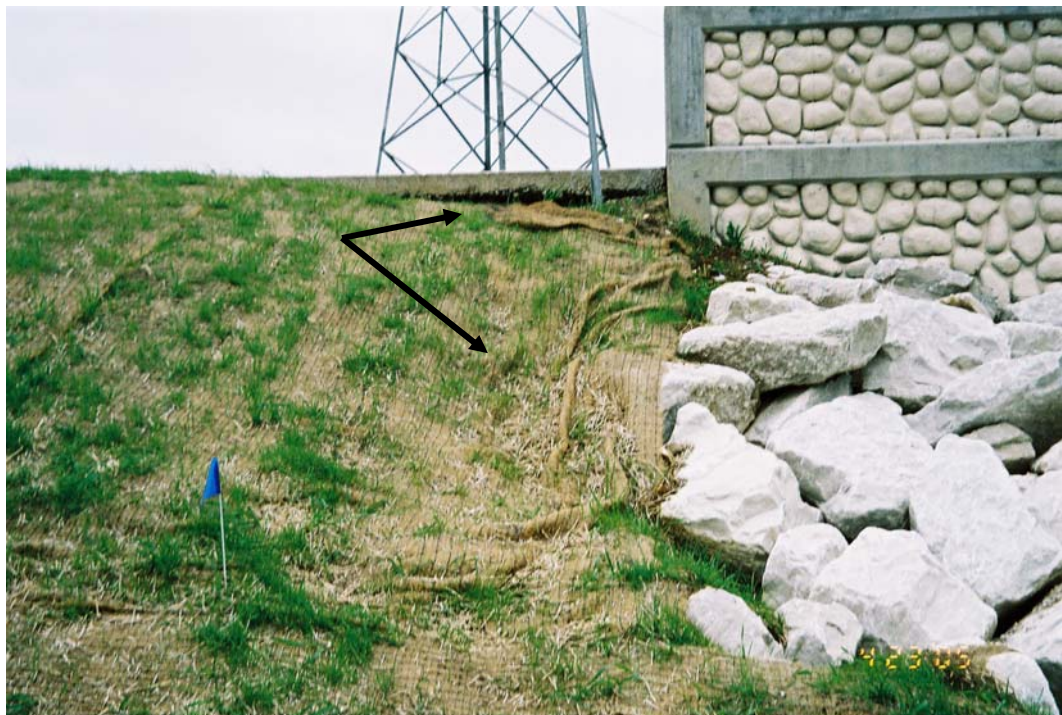
Figure 80: Slope Instability Southwest of Beloit Bridge
