Wambold Dam – Kroll Outlet Renovation

Eagle Spring Lake Management District

Kroll Outlet

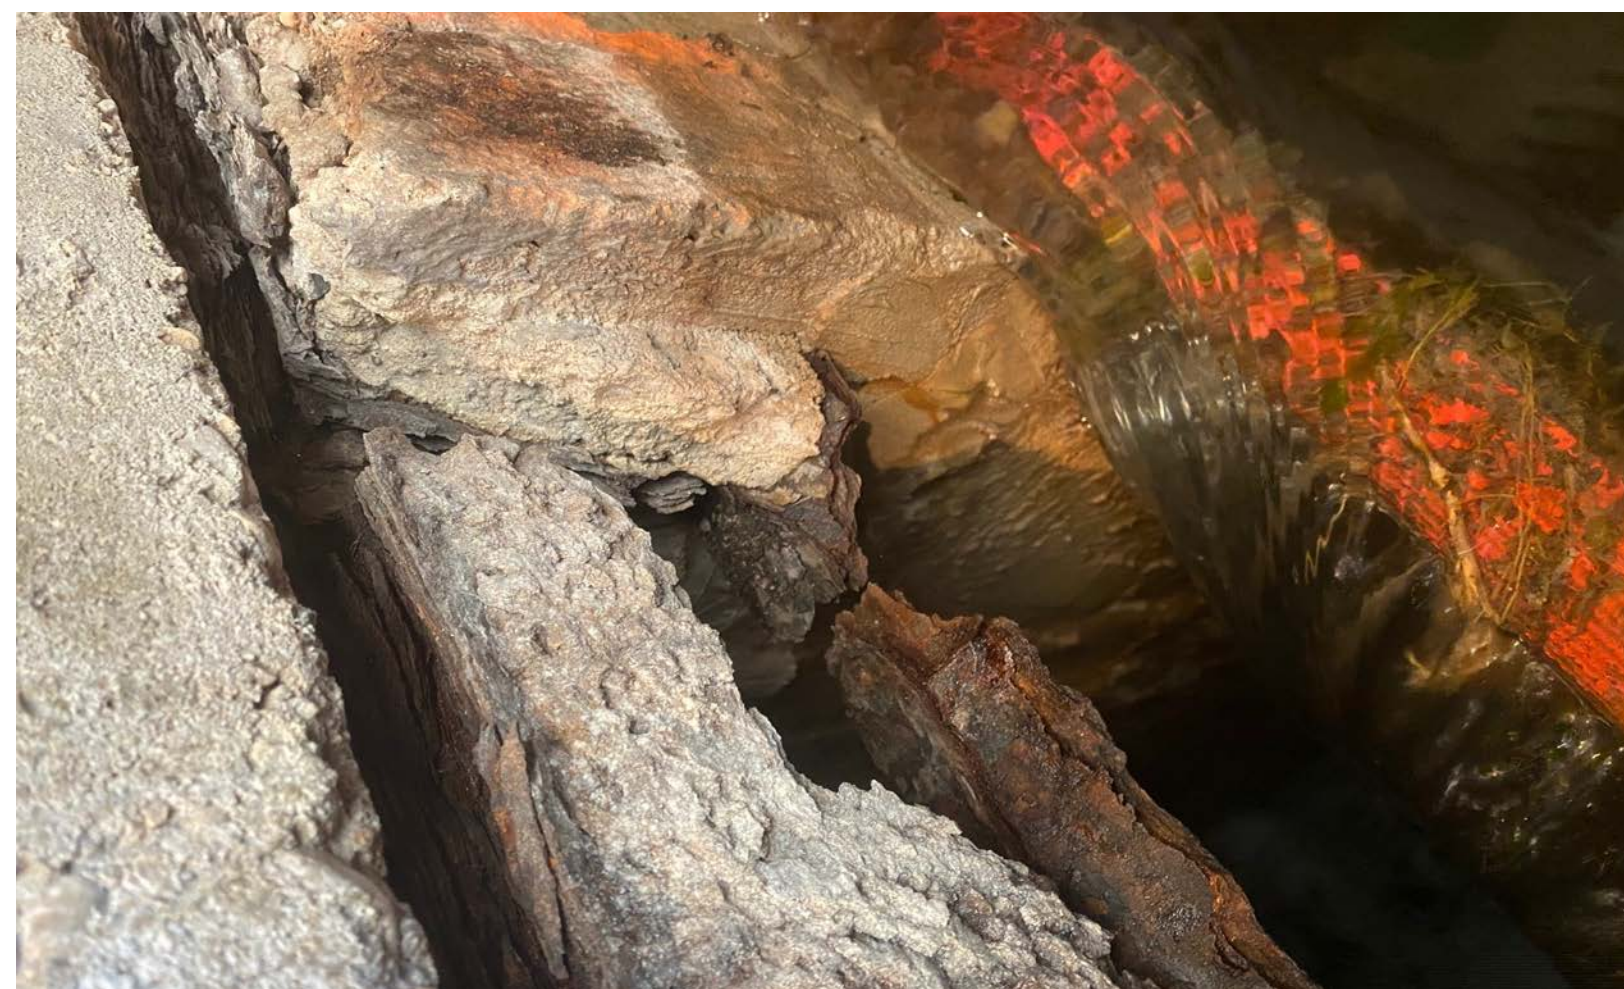
Severe Concrete Deterioration

Concrete had major cracking and exposed aggregate in the intake structure including areas where complete failure had occurred allowing water to bypass the normal intake routing.

- Remove and rebuild intake with new wing walls and trash grate.
- Replace all supporting steel throughout water channel (which also supports floor of building).
- Fill in adjoining underfloor crawlspace for floor support and to add sidewall support to water channel.
- Install two (2) new mechanical gates to control water flow.

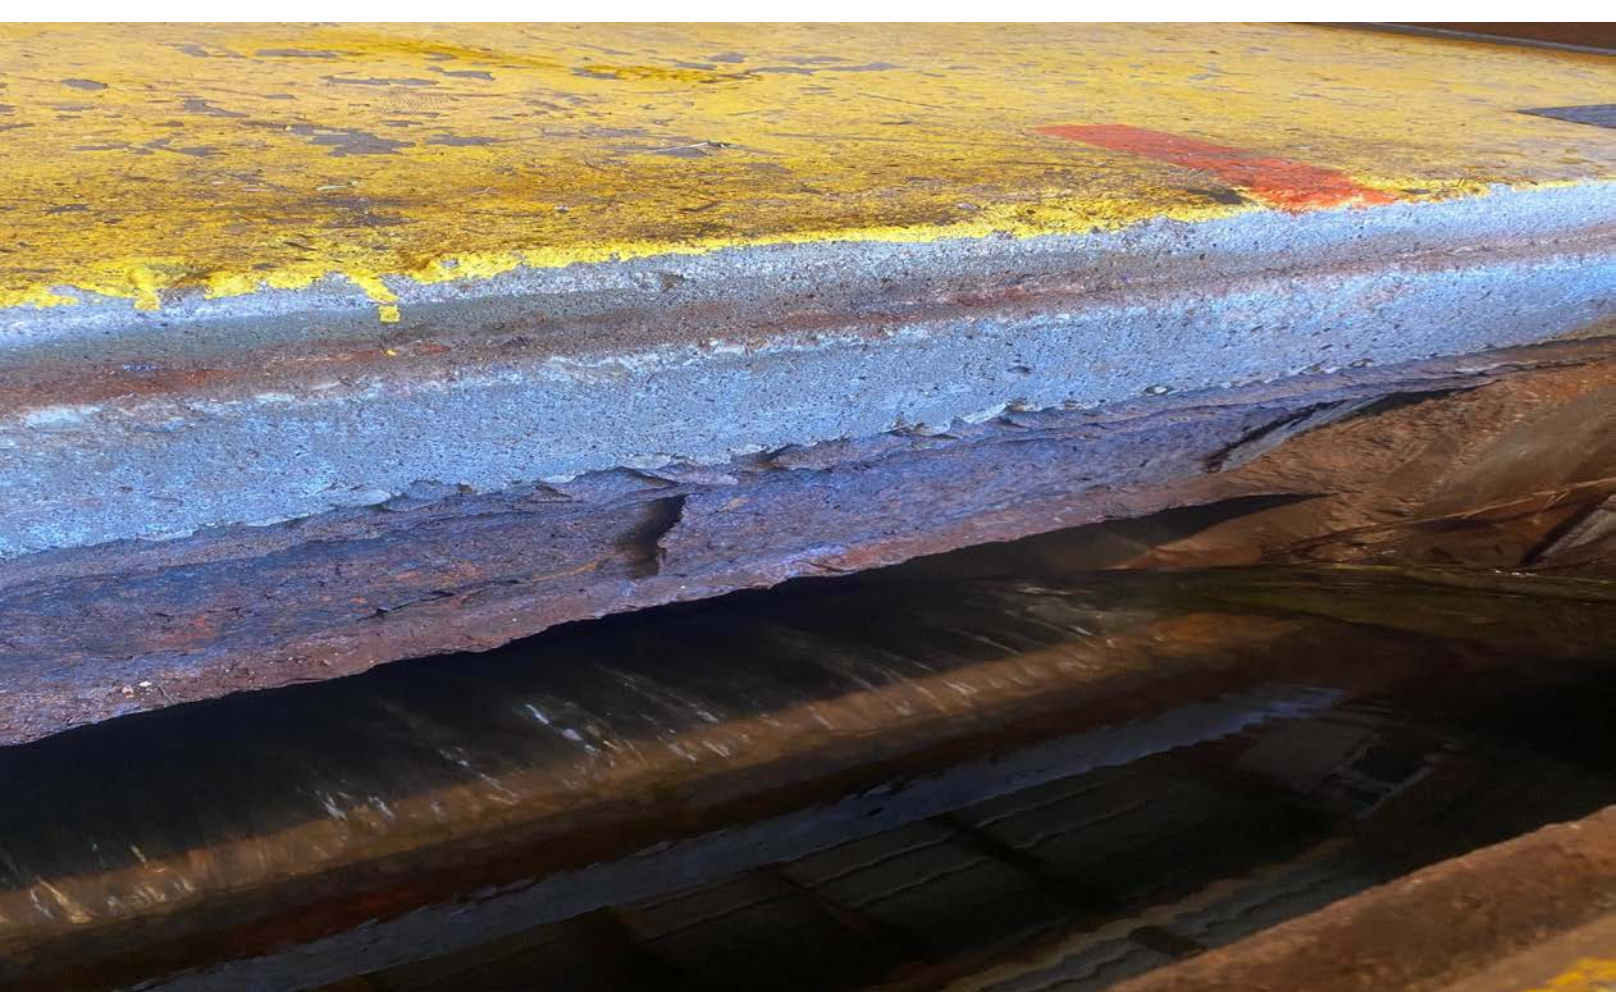
Major Steel Corrosion and Failure

Steel supporting the floor over the water intake chamber was severely corroded compromising its load bearing capacity.

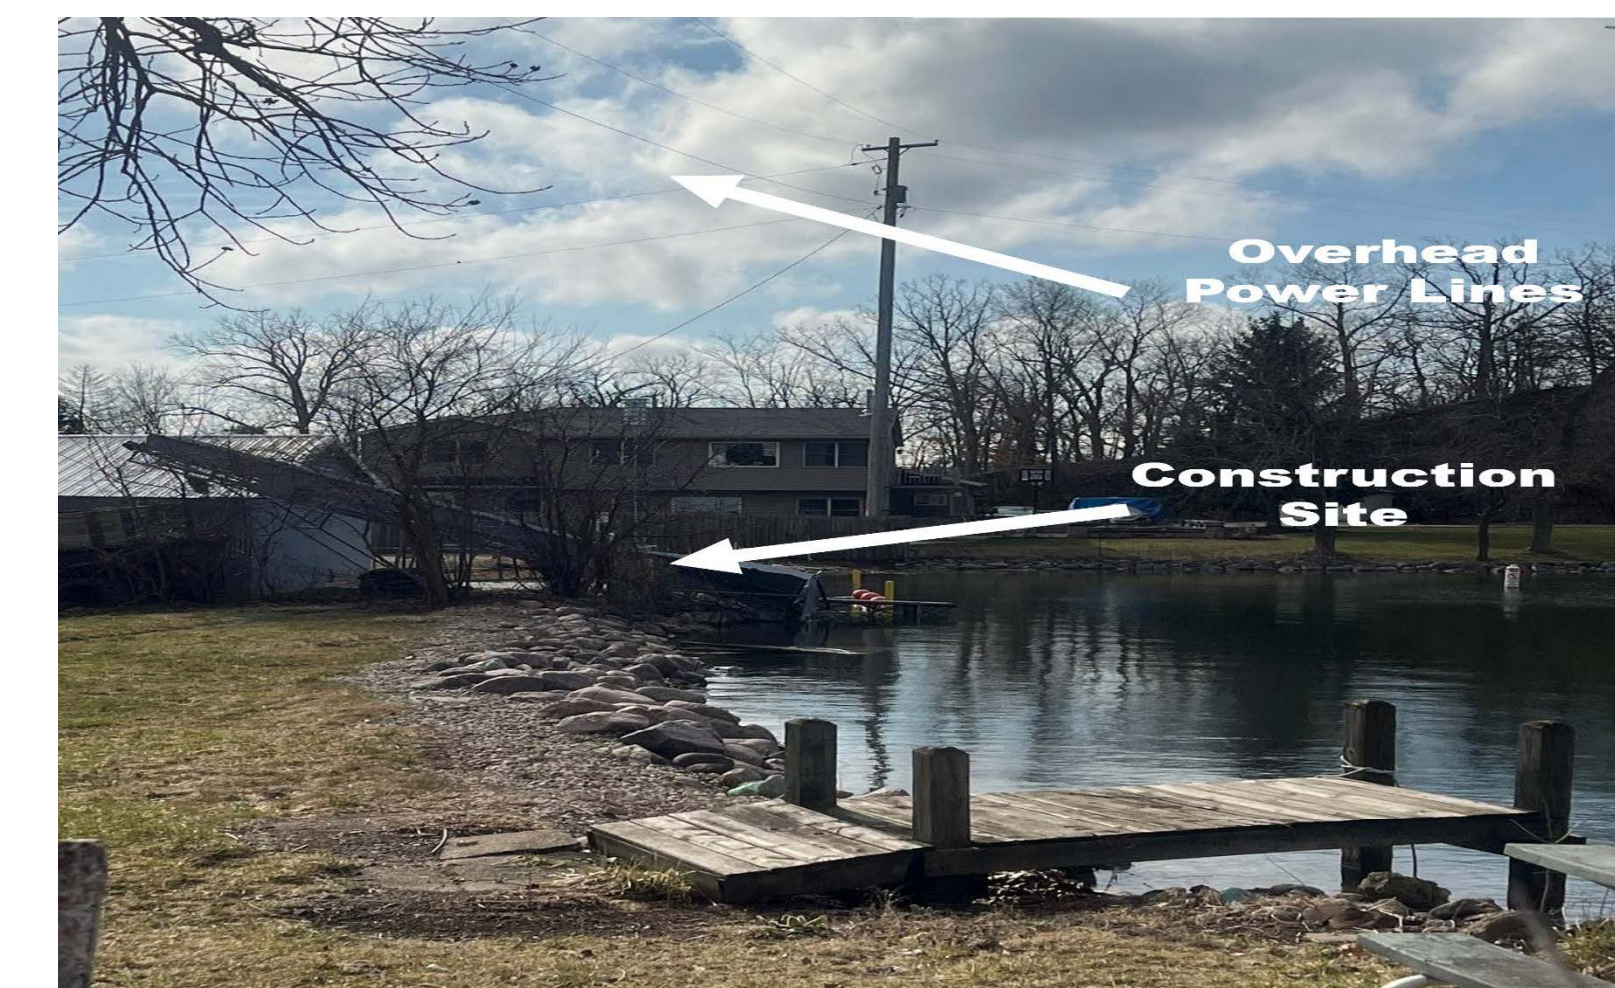
The contractor was concerned about some overhead power lines that were not shown on the plans or listed in the specifications. The temporary relocation of the lines would have cost over \$37,000.00.

The construction manager moved the location of the coffer dam so that the contractor could safely work in the area without interference with the electric lines.

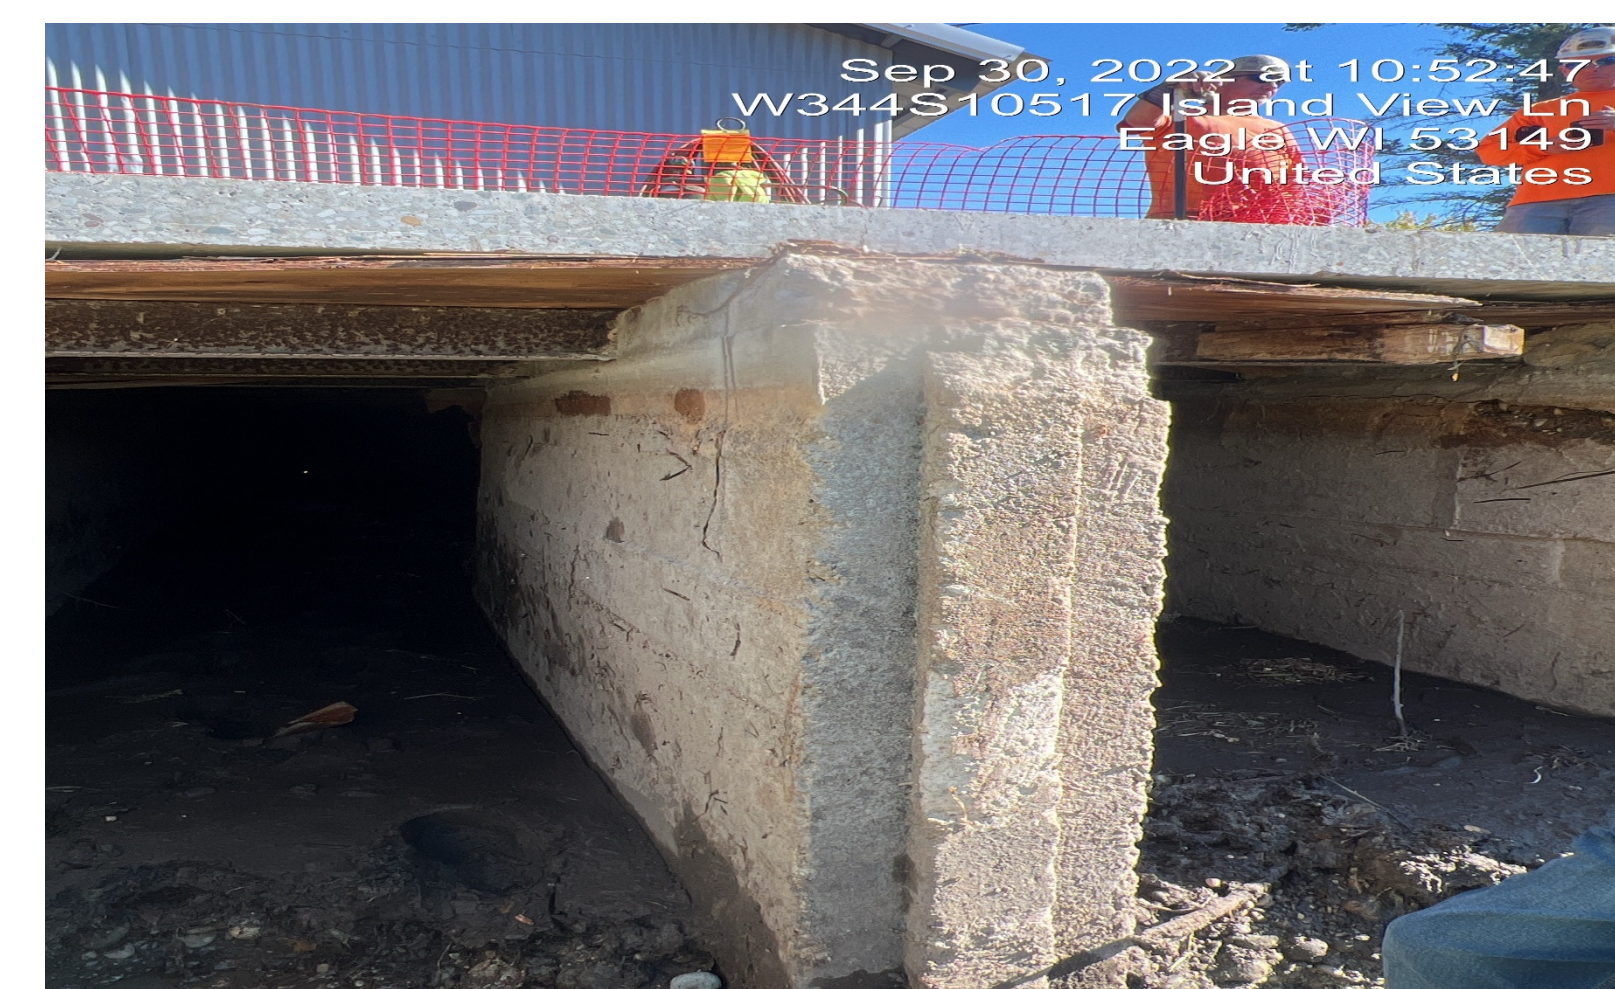
When the old intake was de-watered, a unknown concrete wall appeared and had to be removed.

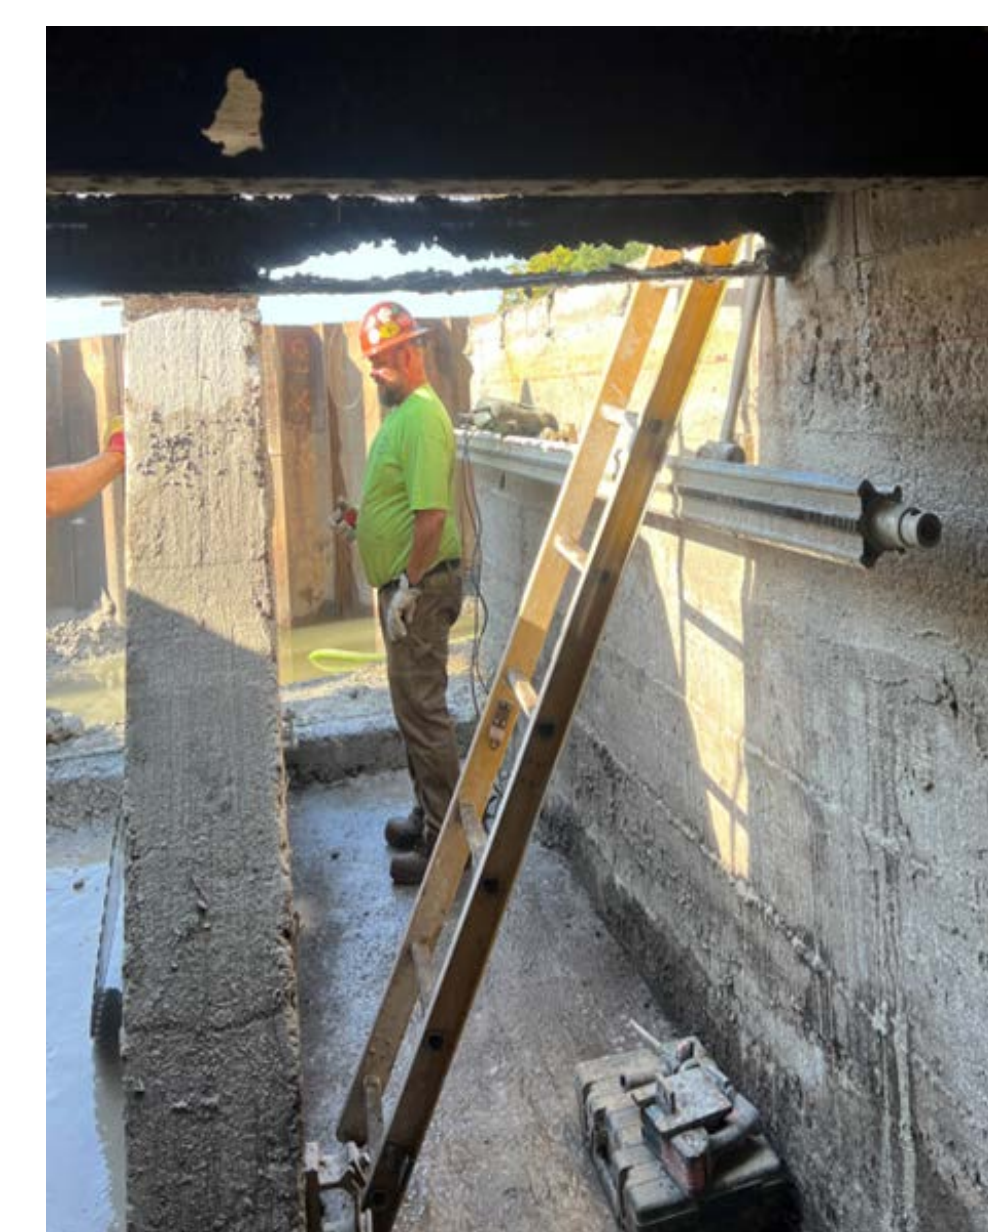
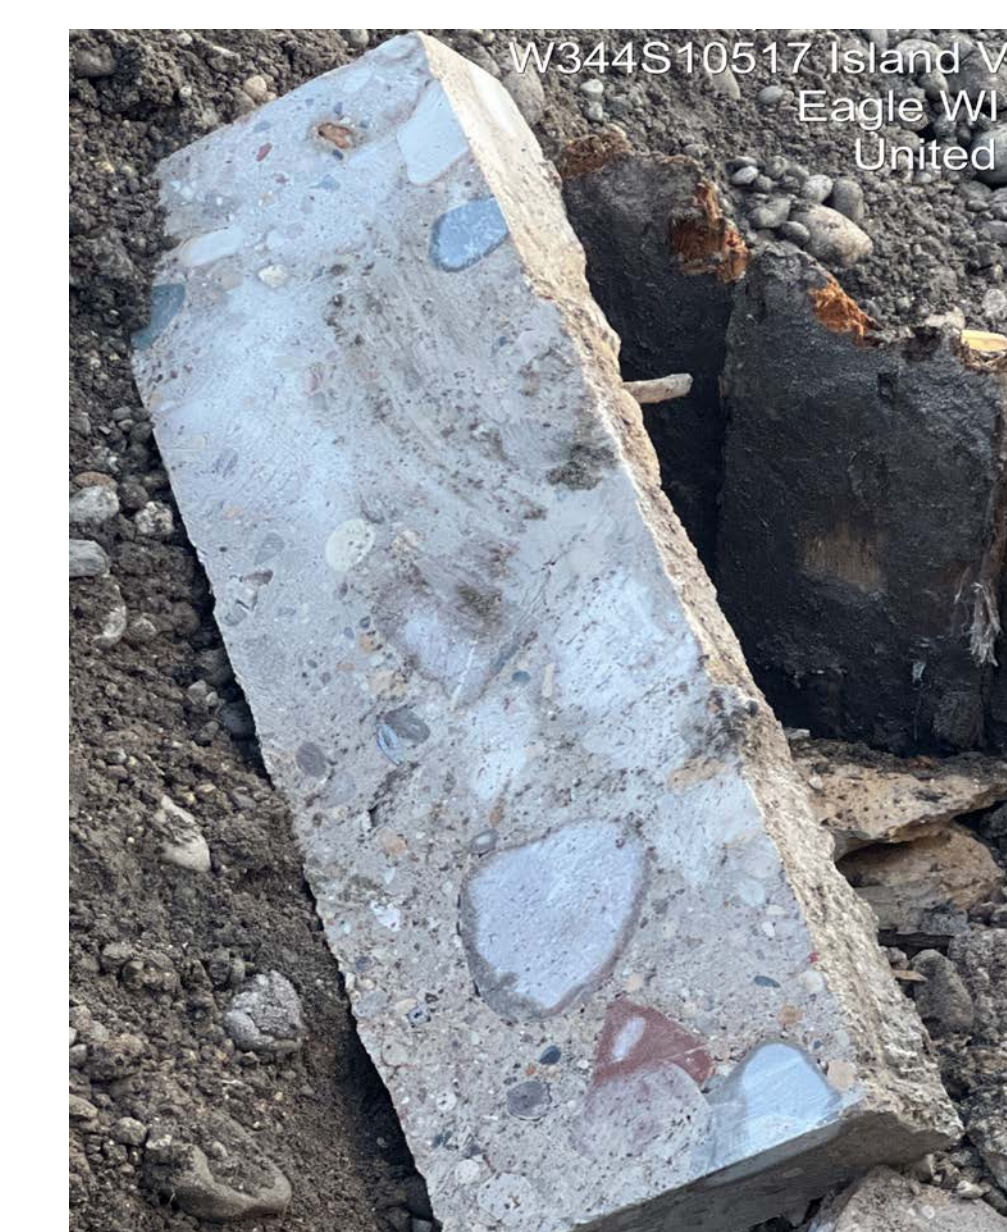
The supporting steel was in much worse shape than previously thought. In some cases an entire beam was missing, and some of the supporting steel you can see through. This required support timbers to be installed before workers entered the area for safety purposes.

As concrete was cut and removed, no rebar was found in the 1935 construction. In addition, aggregate size in the concrete ranged from over a foot to pea gravel. A number of beer bottles were found in the concrete that were disposed of by the WPA days workforce as were tobacco tins a few liquor bottles. Work standards have clearly changed over the years.

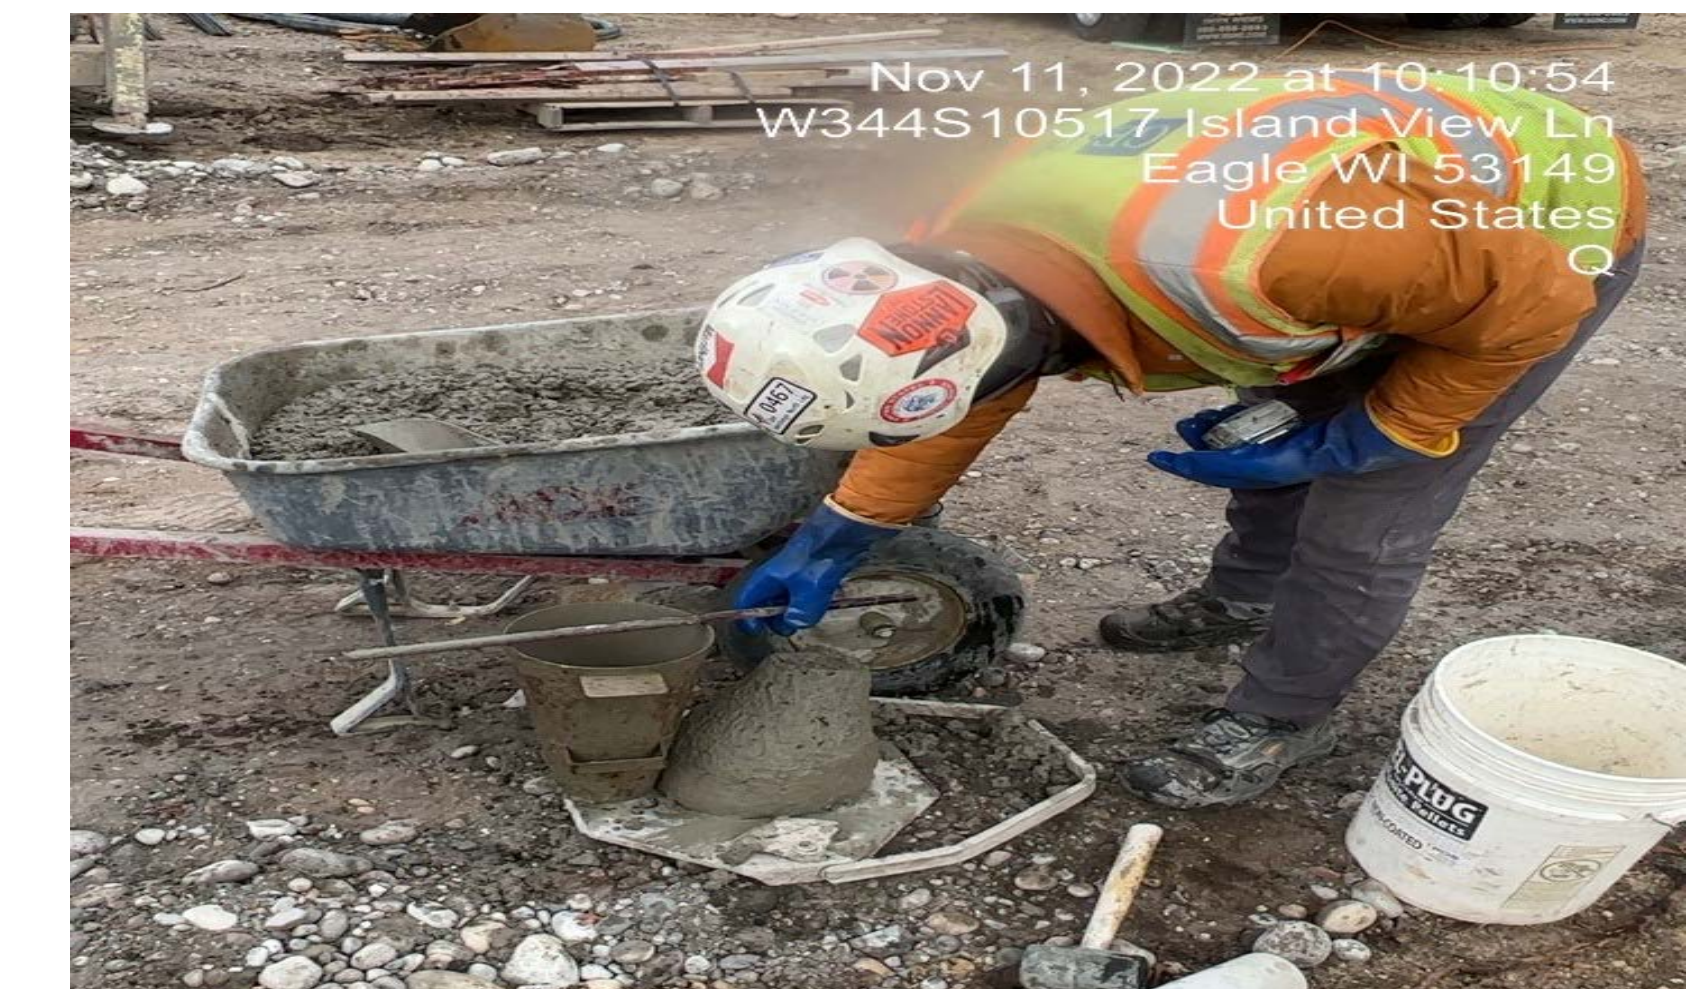
Quality Control

Every load of new concrete arriving at the site was field tested for slump and air entrainment. Samples were also taken for strength testing. Five loads of concrete were rejected by the Project Manager for being out of specifications (and in some cases seriously out of compliance). This resulted in some enlightened discussions with the concrete vendor on site.
