COMPREHENSIVE SANITARY SURVEY EVALUATION OF HIGH RISK BEACHES IN NORTHERN WISCONSIN

A Thesis Submitted
In Partial Fulfillment of the Requirement
For the Degree of

Masters of Science – Biology

June 2014

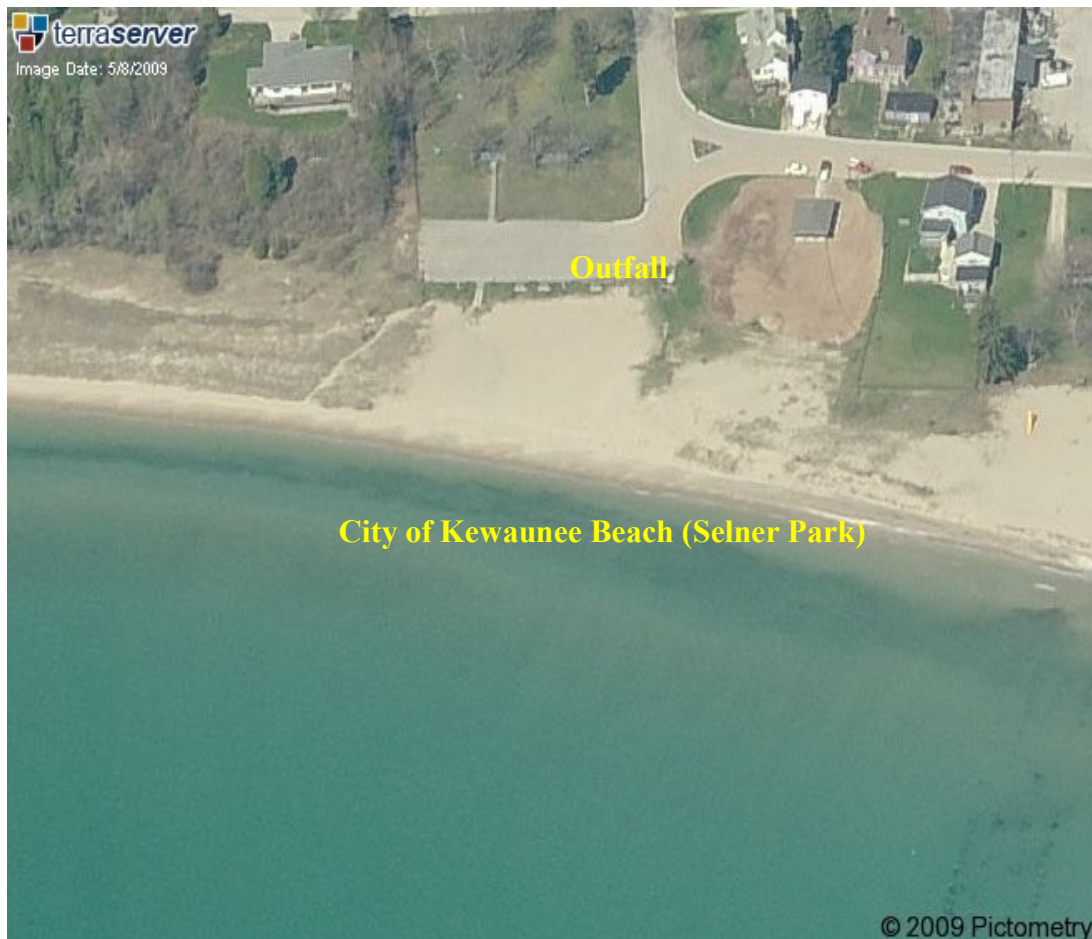
Figure 1. Aerial photo of City of Kewaunee Beach (Selner Park) in Kewaunee, WI.

Selner Park Beach is the official City of Kewaunee public bathing beach. There is park land and single-family beachfront residential property to the west, Pioneer Park and a breakwater to the north, and residential property to the south. Pioneer Park is located approximately 30 meters north of City of Kewaunee Beach (Selner Park) and is the two are treated essentially as one beach (Figure 1).

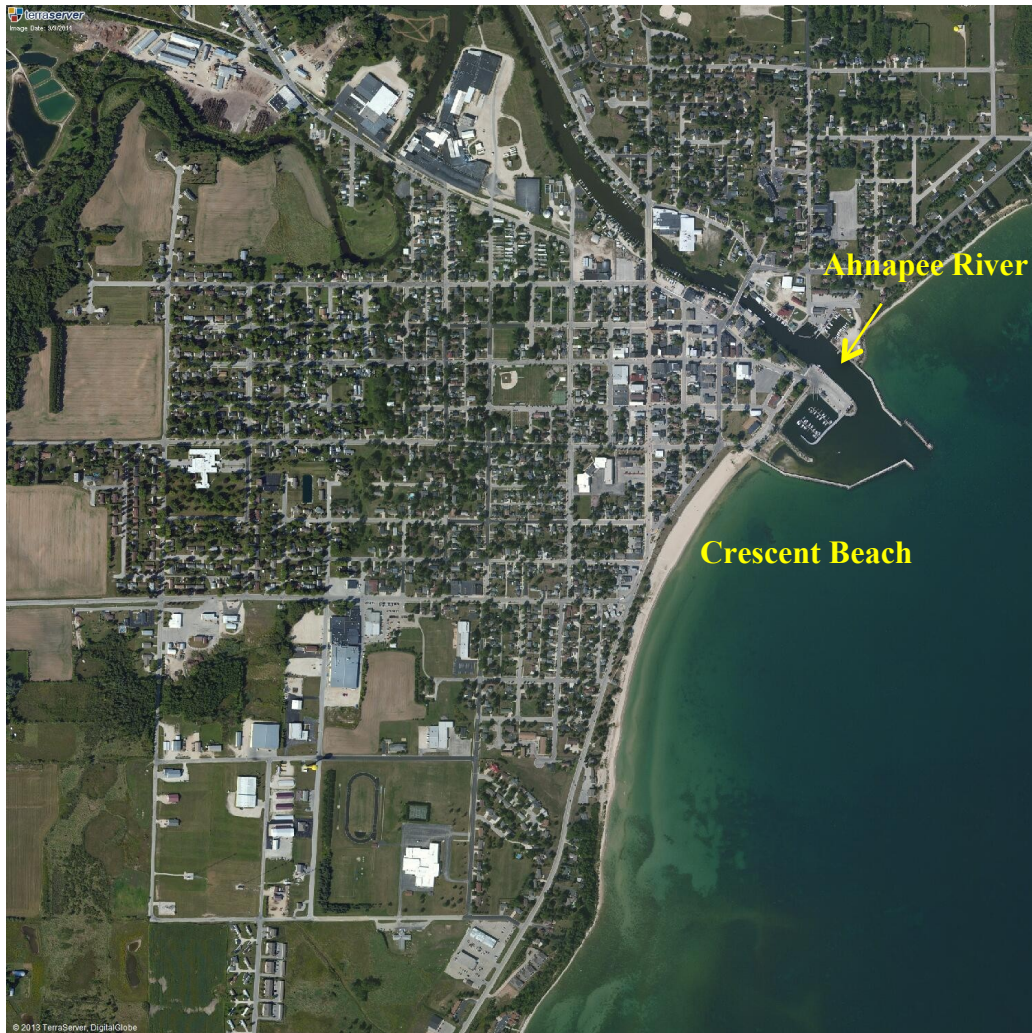
Figure 2. Aerial photo of Crescent Beach, marina, and Ahnapee River in Algoma, WI.

Crescent Beach is a municipal beach and located at the base of a small bluff. It is bounded on the north by a jetty and on the west side by park land. A major roadway and multi-purpose trail are above and run parallel to the beach (Figure 2).

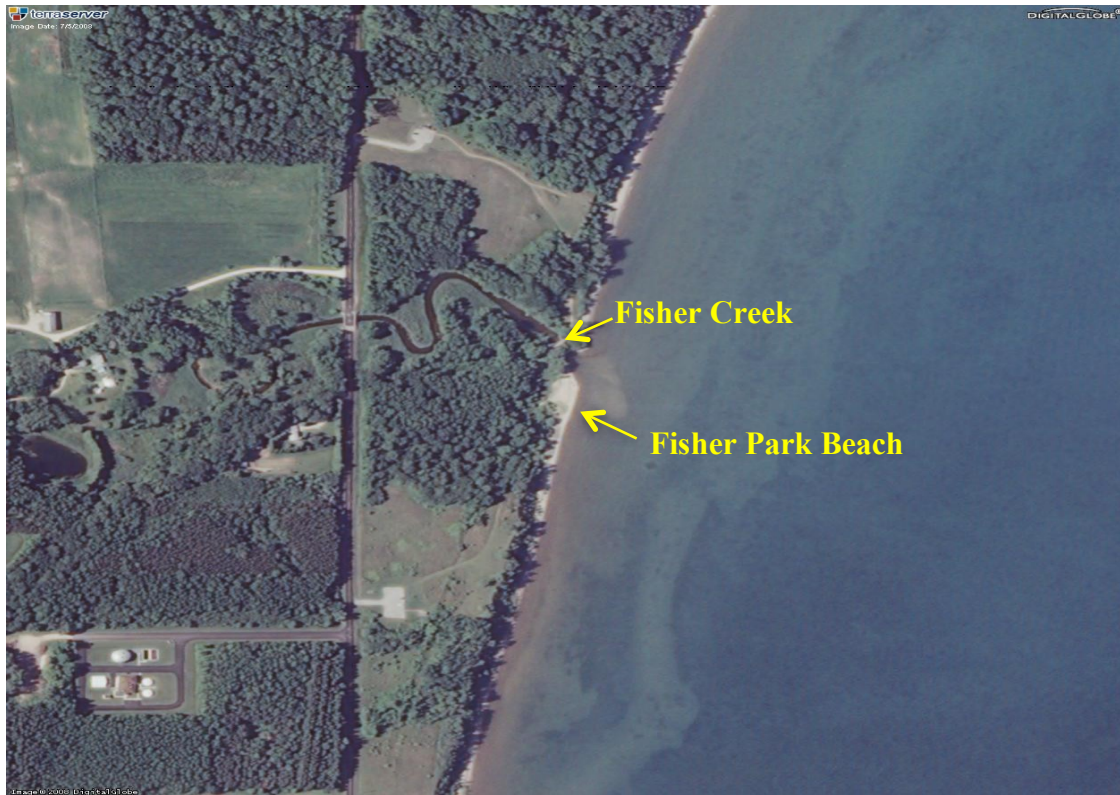
Figure 3. Aerial photo of Fisher Park Beach in Manitowoc, WI.

Fisher Park is a rural beach located in southern Manitowoc County. The surrounding area is comprised mostly of agricultural land with some residential properties (Figure 3). The beach is located at the bottom of a bluff with a park located on the top, with public access to the beach on both the north and south ends of the park.

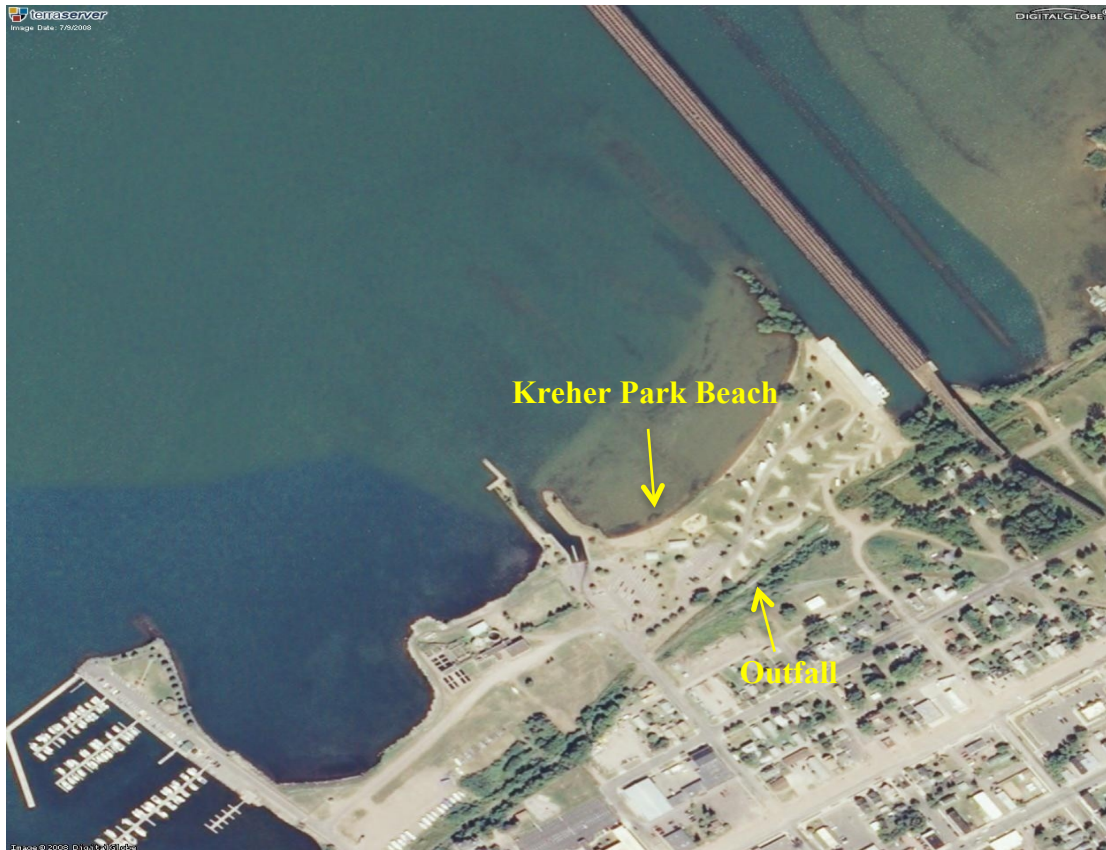
Figure 4. Aerial photo of Kreher Park Beach in Ashland, WI.

Kreher Park Beach is a municipal beach located in central Ashland, WI, on Lake Superior. This beach is located adjacent to a historical oar dock that was recently named a “Super Fund” site. This oar dock is currently being removed. The beach is below a large bluff that has a large municipal stormwater drain. This drain only flows during and after rain events. There is a marina west of the beach with heavy boat traffic. There is also a park and campground directly west of the beach (Figure 4).

The major source of contamination at Kreher Park Beach is stormwater, including municipal and sheet flow from adjacent impervious surfaces. Visual observation showed little-to-no stormwater infiltration due to extensive impervious surfaces surrounding the beach. Since the beach is embayed, normal hydrological circulation is unable to occur. These characteristics along with the low, flat, sand starved beach serve as an optimal reservoir for *E. coli* survival.

fecal material in nearshore water. If a redesign plan would be developed it should address methods for better infiltration of stormwater or deferment from the beach proper. This beach is currently closed to the public while the nearby oar dock is under construction and being removed. Once the oar dock is removed, it is recommended that Kreher Park Beach be reassessed for water quality and beach usage.

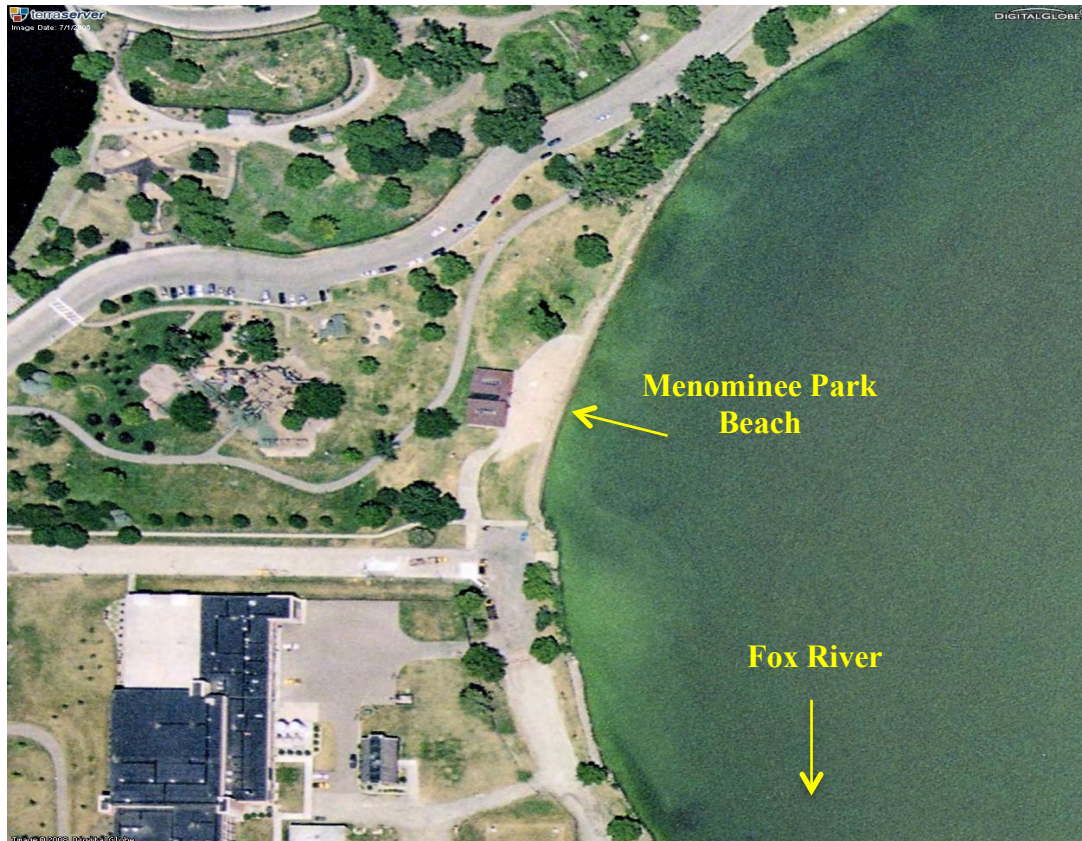
Figure 6. Aerial photo of Menominee Park Beach in Oshkosh, WI located on an inland lake, Lake Winnebago.

Menominee Park is an inland municipal beach located on Lake Winnebago in Oshkosh, WI. Menominee Park Beach is located within Menominee Park; a large park with a small zoo, baseball diamonds, and a marina. There is a large play area near the beach and a concession stand/bath house located upshore of the beach (Figure 6). The Oshkosh Water Treatment plant is directly south of the beach. Water intake for the plant is several hundred yards offshore from the beach.

These data show that conducting sanitary surveys to identify potential pollution sources is effective at inland beaches. Menominee Park Beach exhibited similar characteristics to Great Lake beaches, including ineffective stormwater management, lacking deterrence of waterfowl, and sand starved beach front with few or no sand dunes. With this in mind, Menominee Park Beach is located on a large inland lake (Lake Winnebago). These results may not be the same for beaches located on smaller inland lakes where longshore current, wave action, and macrophytic algae are not present. It is recommended that Menominee Park Beach continue to be monitored to keep the public informed of the water quality. If mitigation is feasible in the future, an assessment should be conducted afterwards to evaluate the effectiveness of the newly mitigated beach.

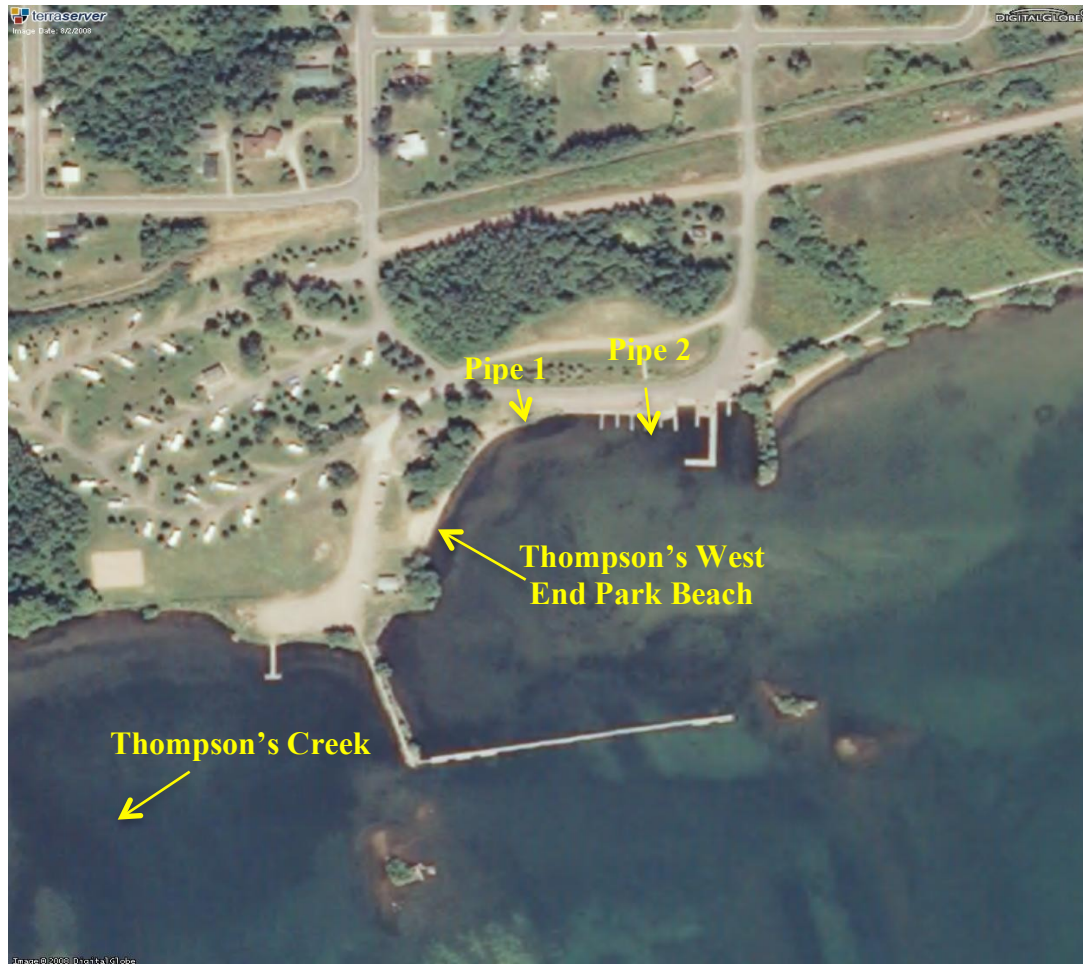
Figure 9. Aerial photo of Thompson's West End Park Beach in Washburn, WI.

Thompson's West End Park Beach is primarily used for swimming, boating, and other recreational activities in the adjacent park and campground. There is a campground directly west of the beach and a jetty extending into the water to the south. There is also a boat launch bordering the east side of the beach with several docks (Figure 9).

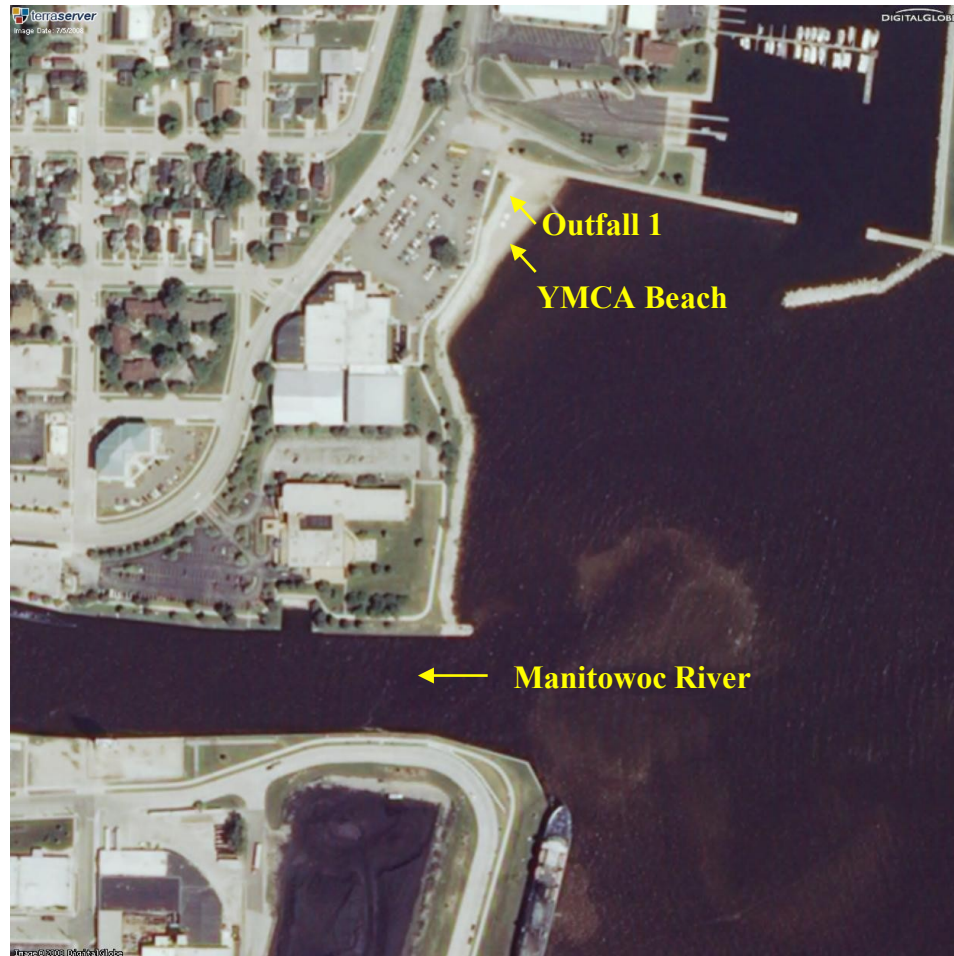
Figure 10. Aerial photo of YMCA Beach in Manitowoc, WI.

YMCA Beach is located in an urban region of Manitowoc, WI. This beach is not only used for swimming, but a number of other recreational activities throughout the summer, including triathlons and dragon boat races. Surrounding area is primarily made up of impervious surfaces and hard infrastructure such as parking lots, a pier, a marina, and boulders placed for bluff stabilization (Figure 10). There is very little vegetation between the adjacent parking lot and beach proper.
