FLOODPLAIN RESPONSE TO HISTORICAL LAND USE CHANGE ON THE
UPPER BARABOO RIVER, WISCONSIN

Austin Jena Krause

A thesis submitted in partial fulfillment of
the requirements for the degree of

2010

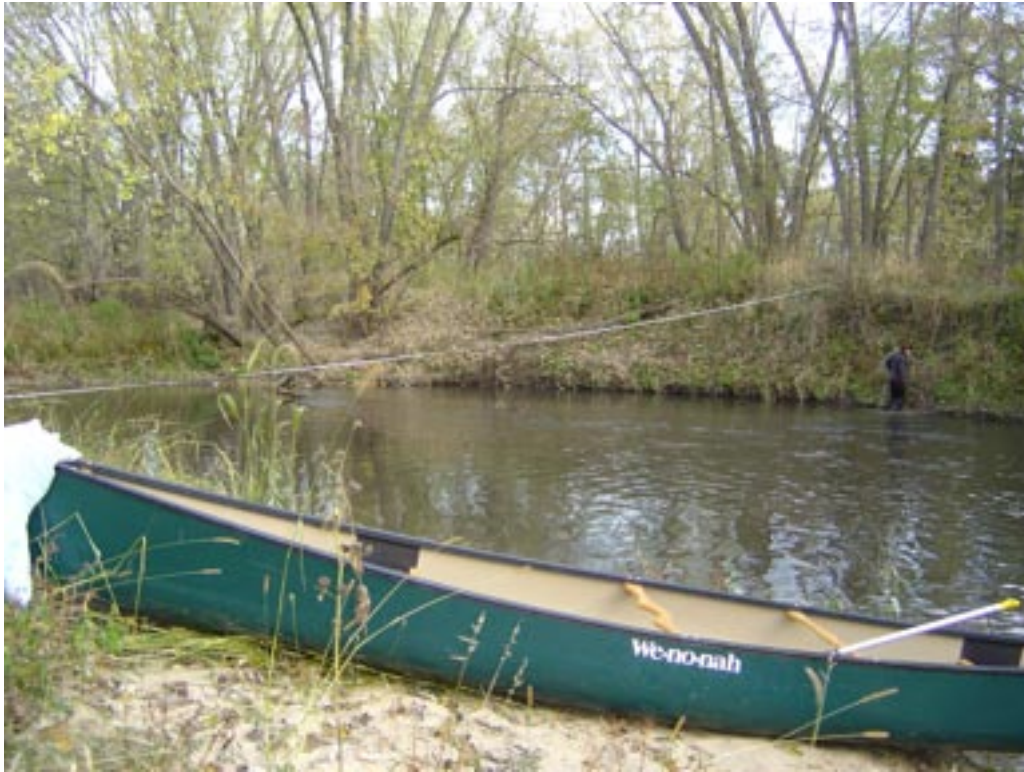
Figure 3. The foreground shows sand deposits on the point bar, while the background shows the cut bank of a meander bend.

Despite the bedrock valley confinement, the remaining floodplain in this system adjusts both by lateral and vertical accretion. Evidence of these processes is noticeable on the Baraboo River. Through Light Detection and Ranging (LIDAR), development of meander migrations or lateral accretion and other meander scars such as oxbow lakes can be determined. Field observations documented lateral accretion on the banks, most notably fresh sand deposition on the point bars and floodplain as a result of the June 2008 flood. The 2008 flood was estimated to have a 500-year recurrence probability (Fitzpatrick et al., 2008). Figure 2 shows valley constriction possibly related to faulting in the Cambrian bedrock (Attig and Clayton, 1990). Downstream, as the valley opens up, the river channel is freer to migrate laterally across the floodplain and the natural channel tends to be more sinuous (Figure 2). Figure 3 shows the effects of lateral migration processes with bank erosion on the far outer bank and deposition of sand on the inside point bar respectively.

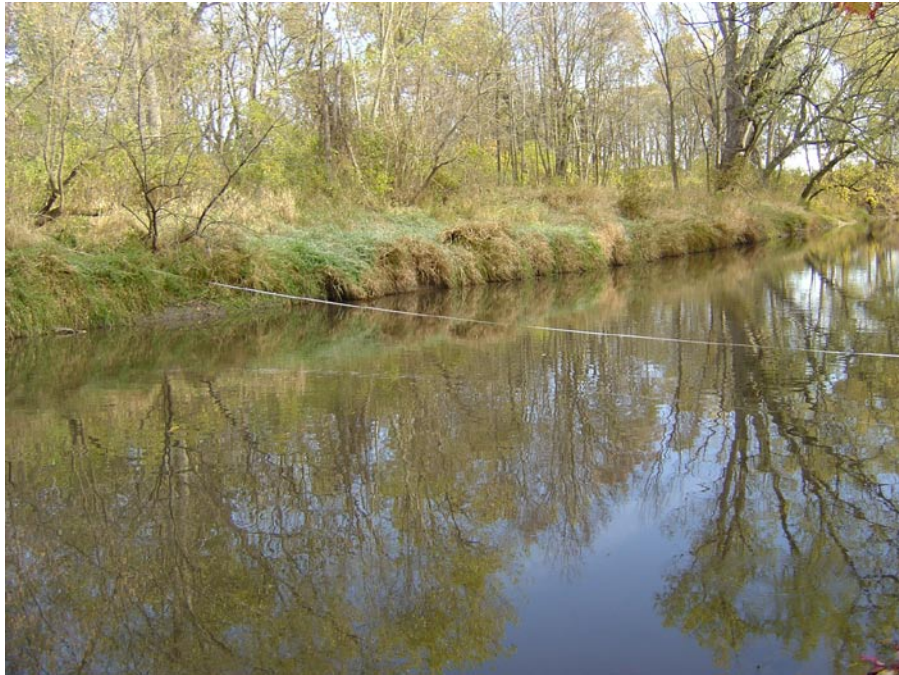
Figure 6. Reed canary grass lining the channel banks.

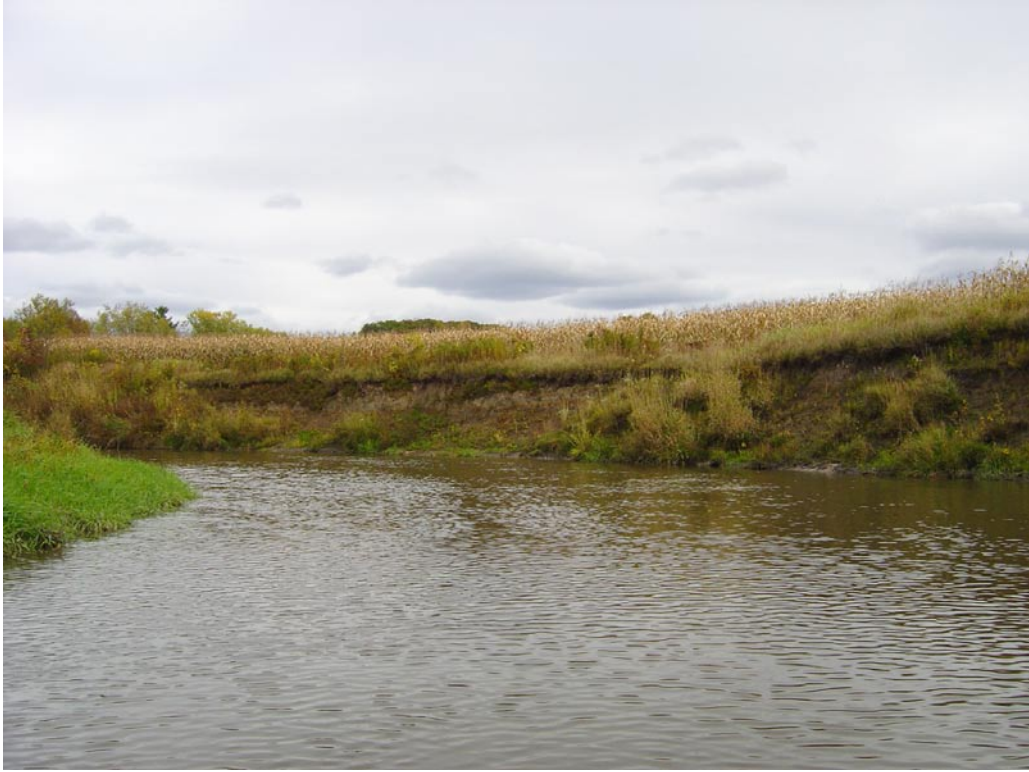
Figure 7. Cornfields growing up to channel banks.

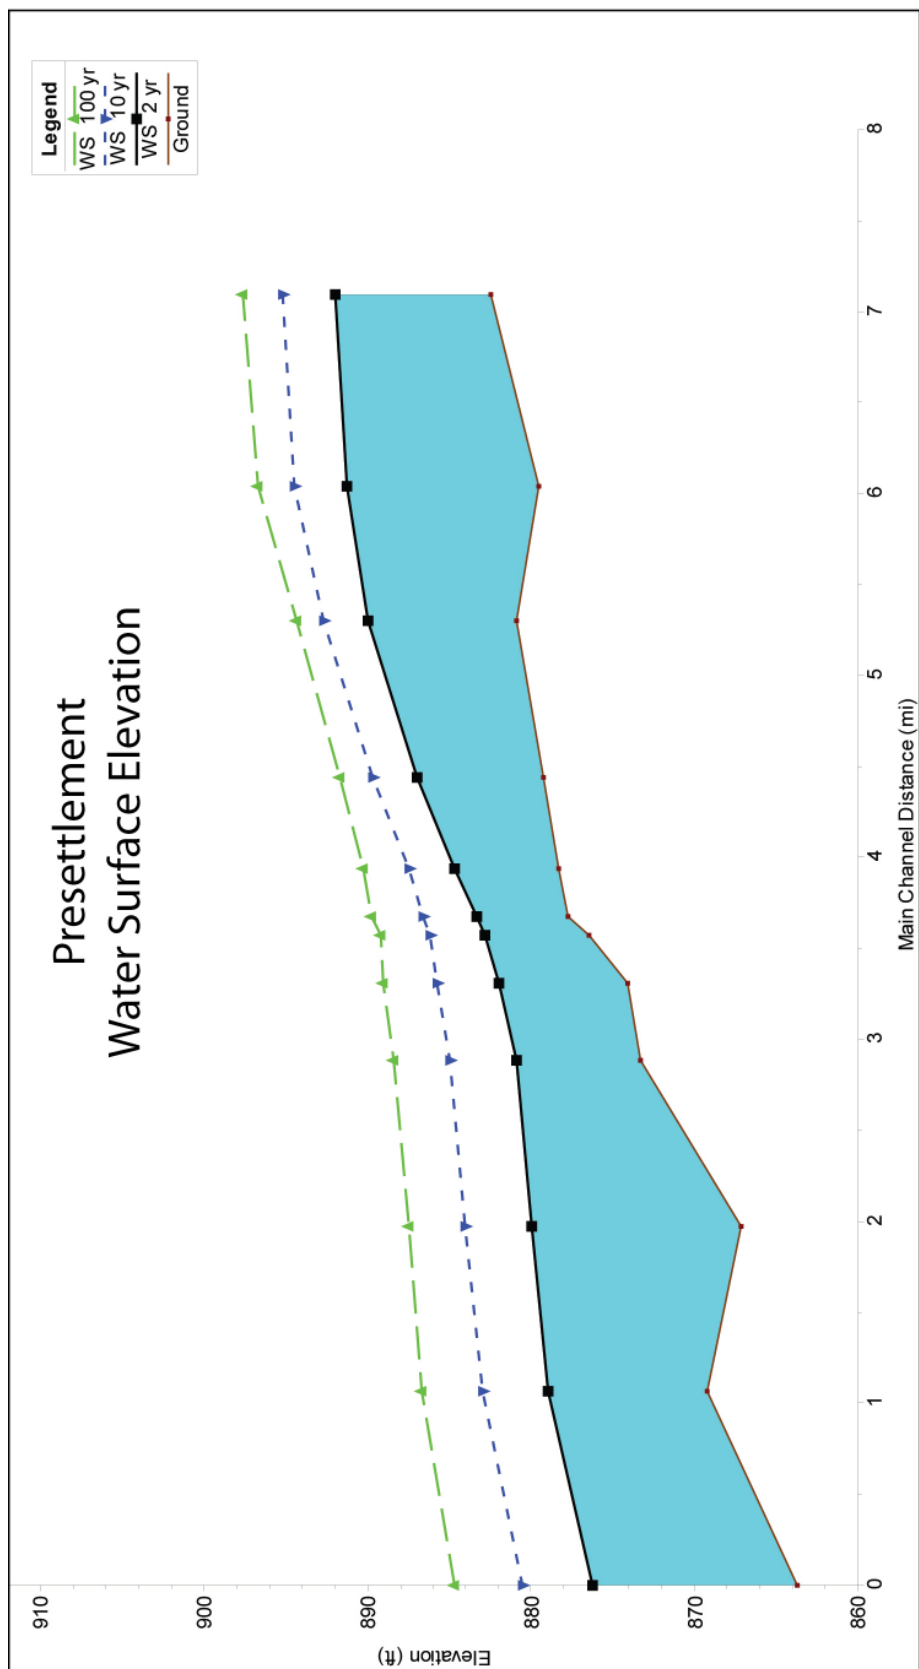
Figure 9. Prettlement longitudinal profile of water surface elevation after adjustments to cross-sections 9 and 10.

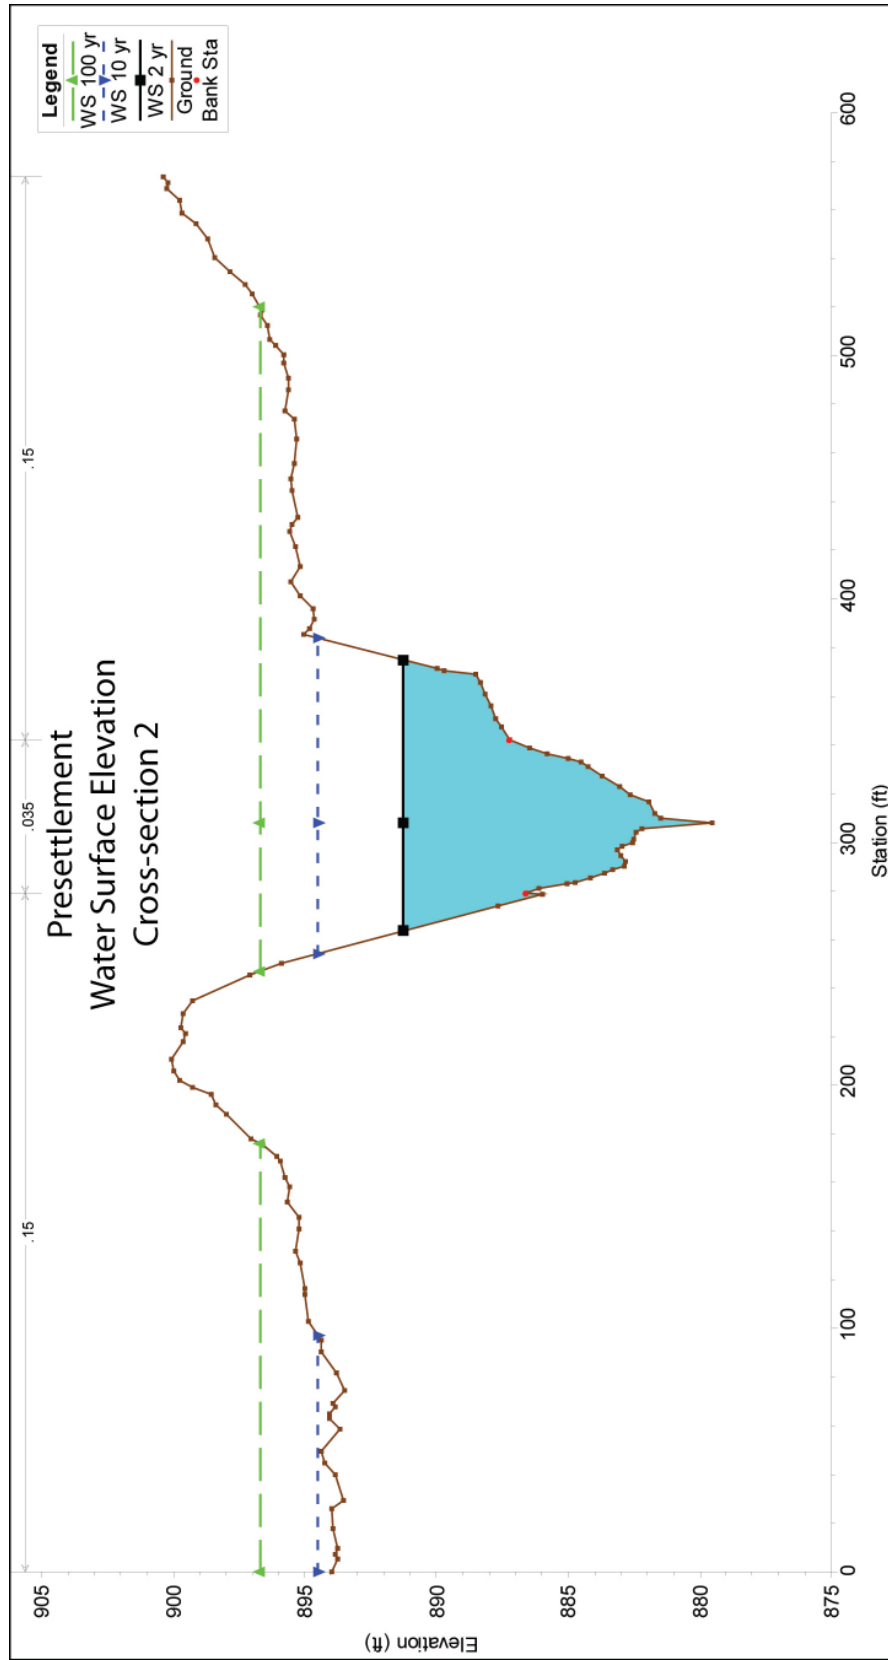
Figure 14. Presettlement water surface elevation at cross-section 2.

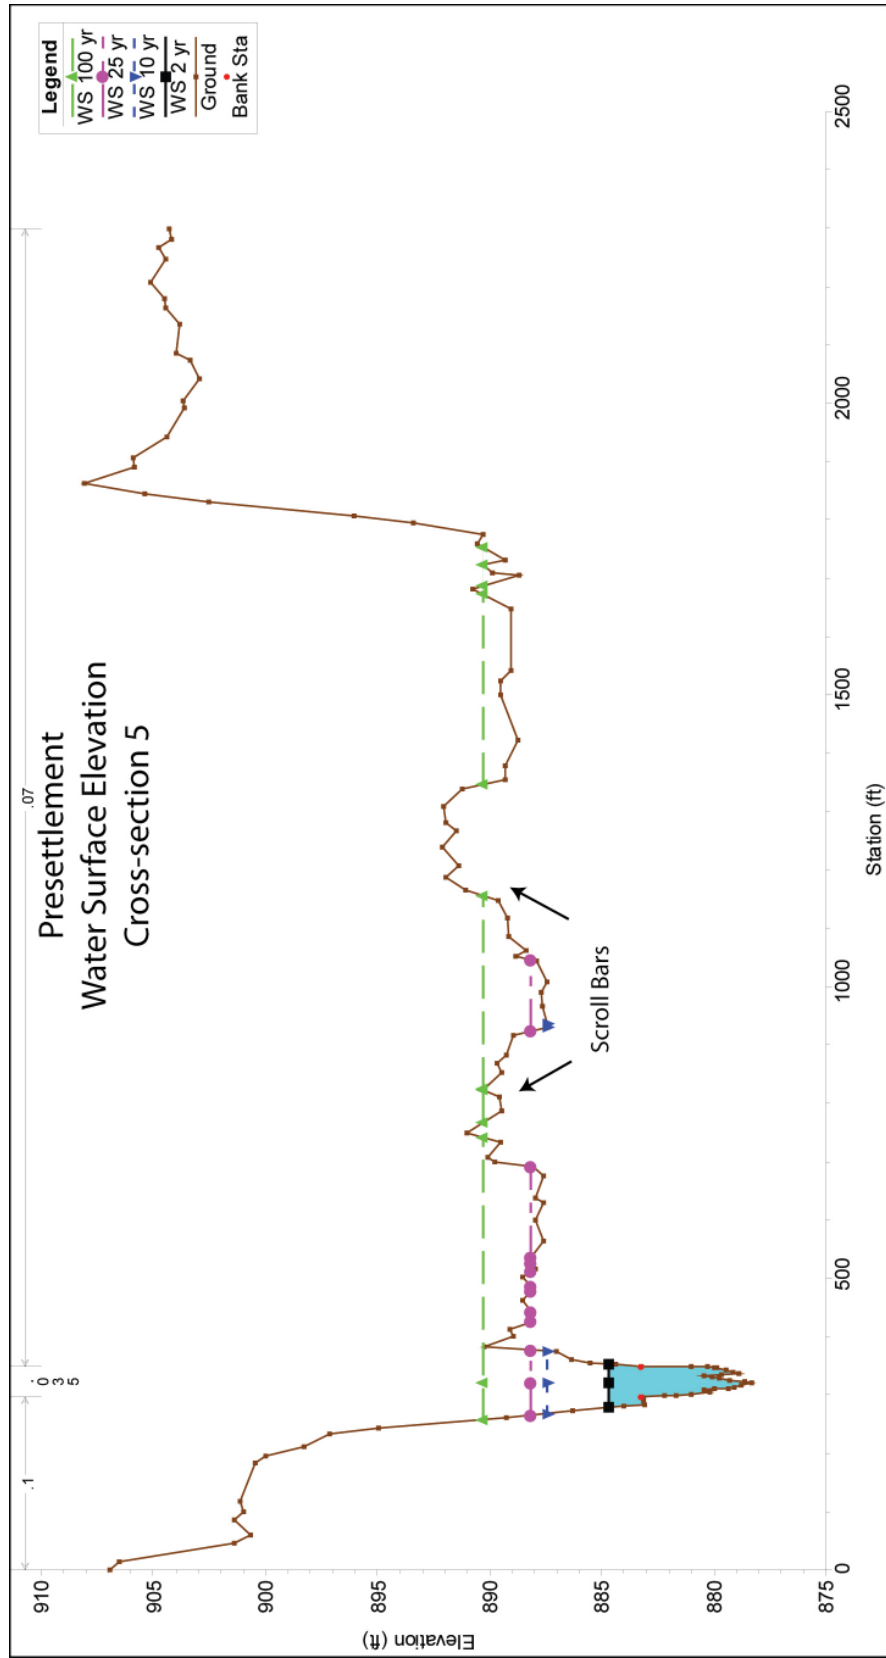
Figure 16. Presettlement water surface elevation at cross-section 5.

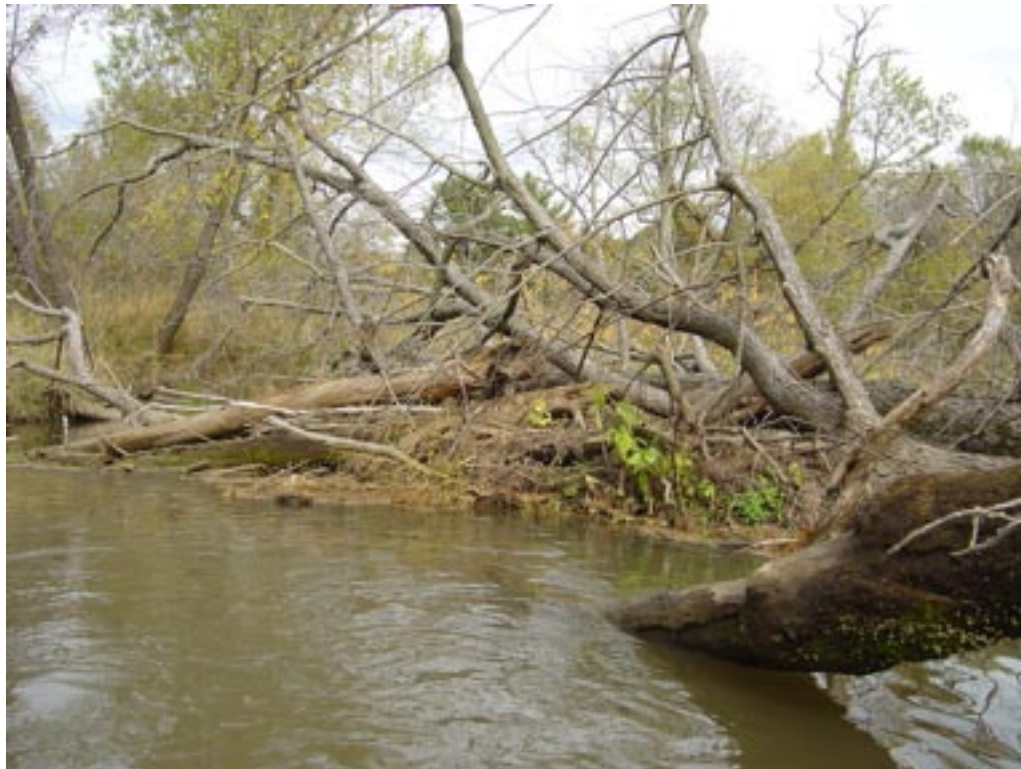
Figure 32. Tree dam obstructing flow on the Baraboo River.

Another type of channelization includes the removal of instream obstructions, which converts heterogeneous channel systems to homogeneous systems. Removing tree dams from the channel causes the channel geomorphic structure to lose complexity with natural changes in flow and decreases habitat availability (Abbe and Montgomery, 1996). It is also possible that removing obstructions could induce instability upstream and downstream (Brierley and Fryirs, 2005). A change in vegetation along the bank and increase in runoff from agricultural practices have contributed to the increased roughness in the channel, but a decrease in
