## **Guidance, Parameters, and Recommendations for Rubblized Pavements**

WHRP 06-13

**Final Report  
Report No. WHRP 06-13  
(ARA Project No. 16730)**

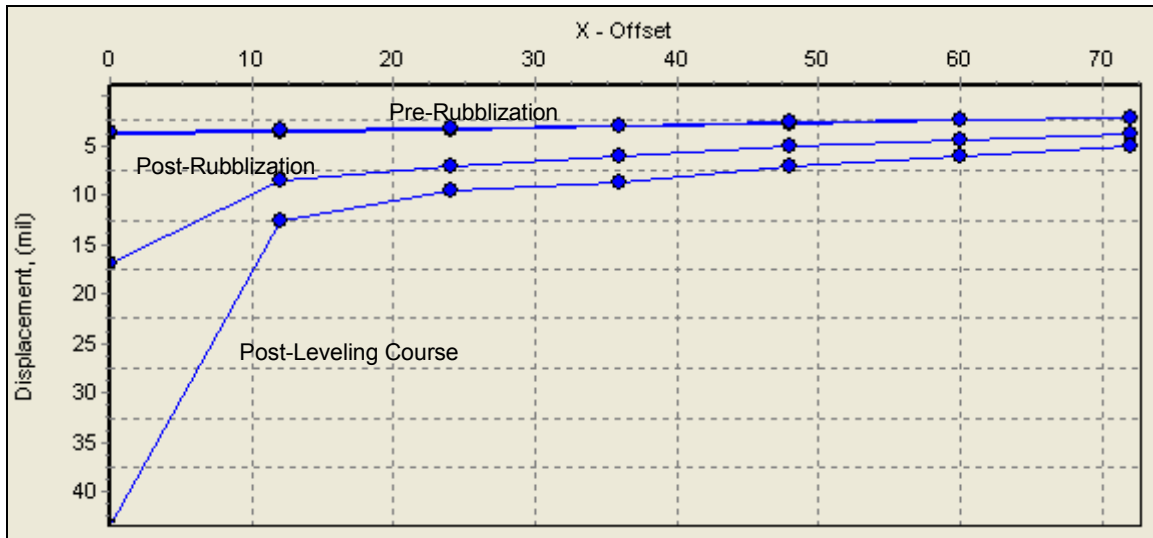
**Figure 5 FWD deflection basins measured on rubblized PCC airport pavement at different times during the rubblization process.**

Figure 5 shows FWD deflection basins from a rubblized airport pavement before rubblization, after rubblization, and after placing a recycled concrete aggregate (RCA) base course. The figure shows that the RCA leveling increased the deflections, particularly near the loading plate – suggesting a lower modulus material. This lower modulus material is acting as a cushion layer or course. Cushion courses have not been used extensively, because of the increases in pavement surface elevations.

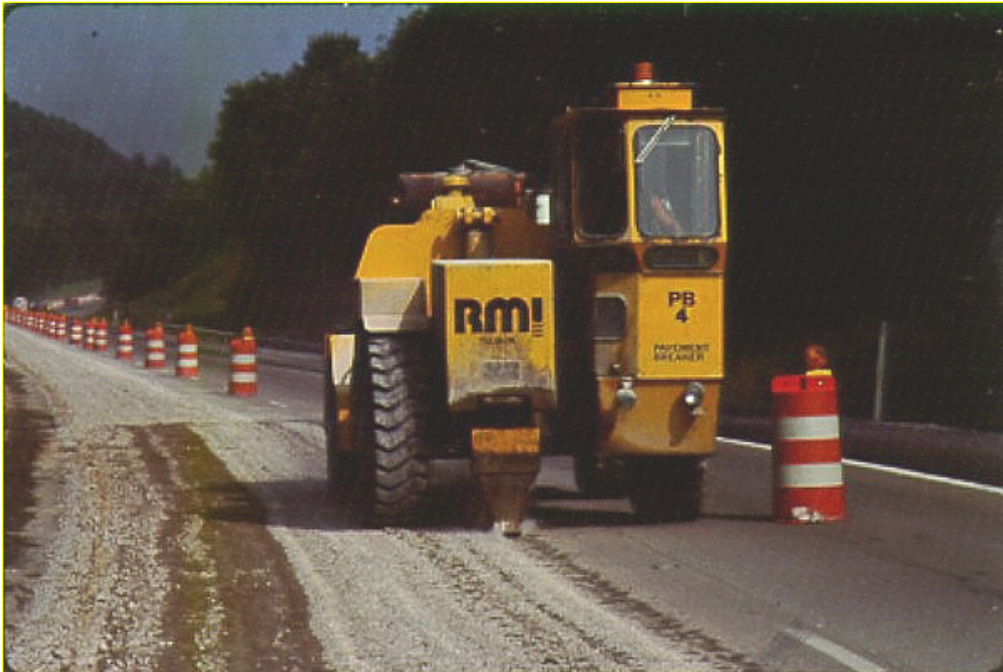
**Figure 7** Photo of the resonant frequency pavement breaker for rubblizing PCC slabs.

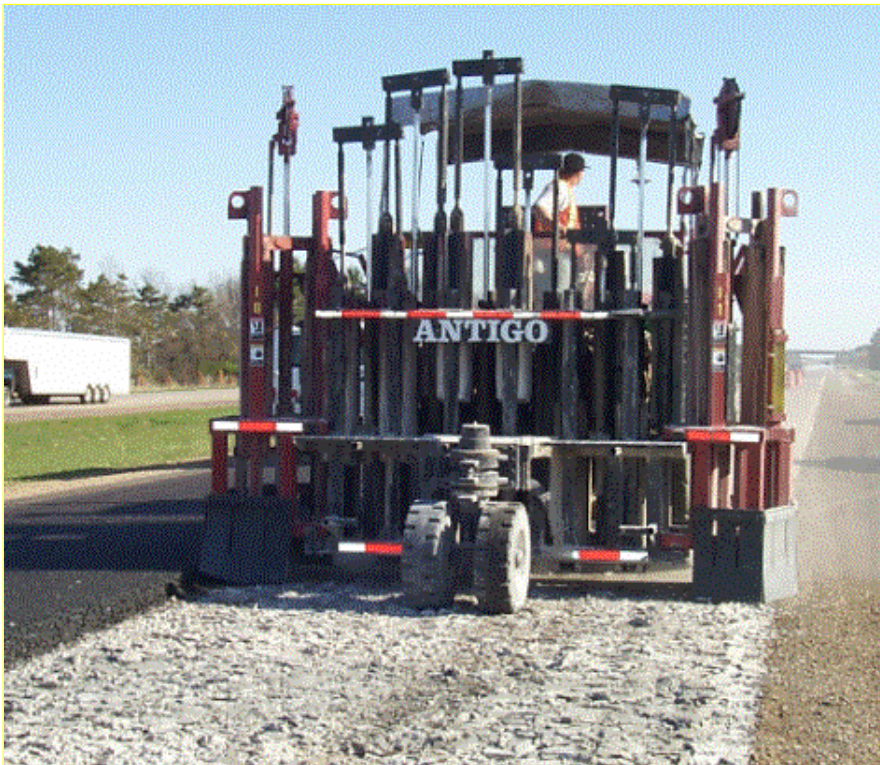
**Figure 8** Photo of the multiple drop hammer for rubblizing PCC slabs.

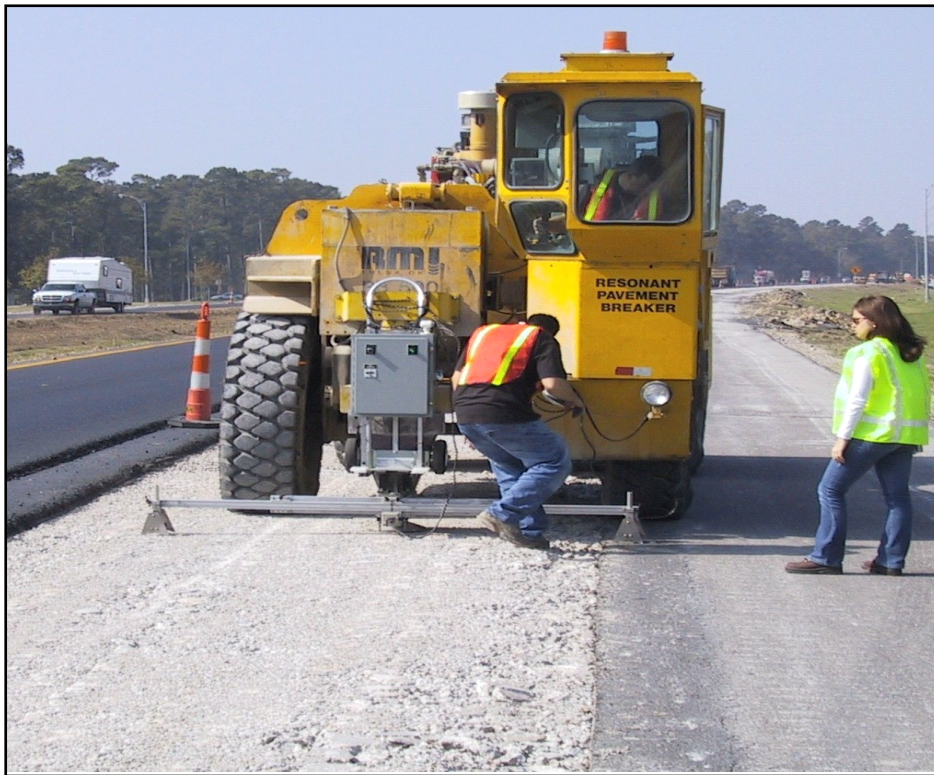
**Figure 12** RMI bulk modulus test on rubblized PCC highway pavement.

A possible candidate that is being looked at for quality control testing is the bulk modulus device being developed by RMI. Figure 12 shows the bulk modulus device being used on a highway project. This device measures the deflection of the rubblized layer when a load is applied, and the in-place bulk modulus is directly related to the type and condition of base and subgrade underneath the rubblization layer. The static load ranges from 62 to 155 MPa (9 to 22.5 kips). The average in-place bulk modulus value for a 230-mm (9-in) rubblized pavement, and a 2-MPa (9-kip) load was about 1,075 MPa (156 ksi) on one project. Data collected by ERDC showed a correlation between bulk modulus measured in this manner and calculated elastic modulus values from other deflection basin tests.

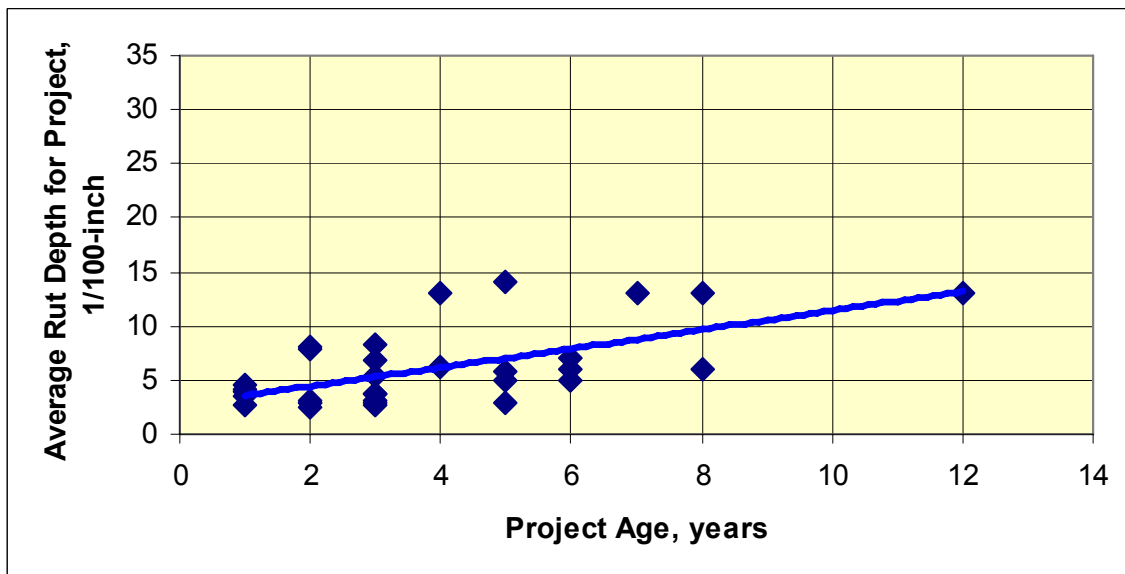
**Figure 18** Average PDI values with project age for the rubblized projects.

**Figure 19** Average rut depths with project age for the rubblized projects.

**Figure 20** Average IRI values with project age for the rubblized projects.

Figure 18 through 20 show the average distress (PDI and rut depth) and IRI values with project age for the rubblized projects. The trend lines included in each figure show definite increases in distress and IRI (roughness) with project age, as expected. Figure 21 shows a comparison between the average PDI and IRI values calculated for the rubblized projects. As shown, the average PDI and IRI values are related. One of the design premises included in the Mechanistic-Empirical Pavement Design Guide (M-E PDG) developed under NCHRP 1-37A is that the IRI is dependent on the surface distress (ARA, 2004). The Wisconsin pavement data for the rubblized segments shows a similar increase in IRI with increasing PDI values.
