WISCONSIN HIGHWAY RESEARCH PROGRAM

Bridge Integrated Analysis And Decision Support – Phase II

Final Report

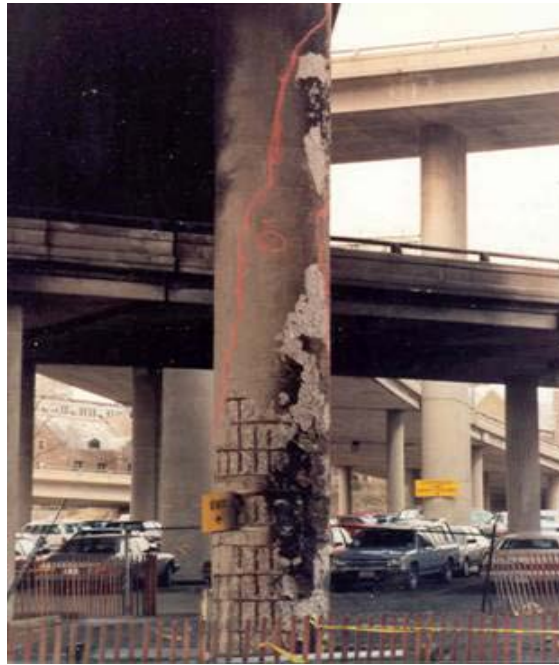
On Friday, November 27, 1992, a gasoline truck lost control over the bridge before 10:00 a.m., and dropped, through a protective concrete barrier, 33 feet onto a parking surface, where it exploded into flames and damaged several nearby vehicles [1]. The fire from the gasoline explosion resulted in heavy scaling and delamination of concrete in piers supporting the bridge (see Figure 1).

Figure 1. Column with Scaling and Delamination Due to Fire

A WisDOT representative responded to the call and performed a visual examination of the structure. He verified that the fire damage was restricted to the surface and that the pier and superstructure were still intact. Loose concrete was removed off of the affected surfaces but it was decided to reopen the interchange as soon as all traffic safety provisions could be made. The traffic control included re-

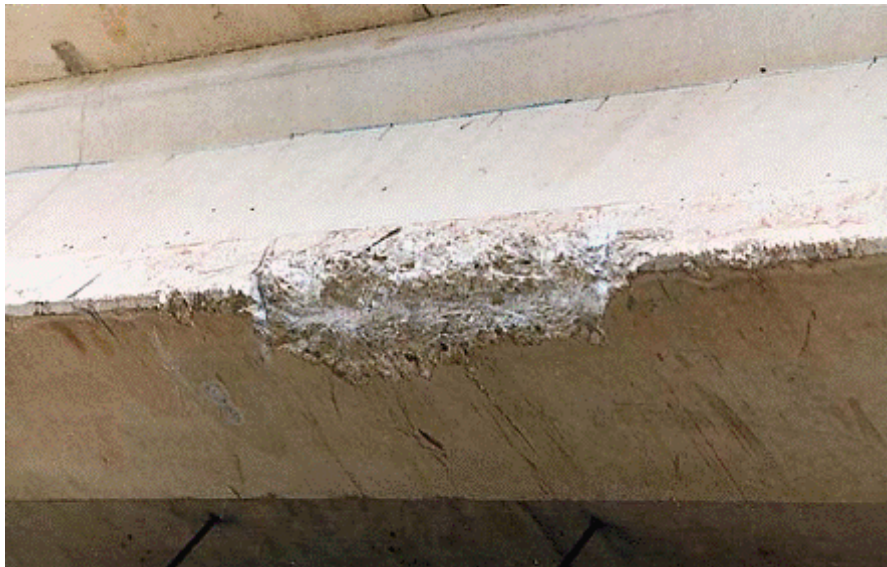
Figure 9. Minor Damage - Shallow spalls, scrapes and minor cracking

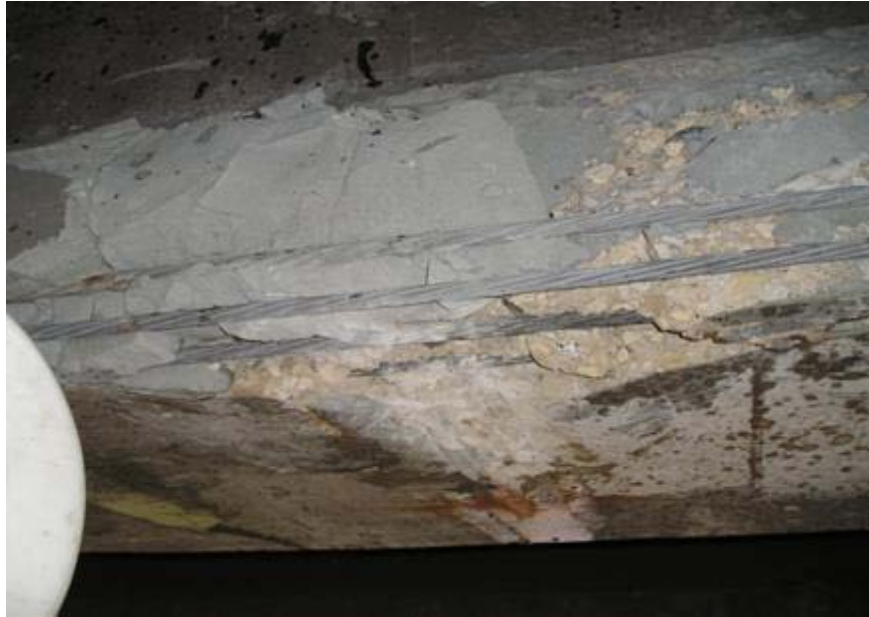
Figure 10. Moderate Damage - Large spalls, minor loss of section and exposed strand

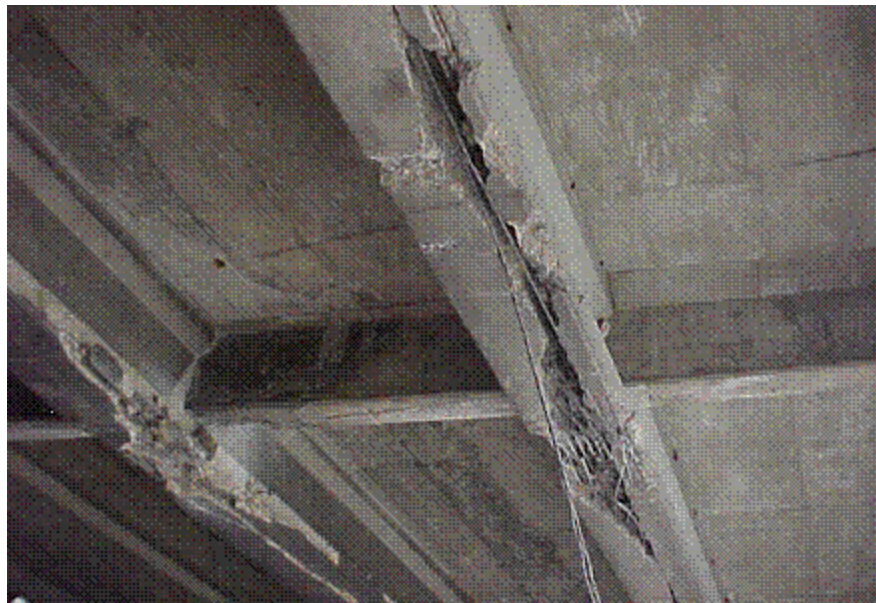
Figure 11. Severe Damage - Severe cracking, major loss of section, and damaged strands

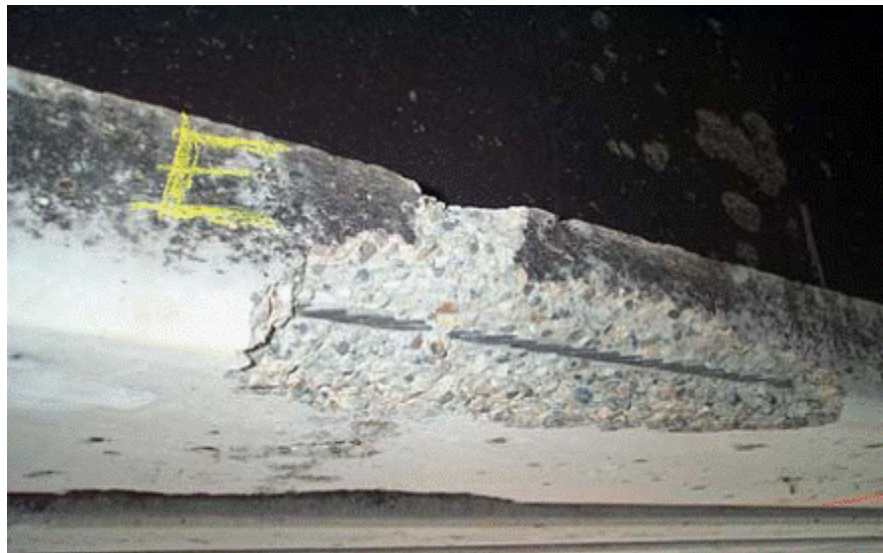
The intensity of the fire and the concrete damage level after being exposed to flames can be identified based on the resulting color. According to the Precast/Prestressed Concrete Institute (PCI), concrete that is not discolored and has been heated and then cooled did not reach temperatures above 600°F. If the concrete has turned into a pink color due to fire, it could have reached temperatures between 600°F and 1100°F. Concrete heated above 1100°F and then cooled tends to develop a whitish-gray surface; and for above 1700°F some concretes turn to a buff or yellowish color [40] (see Figure 12).

Figure 12. Concrete Girder Damaged by Fire (Buff color)

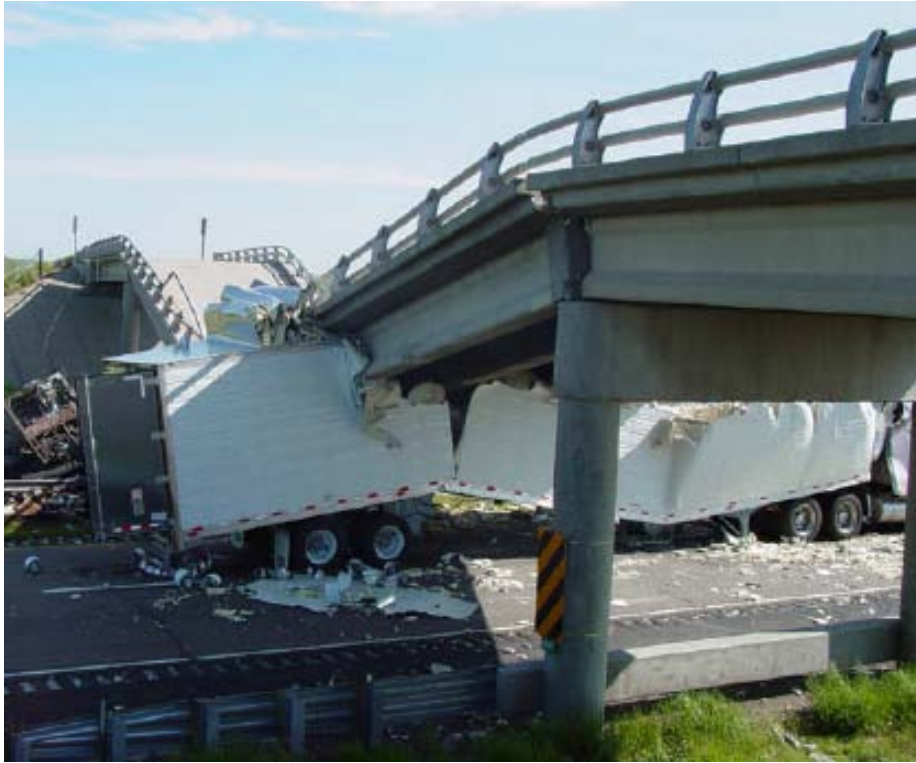
According to the WisDOT's Structure Inspection Manual [43], signs of pier impact damage include scrapes, chips, cracks, spalls, and possibly a fractured section of a pier component. In cases of severe collisions, reinforcing bars can be exposed or damaged. The WisDOT manual classifies the impact damage into three condition states based on the observed evidence on the structure. These include: Condition state 1 - that is defined as having previously repaired damage and new minor evidence of impact, Condition State 2 – with unrepaired former minimal damage including spalls and exposure of a few reinforcing steel bars, and Condition State 3 – with evidence of severe damage to cause concerns for public safety or serviceability of the member or structure (see Figure 13).

Figure 13. Example of a Severe Impact Damage to Substructure

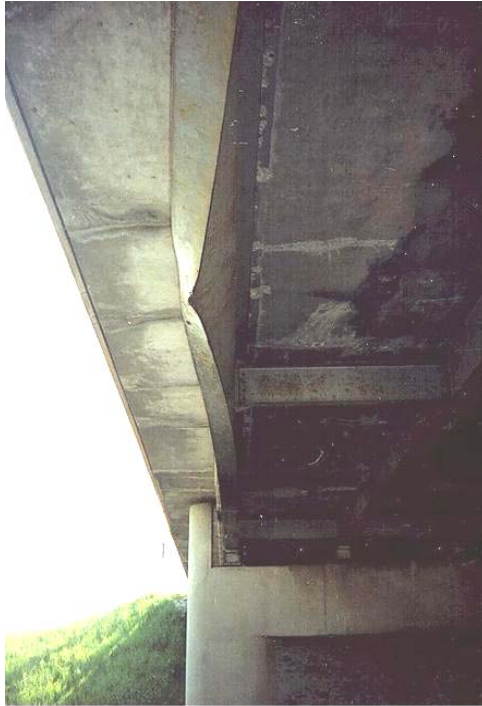
- Condition State 3: When the damage causes concerns regarding safety or bridge's serviceability. The member may have been severely damaged to the extent that it may no longer possess its original structural capacity. In such cases, an appropriate structural analysis will be warranted to determine the member's new capacity. Accordingly, appropriate repairs should be implemented for the affected structure (see Figure 16).

Figure 16. Condition State 3 for a Steel Girder Severely Damaged by Impact (major distortion of the web and bottom flange)

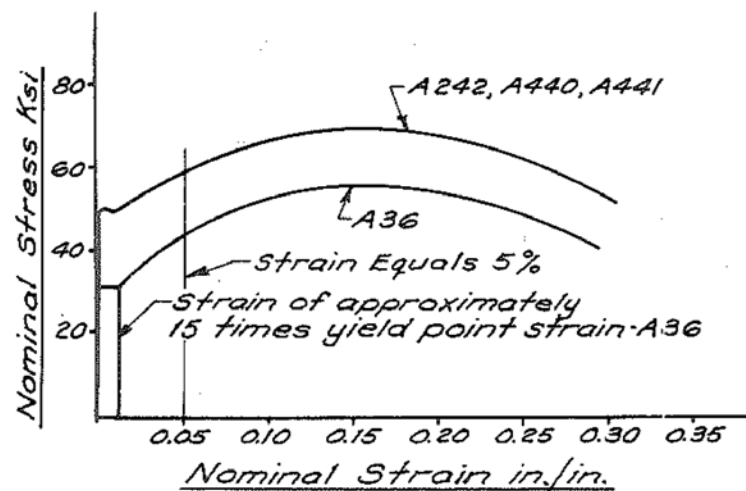
displacement, strain hardening occurs in the steel and further deformation will take place only if there is some increase in the level of the applied stress. Shanafelt and Horn [47] state that for steel strains bellow 5% from impact loads on bridge members there will be little effect on the materials properties. It must be noted however that most of the strain caused by vehicular impacts in steel bridge members would fall within 5 to 10 times the strain at the point of yield. As such, no significant degradation can be expected in the affected steel unless cracking or fracture occurs.

Figure 17. Nominal Stress Strain Diagrams for Typical Bridge Steels

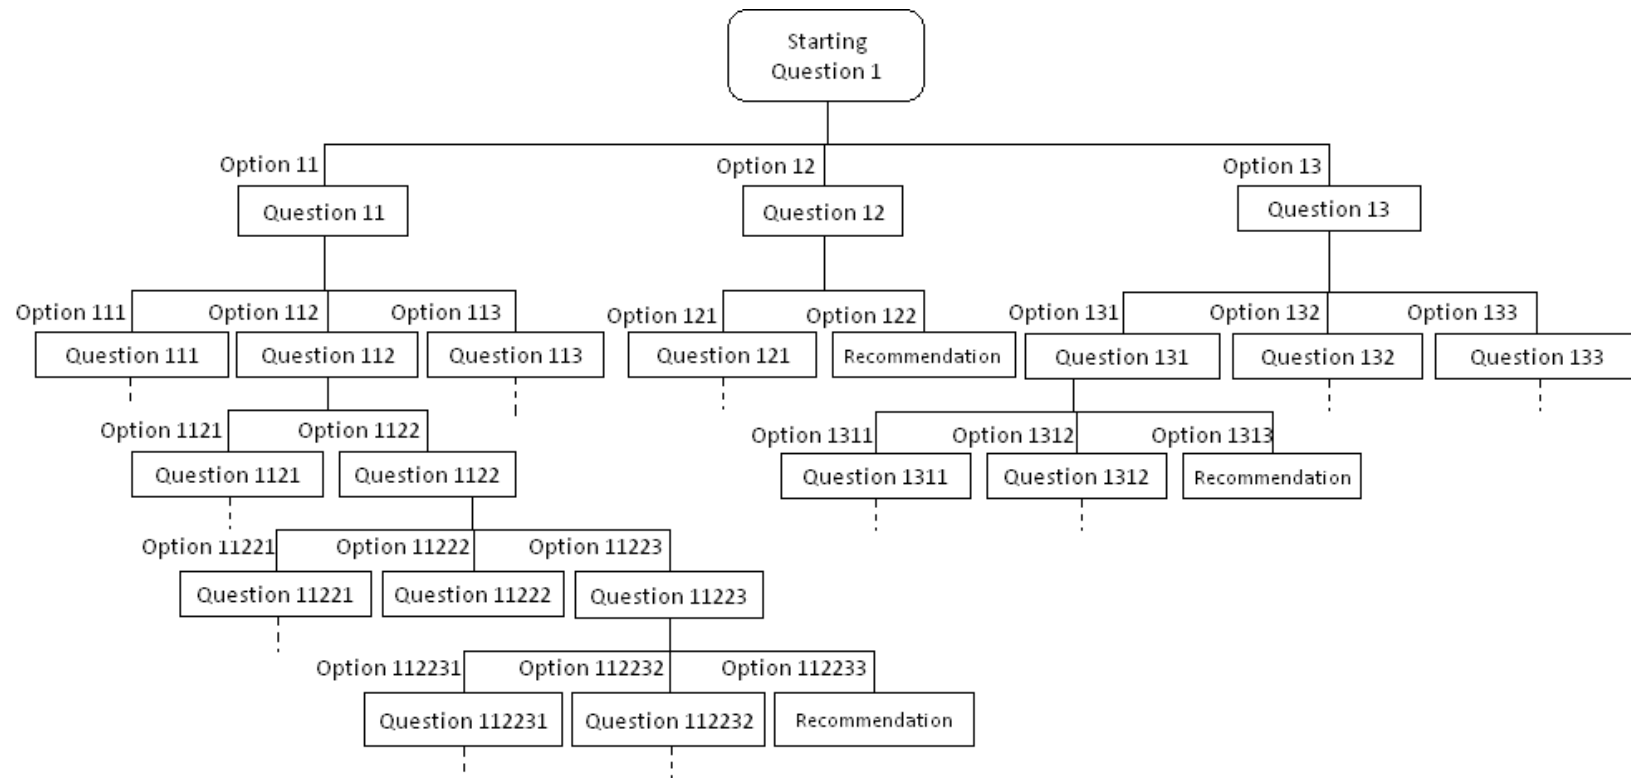
A system of rules and procedures were created in the form of a decision tree, as shown in Figure 19, to organize the collected information. The nodes of the decision tree represent the questions presented to the user while the links represent the options given for each question. The interaction between these components determines the nodes to follow and an eventual recommendation when the process is completed. The questions are organized based on following a format of hierarchy, so the most general or relevant question is considered first. When the more general questions are answered, more specific questions are asked and the final recommendation is provided at the completion of the process.

Figure 19. General Decision Tree used for Developing BEES

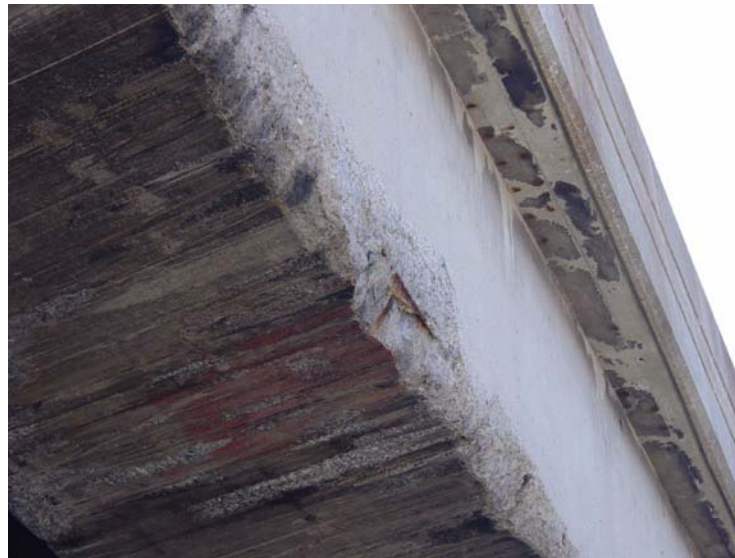
2. *Moderate damage*: If the visual inspection indicates the presence of large cracks located in the area of the impact or other critical locations, and shallow spalls and/or loss of section large enough to expose undamaged prestressed tendons then the damaged caused by the impact is classified as Moderate. A crack width between 0.1" and 0.19" for reinforced concrete girders and between 0.009" and 0.03" for prestressed concrete girders is considered as causing moderate damage [43]. It is considered here that such cracks, and moderate spalls and/or loss of section are not severe enough to be classified as causing major structural damage. Partial damage that does not comprise the safe usage of the structure is also considered as moderate (see Figure 22).

Figure 22. Moderate Damage – RC Girder Damaged by Impact (spalls and exposure of undamaged steel bars)

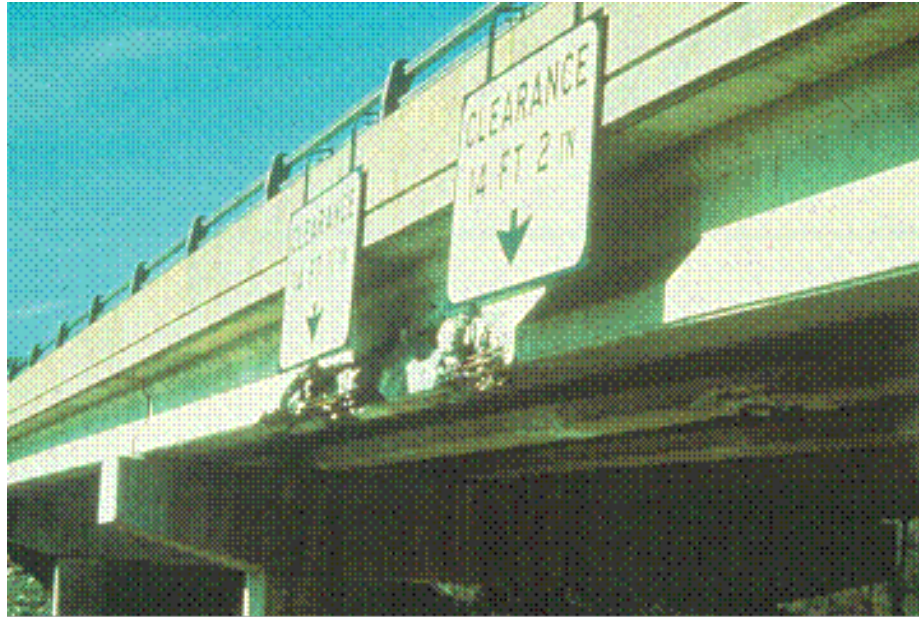
cracking, and/or girder distortion, the damage is classified as severe. Cracking is considered severe for example when it propagates from an impacted flange into the web of the girder. In cases of severe damage, a crack width will exceed 0.19" for reinforced concrete girders and 0.03" for prestressed concrete girders [43]. Due to the severity of the damage, it is considered that the structural integrity has been compromised (Figure 23).

Figure 23. Severe Damage – PS Concrete Girder Damaged by Impact (extensive spalls and loss of section, severe cracking and multiple exposed or damaged strands)

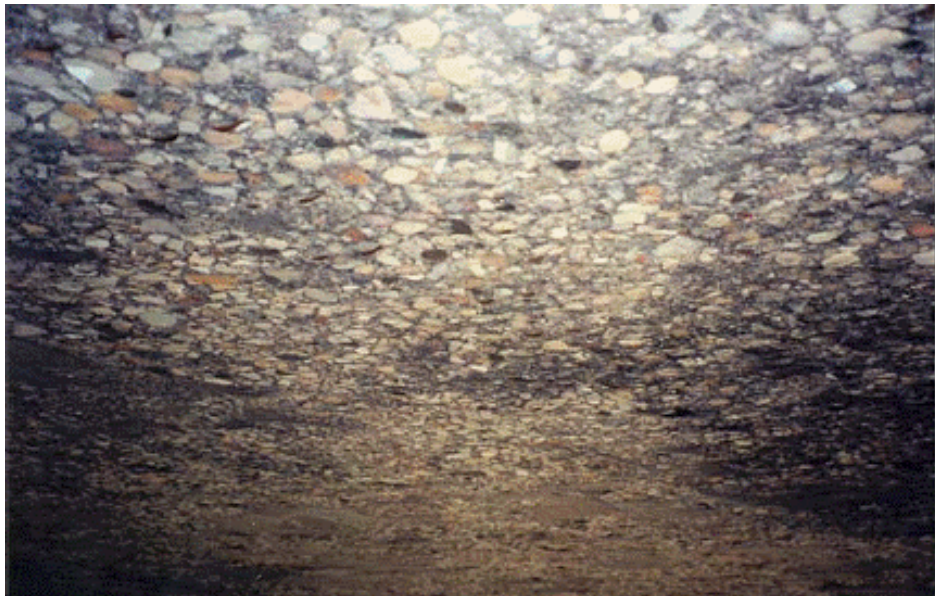
1. *Minor damage:* For fire damage to concrete girders or decks, a minor damage is defined as the presence of isolated cracks, few spalled and delaminated areas, and no exposure of reinforcing steel or prestressed strands. Under this condition, the structural integrity of the member or structure is not compromised. If scaling is evident, it will be considered minor if the cement paste loss is limited to 1/4 inch deep, and it is accompanied with only surface exposure of coarse aggregates (see Figure 24). The detrimental effects of concrete exposed to temperatures below 600°F are considered minimal, since the damage is mostly limited to the surface. Concrete below this temperature is not discolored or damaged. For the identification of the concrete color after the fire, it is necessary to remove the soot that mask the actual color.

Figure 24. Minor Damage – Concrete Girder Damaged by Fire (minor spalling with no reinforcement exposure)

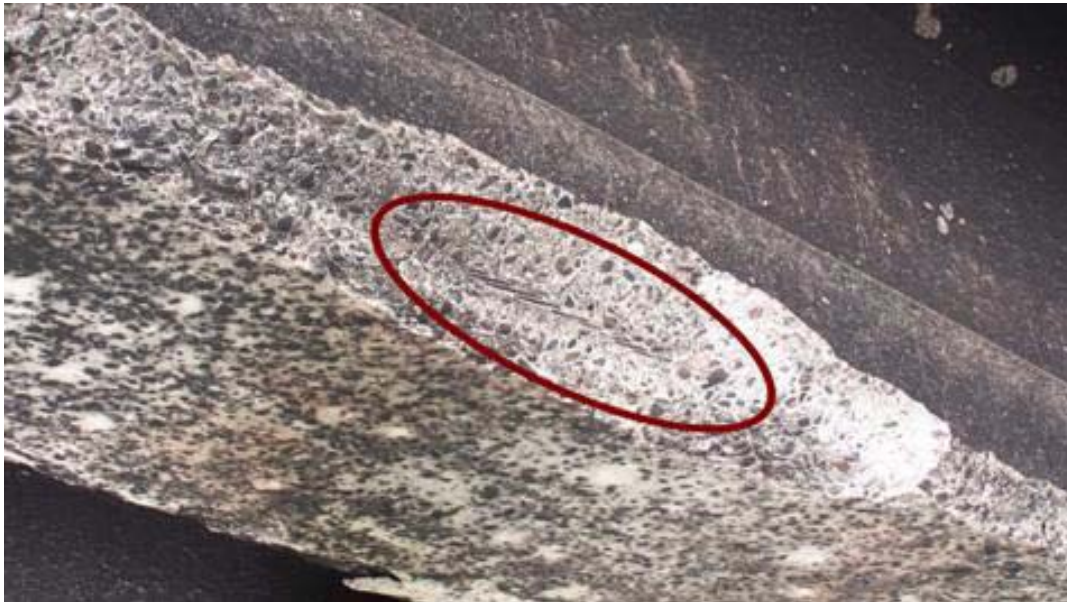
2. *Moderate damage*: Under this classification, concrete contains greater amounts of cracking, and spalled and delaminated areas as those classified under *minor damage*. Scaling is classified as moderate if there is a cement paste loss of from 1/4 inch to 1 inch deep, and the exposure of the sides of the coarse aggregates [43]. Steel may be exposed under this classification but there should be no visible signs of loss of prestressing force, member sag, or flexural cracks (see Figure 25). Concrete members exposed to temperatures between 600°F and 1700°F are somewhat permanently damaged. At these temperatures, the color of the concrete exposed directly to the flames changes. A pink coloration appears if temperatures between 600°F and 1100°F are reached due to the formation of ferrous salts. At temperatures above 1100°F and below 1700°F, concrete exhibits a white-gray coloration. At temperature exposure below 1700°F, the damage level is not considered severe enough to compromise the structural integrity of the member. Partial damage that does not comprise the safe usage of the structure is also considered as moderate

Figure 25. Moderate Damage – PS Concrete Girder Damaged by Fire (rounded concrete edges and exposure of strands)

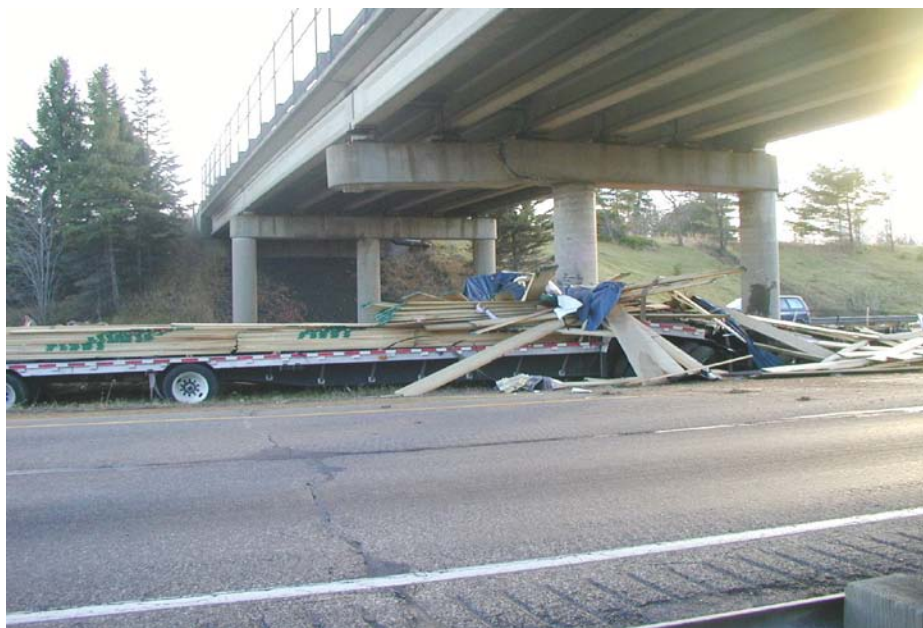
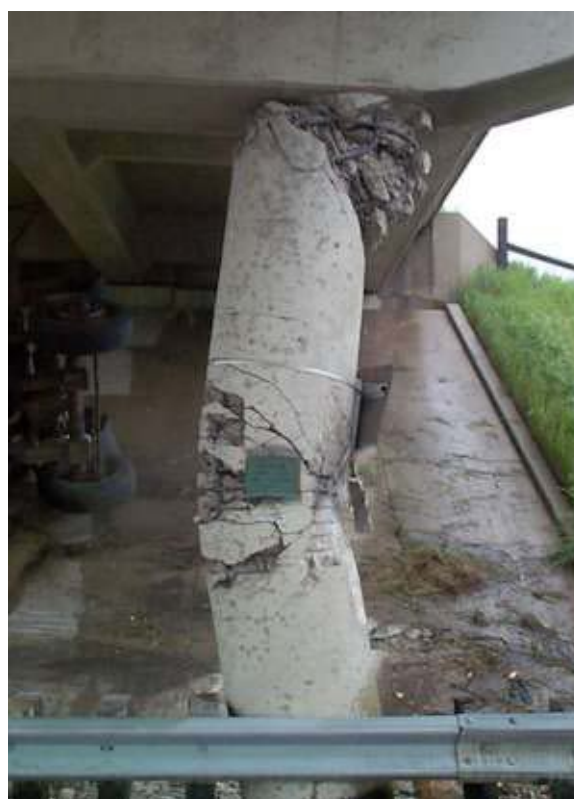
3. *Severe damage*: A severe damage is defined when the safety of the public and structural integrity have been compromised (see Figure 26 and Figure 27). Excessive flexural cracks at the base of concrete columns and horizontal or diagonal cracks at the pier-cap/column interface are signs of excessive lateral bending. This cracking pattern is considered to be a severe damage to the member. Overloads or differential substructure settlement produced by an impact can be identified with mid-height flexural cracks, as well as vertical cracks and crushed concrete [43]. The structural integrity may be compromised if one or more columns are severely damaged or severe spalling and exposure of damaged steel are evident in the affected member.

Figure 26. Severe Damage – Concrete Substructure Damaged by Impact

Figure 27. Severe Damage – Concrete Substructure Damaged by Impact

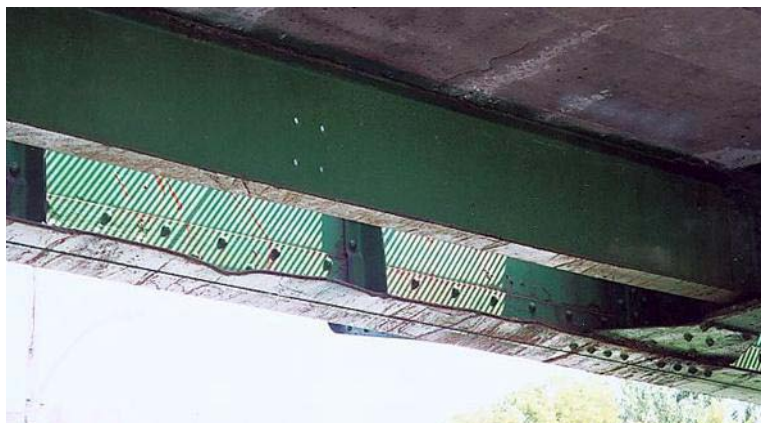
1. *Minor damage*: A minor damaged is defined if the visual inspection does not indicate any evidence of structural damage. Under this damage classification, structural members or elements may experience minor damage such as dents, scrapes, and distortions but no cracks should exist in the primary and secondary members or at the toes of butt and fillet welds in such members (see Figure 28).

Figure 28. Minor Damage - Steel Girder Damaged by Impact (girder lower flange slightly distorted, scrapes underneath the member)

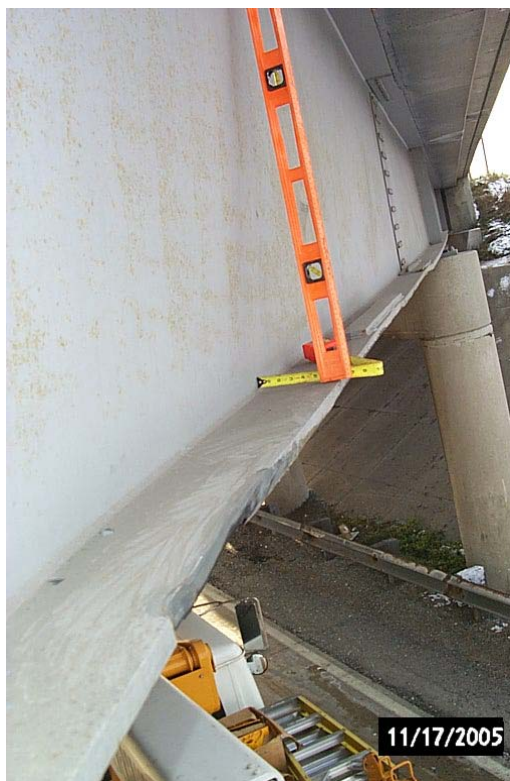
2. *Moderate damage*: Under the moderate damage classification, there may be considerable deformation, minor cracking, dents or nicks but there will be no safety concerns or diminishing effects on the structural integrity. No immediate repair will be required to keep the structure in service under the moderate damage classification. Critical areas such as welded connections and the area of primary damage must be examined for possible cracking. Evidence of peeling of paint or scaling should be considered as an indicator of unusual strain that could lead to possible cracking (see Figure 29).

Figure 29. Moderate Damage - Steel Girder Damaged by Impact (local distortion of the bottom flange)

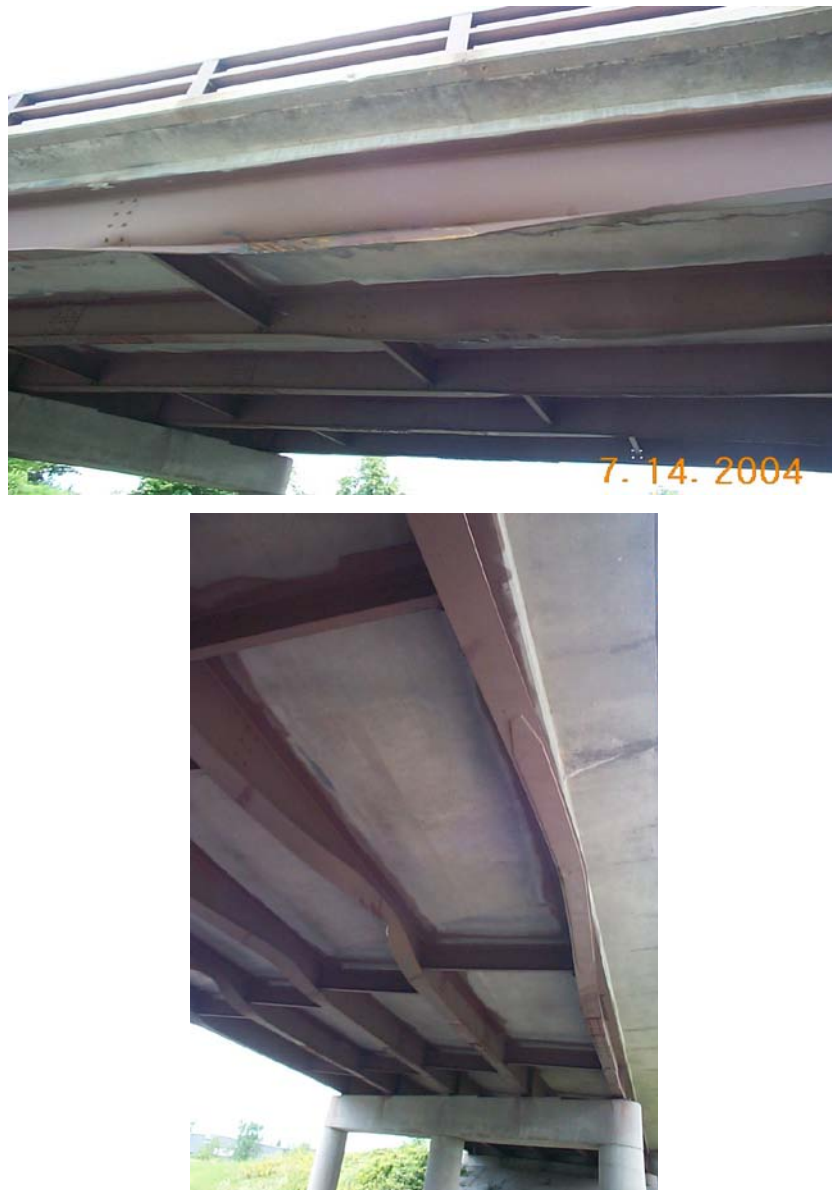
elements, or severe nicks or gouges on plate edges or member corners (see Figure 30).

Figure 30. Severe Damage - Steel Girders Damaged by Impact (lateral and in-plane distortions of multiple girders)

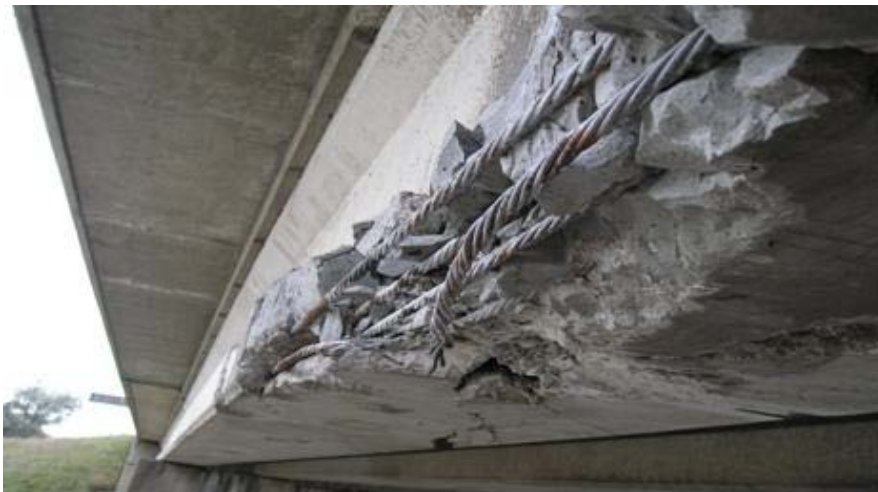
Figure 50. Detailed View of Severely Damaged Exterior PS Concrete Girder

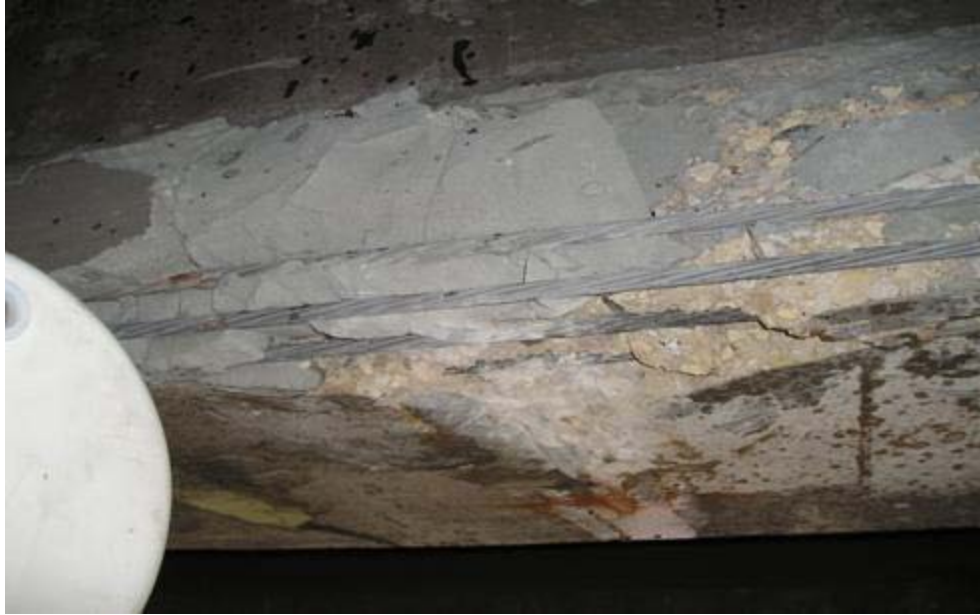
Figure 51. Failure of Previously Repaired Locations in Girder Flanges (separated concrete patches)

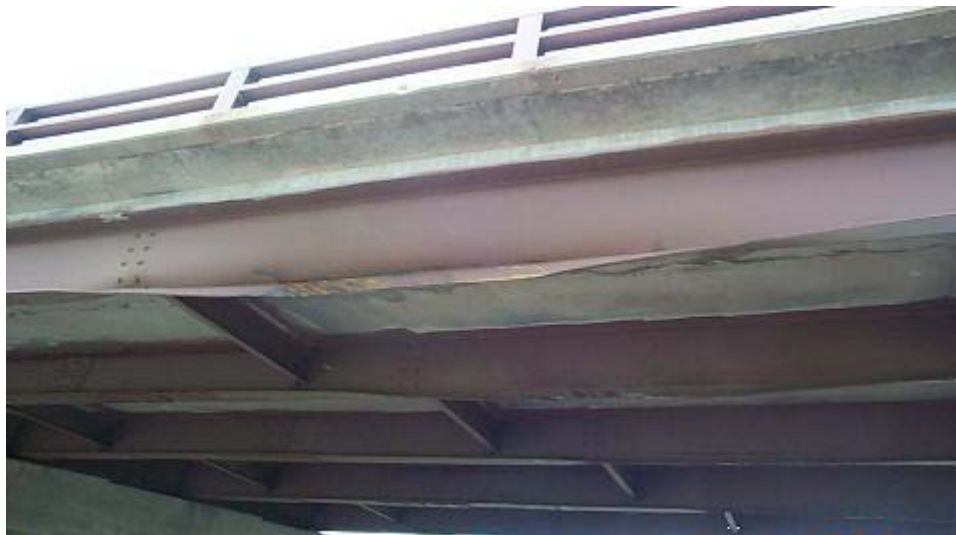
Figure 74. Impact Damage to Steel Girders in Bridge ID # B-14-0044 (side view)

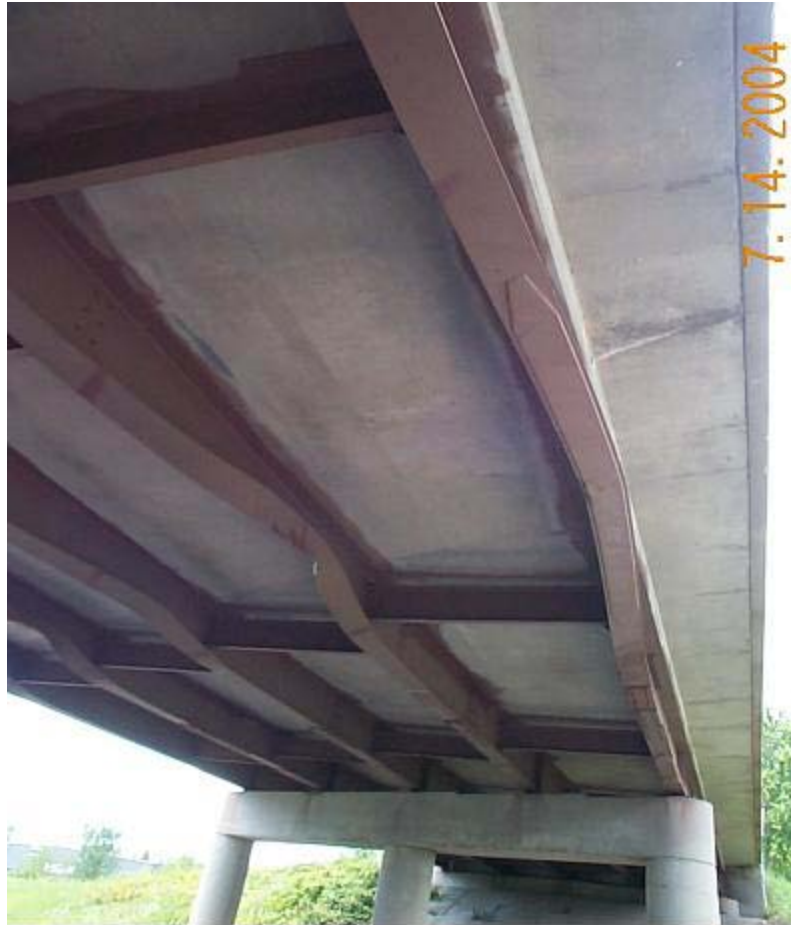
Figure 75. Impact Damage to Steel Girders in Bridge ID # B-14-0044 (underside view)
