INTRODUCTION

1.1 PROBLEM STATEMENT

A number of concrete bridges in Wisconsin and elsewhere have shown signs of deterioration due to aging, corrosion, and other detrimental factors. Although bridges are generally expected to yield a service life of 50 to 100 years, some bridges are exhibiting signs of distress at a much younger age. Increased traffic requirements, the use of deicing salts, and lack of adequate preventive maintenance programs contribute to deterioration of existing bridges. Considering the enormous cost and effort required to remedy bridge deficiencies, it is crucial that a concerted effort be made to identify practical, effective and economical methods for repair and rehabilitation of bridges. This research project addresses repair and rehabilitation techniques for reinforced and prestressed concrete bridges, focusing primarily on corrosion of prestressed concrete beam-ends.

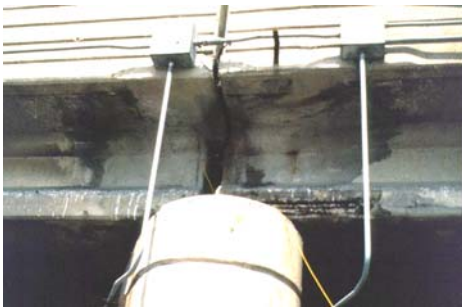
Figure 1. Damaged Beam-Ends

The most prevalent cause of deterioration in concrete bridges is corrosion. Diffusion of chloride ions through concrete can destroy the passivity of steel and initiate the corrosion process. In northern climates, such as Wisconsin, the primary source of chlorides is found in deicing salts used to melt snow in the winter. Bridges in northern climates are susceptible to corrosion in a manner different from bridges located in warm coastal climates. In such climates, girders are prone to corrosion mainly at the end regions (Figures 1 and 2). This is the

result of water leaking through faulty expansion joints and then reaching the girder ends. Improper drainage can also allow salt water to penetrate into other parts of the superstructure, including fascia girders. The resulting steel corrosion and the spalling of concrete, can cause irreversible damage to beam-ends. Rehabilitation of damaged beam-ends generally requires the complete removal of the damaged region, followed by reconstruction. Issues with this repair procedure include reoccurring spalls due to inadequate bond between the new and existing concrete. In addition, these types of repairs may not be very effective in the long term as contaminants in areas adjacent to the repair can, overtime, migrate to the repair region. This effect is more pronounced if drainage issues are not corrected. Since this type of damage is frequently encountered in northern states such as Wisconsin, the effectiveness of various traditional and state-of-the-art repair techniques are investigated.

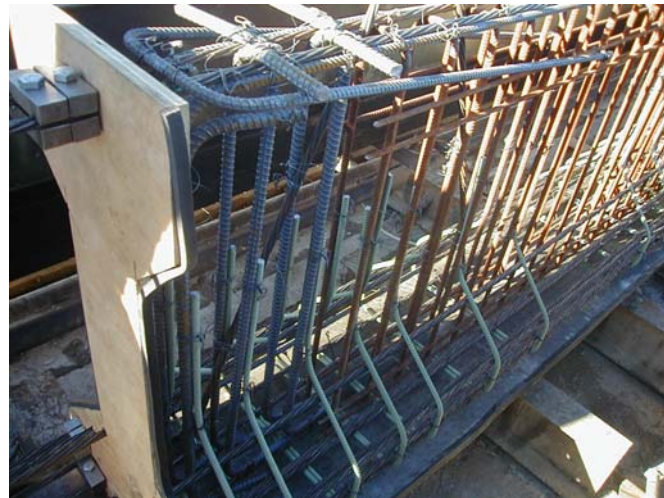
Figure 13. I-Beam Steel Cage

All specimens were pretensioned and cast in January 2002 at Spancrete's production facility in Green Bay, WI. The steel was placed by the fabricators and verified by the investigators. Two cathodes were placed at each beam end. The investigators also verified the electrical continuity of the main steel cage and the electrical isolation of the cathodes prior to casting of concrete.

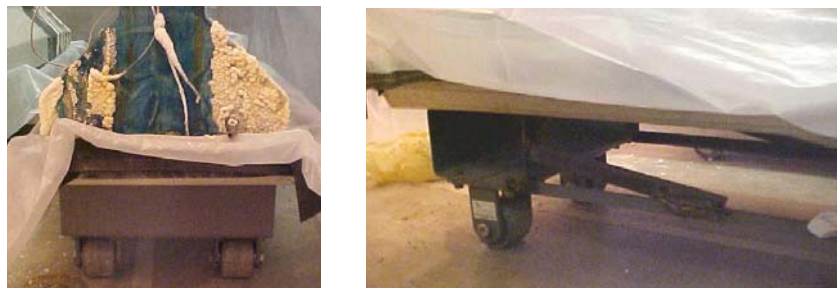
Figure 14. Beam Support System: front view (left) and side view (right)

After the beams were properly cured, they were delivered to the UW-Milwaukee Structures Laboratory. The indoor exposure regime was designed to simulate corrosion aging of prestressed concrete bridge beam-ends. The beams were positioned on neoprene pads on top of a constructed support system. Steel tube sections, with castors located at either end, supported the beams and a steel trough covered by roofing membrane (Figure 14). The support beams were built with castors to allow easy movement of beams in and out of their positions. The salt-water distribution system was constructed to subject the beams to controlled salt-water exposure. The system (illustrated in Figure 15) included the use of a water reservoir, located above the beams, which gravity fed the salt water to the beam-ends through a series of pipes, valves and hoses. The excess salt water was collected from each beam (trough system) and routed to a storage tank located in the building's basement. As needed, the water was then pumped back up to the reservoir. A photograph of the experimental set-up is shown in Figure 16. The beams were subjected to wet/dry cycles, which consisted of 4 days of exposure to salt water drip followed by 3 days dry. The salt-water exposure was designed to simulate the exposure commonly encountered in the field when the expansion joint fails and the bridge is subjected to deicing salt applications.

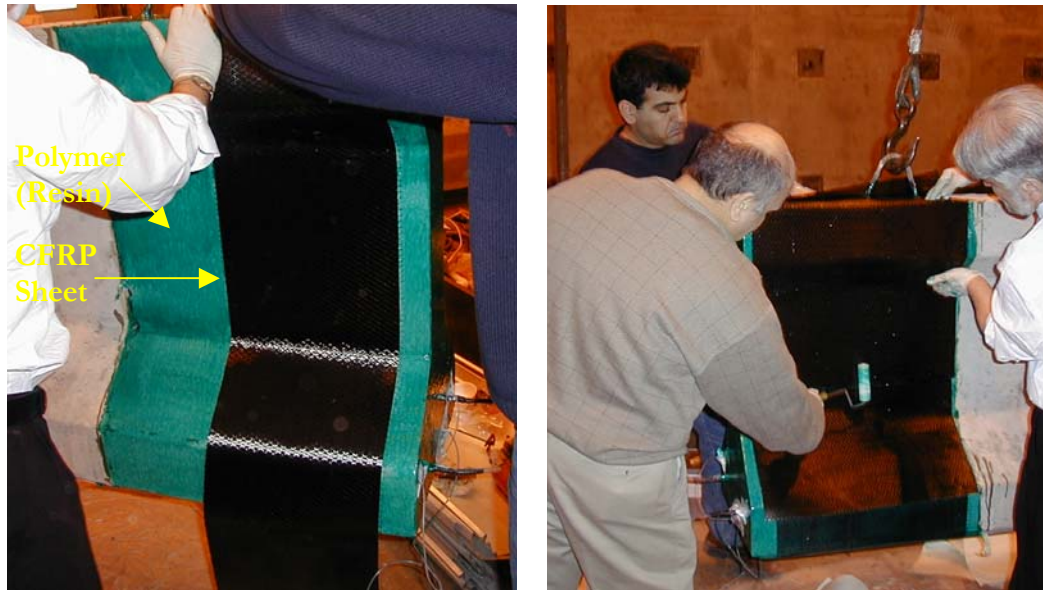
Figure 22. Installation of CFRP System

CFRP sheets were applied to one beam-end prior to the accelerated corrosion regime and to a second beam end after the first exposure cycle of the testing. The system employed was REPLARK 30 manufactured by Mitsubishi Chemical Corporation. It consists of the carbon fiber fabric, primer, putty, and resin. Since the system is lightweight and flexible prior to curing, the sheets can be installed around circular and square surfaces, as well as around irregularly shaped surfaces. In these tests, two fabric/resin layers were installed on the beams, with fiber orientation in the two layers at 90° with respect to each other. Figure 22 illustrates the installation of the FRP system.
