Changes in Chemical Properties of Surface Waters in Dunn County

Bryanna Hoffman, Madeline Candline, Riley Strobush, Ana M.Q. Vande Linde, Ph.D.

Department of Chemistry and Physics

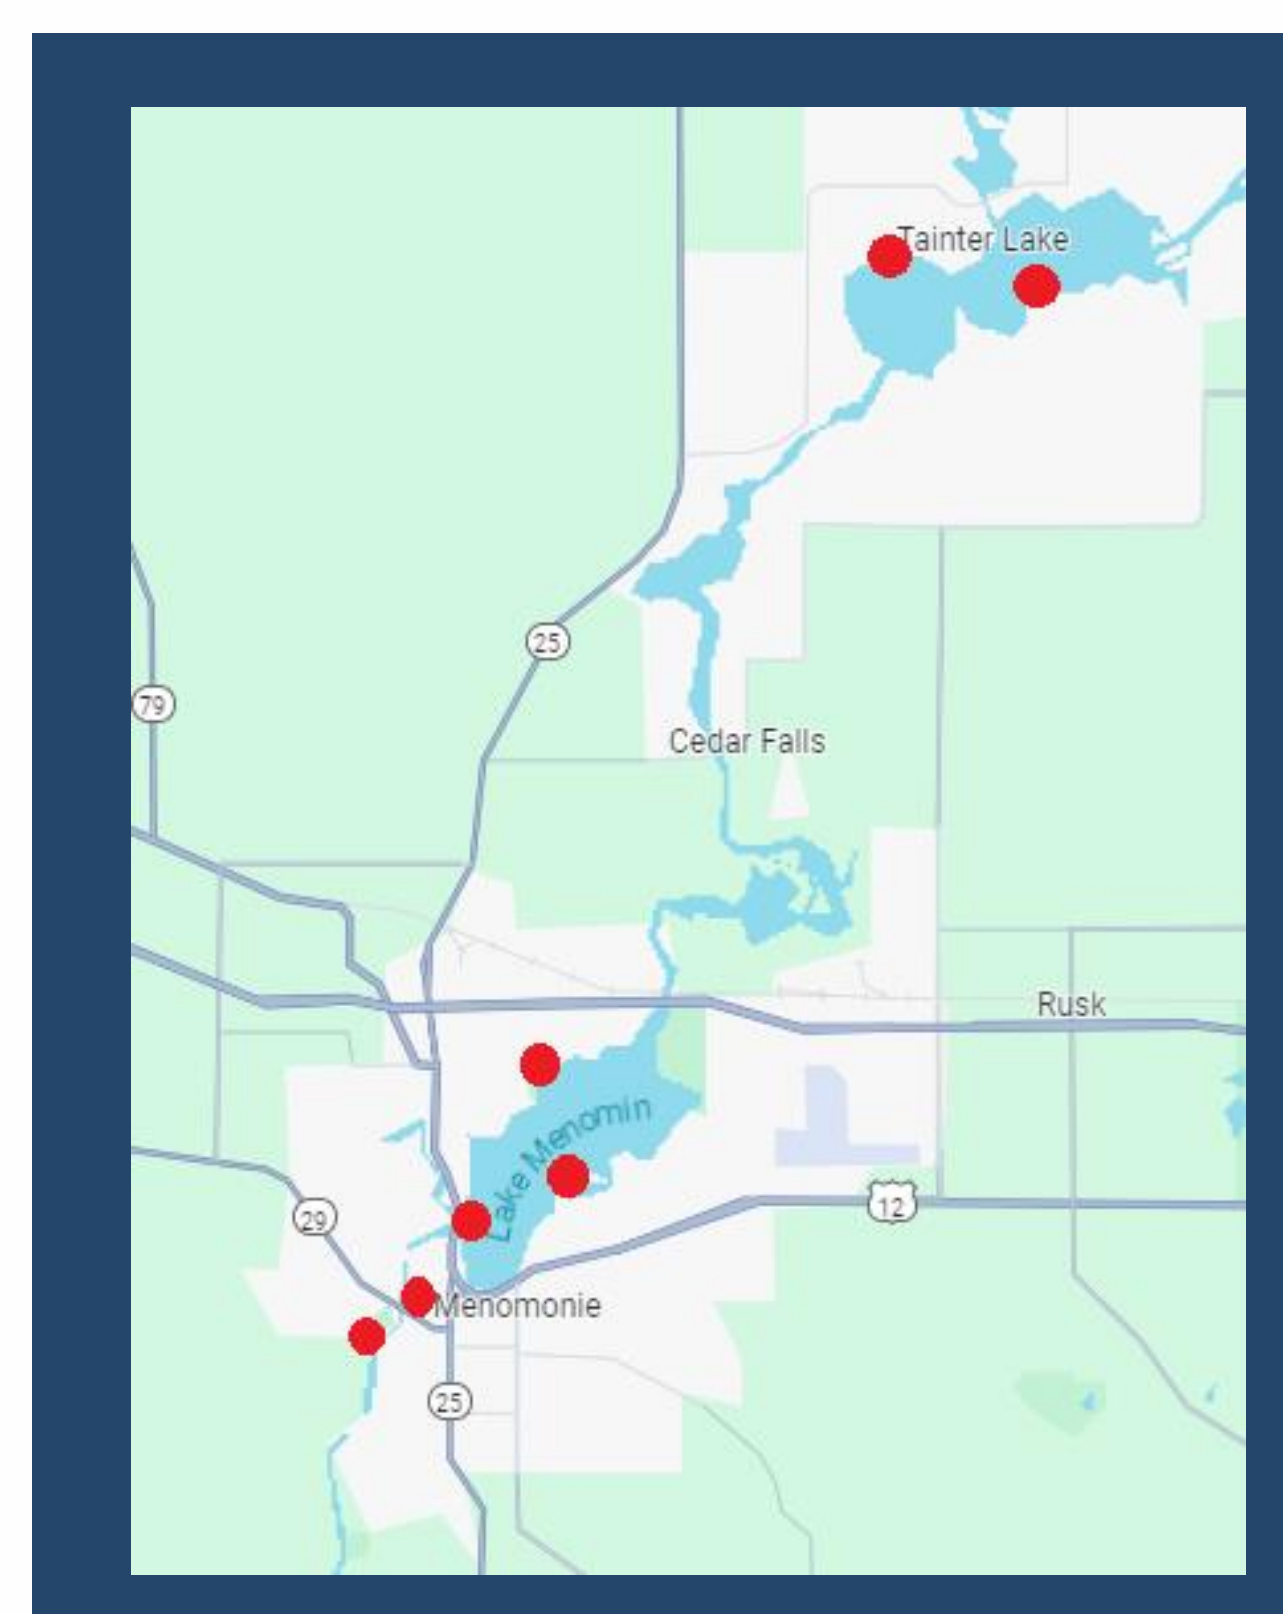
Figure 1: Water Sample Collection Sites

Figure 1 shows the locations of the sites where water samples were collected. In Lake Menomin, samples were collected at the Cemetery Island (Site 1), at the Highway 12 Boat Launch (Site 2), and the Wakanda Boat Launch (Site 3). In Tainter Lake, samples were collected at the Champney Park Boat Landing (Site 1) and Northwest Boat Landing (Site 2). In the Red Cedar River, the collection sites were upstream from the treated wastewater dump area at the River Road Boat Landing (Site 1) and downstream from the dump area at the Riverside Park near the Red Cedar Trail (Site 2).
