Wisconsin Highway Research Program

Evaluation of Bridge Approach Settlement Mitigation Methods

Final Report

October, 2007

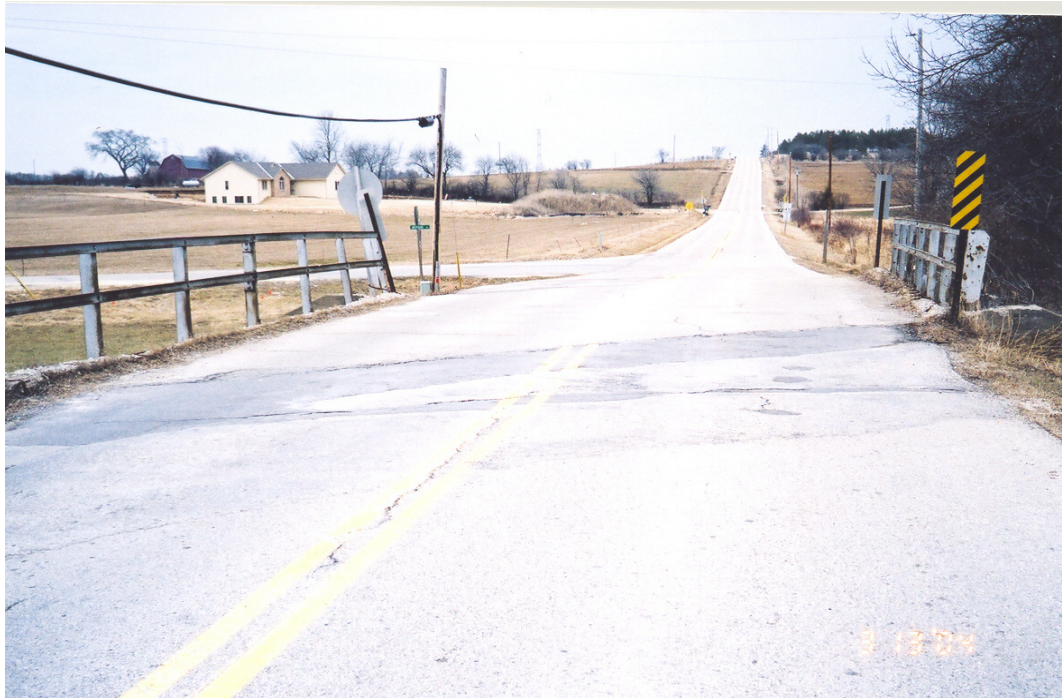
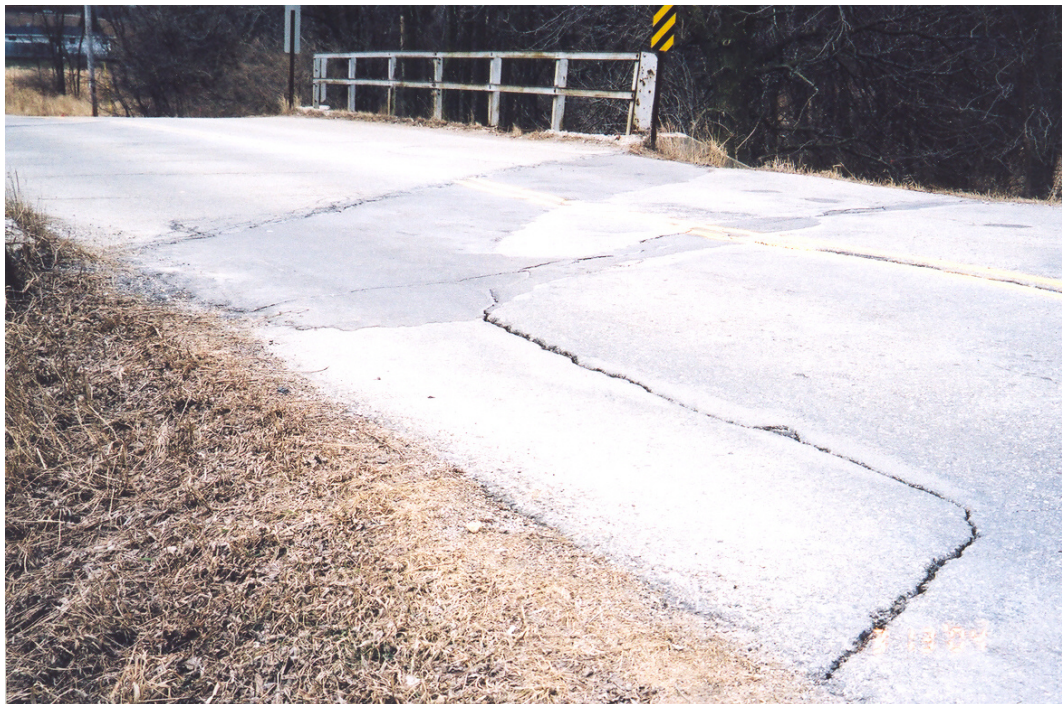
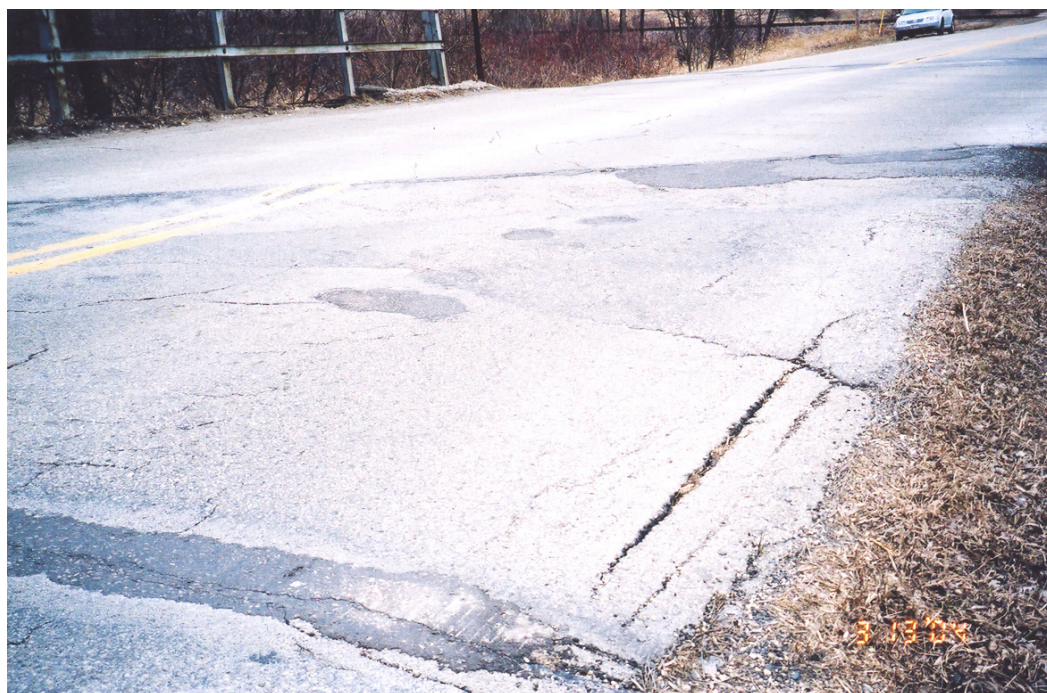
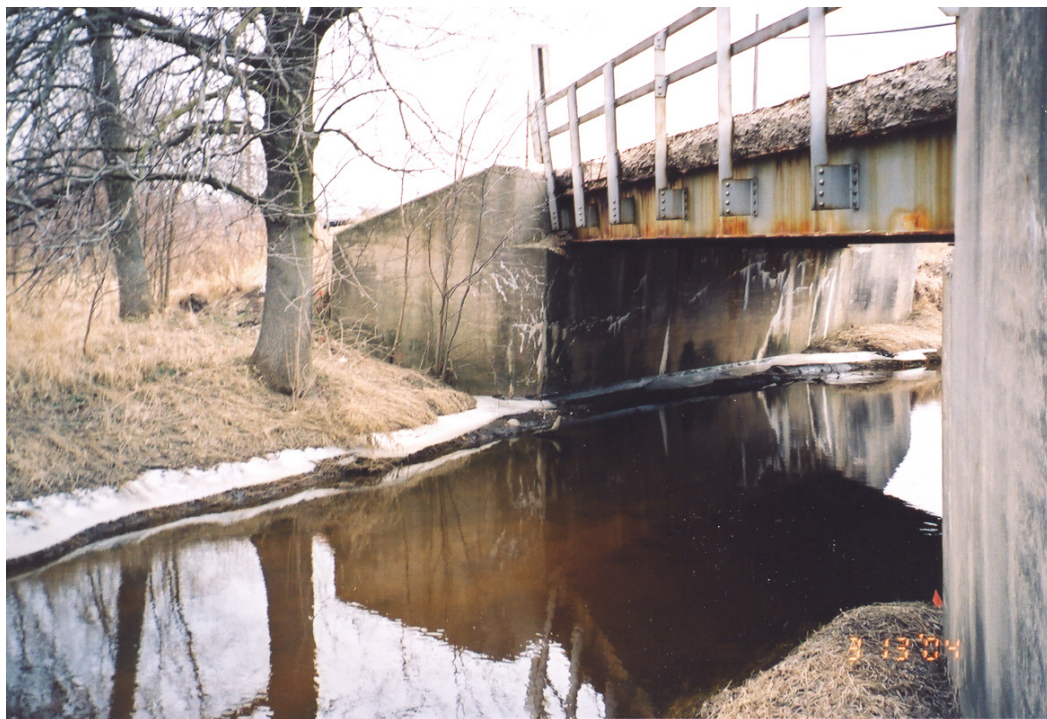
Based on site visits and the structure survey report by Olsen (2003), the bridge, substructure and approaches were in poor to very poor condition. Photos of the existing bridge taken in March 2004 are presented in Figures 39 to 43. As shown in the photos, the bridge had spalling concrete, and voids were noted between the approaches and the bridge. The approaches had numerous asphalt patches and had settled significantly. Two borings adjacent to the existing abutments indicated the asphalt pavement was 16.5 to 17 inches thick over 3 feet of base course. A third boring located 12 feet west of the west abutment boring indicated only 5 inches of asphalt over 1.2 inches of base course. In addition, the wingwalls appeared to have rotated because voids were noted between the bridge and the walls. Steep embankments surrounded the wingwalls, and greater lateral

deflections were noted on the north side. Erosion was observed in a ditch located parallel to the embankment on the northeast side of the bridge.

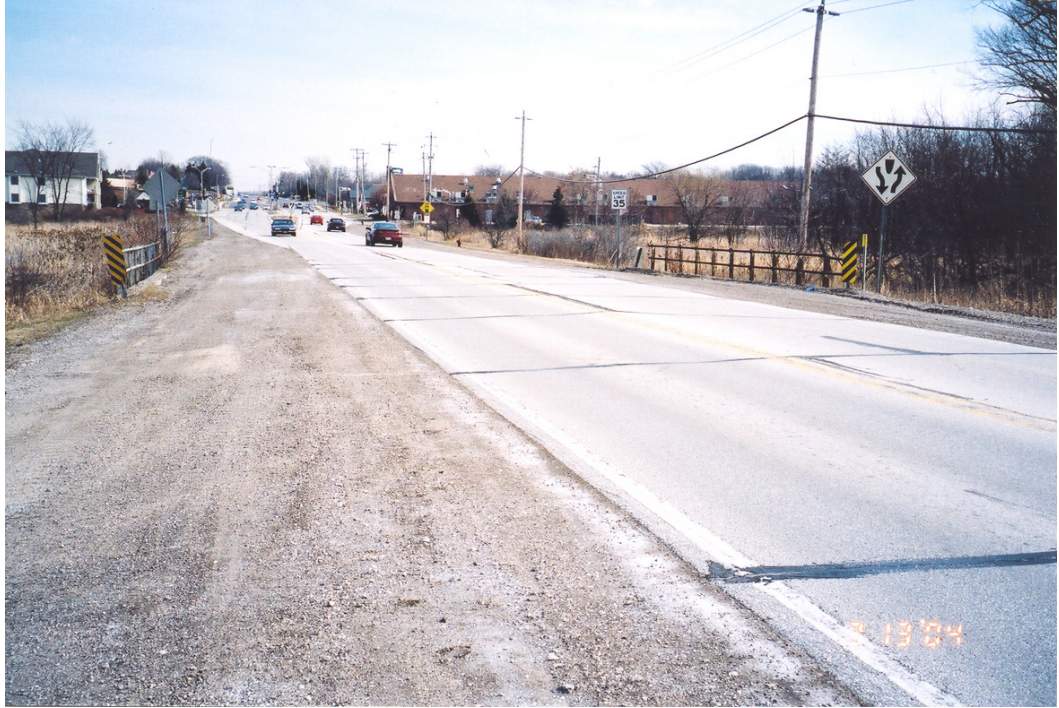
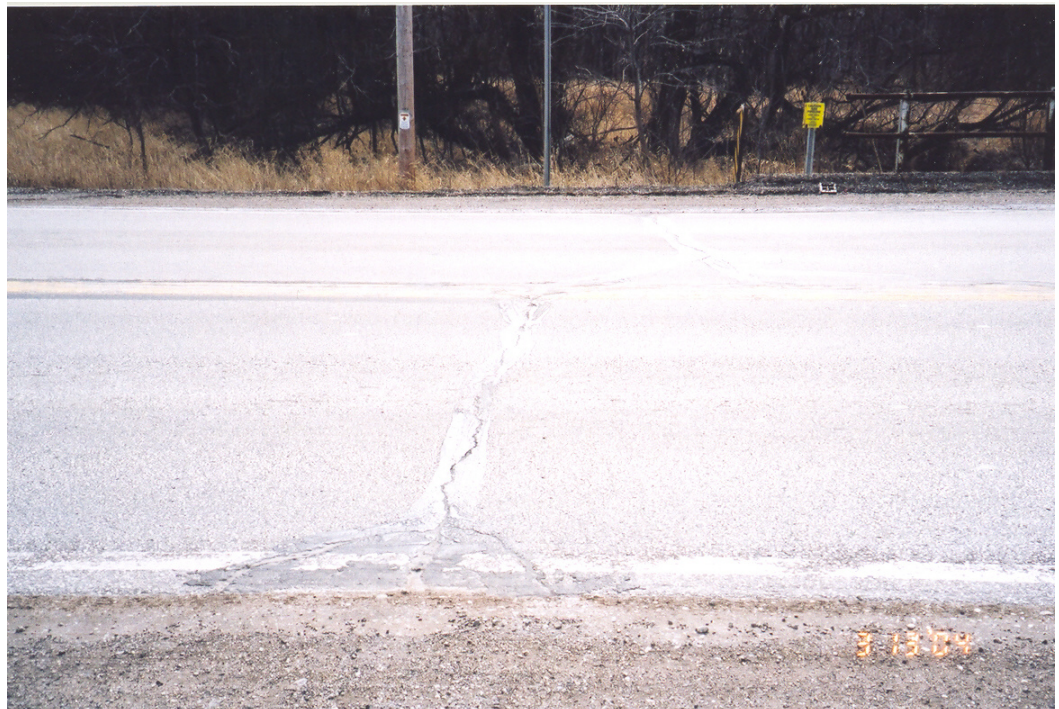
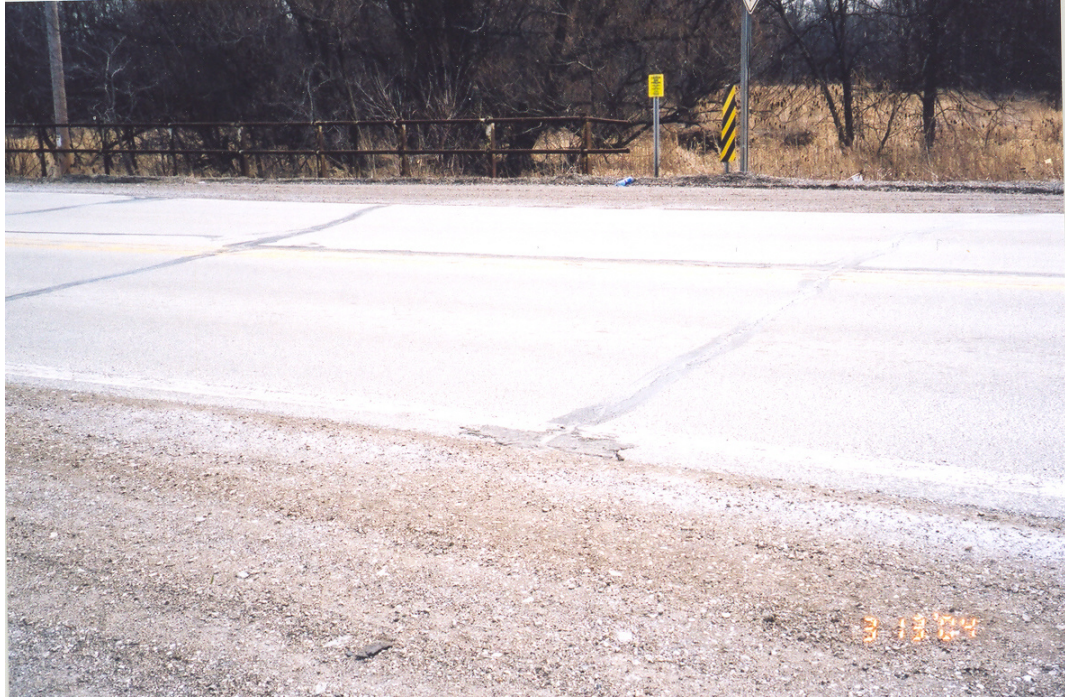
Based on a site visit and structure survey report by McMahon (2003), the bridge, substructure and approaches were observed to be in poor condition. Photos of the existing bridge taken in March 2004 are presented in Figures 48 to 51. As shown in the photos, the bridge had spalling concrete, exposed rebar, and distressed concrete. The eroding banks of the river appear to consist of silts and clays. The asphalt approaches indicated some transverse cracking. The shoulders were gravel, and steep embankments surrounded the bridge.

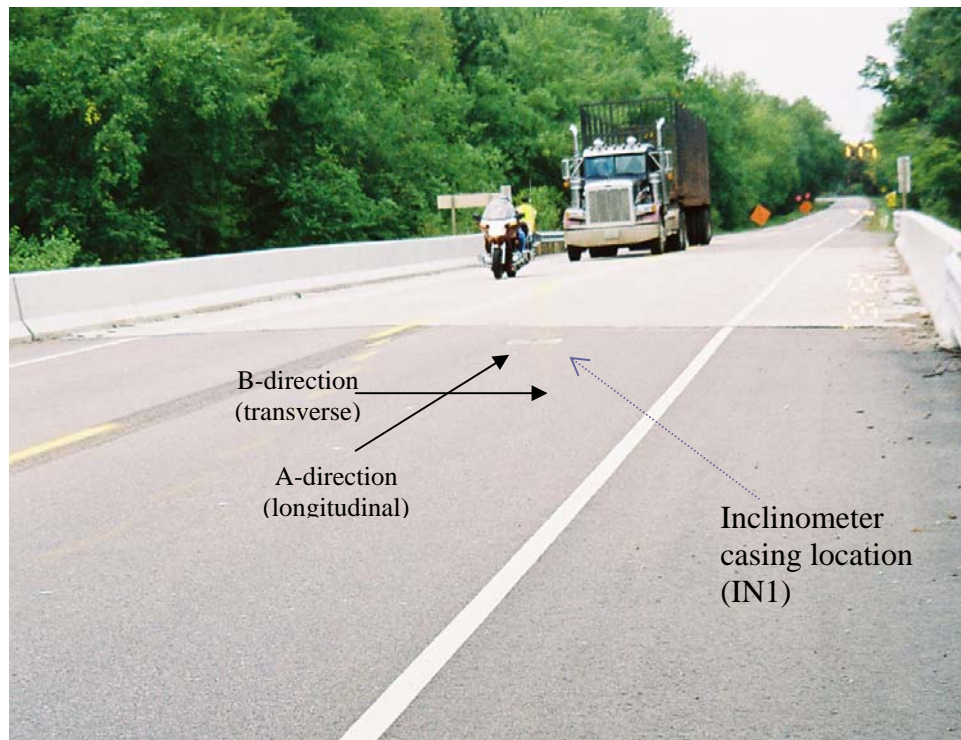
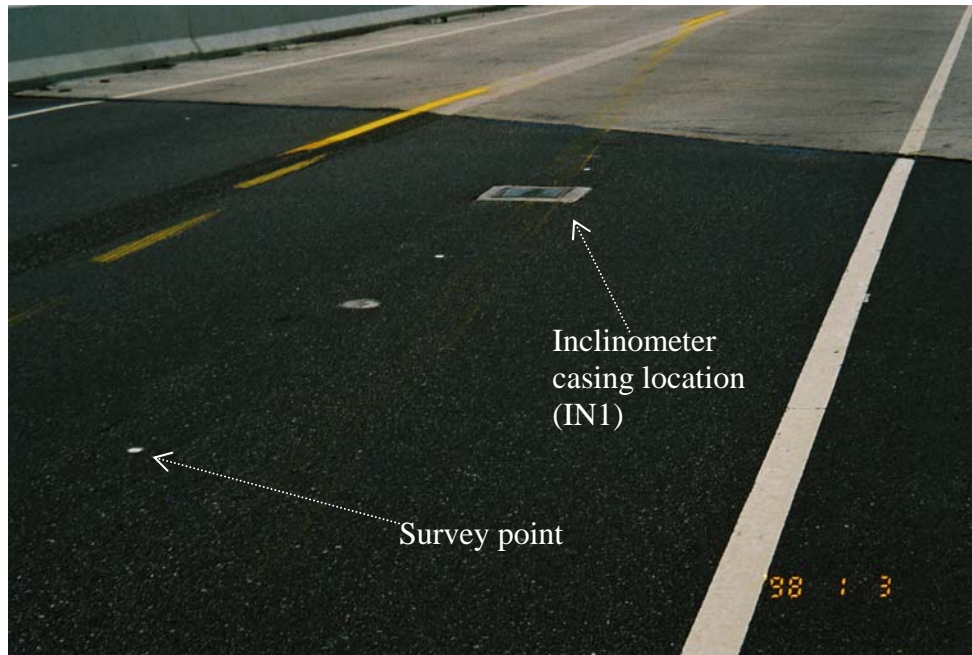
Numerous site visits have been carried out to all four bridges since they were constructed. Up to the date of this report preparation (June 2007), the Hemlock Creek bridge and its approaches appear to be in very good condition. On August 31, 2004, a site visit was conducted at the same time of the 3rd inclinometer readings. The bridge appeared to be in good condition with no observable cracking or movement. Photos of the bridge taken at the site visit are presented in Figures 61 and 62.

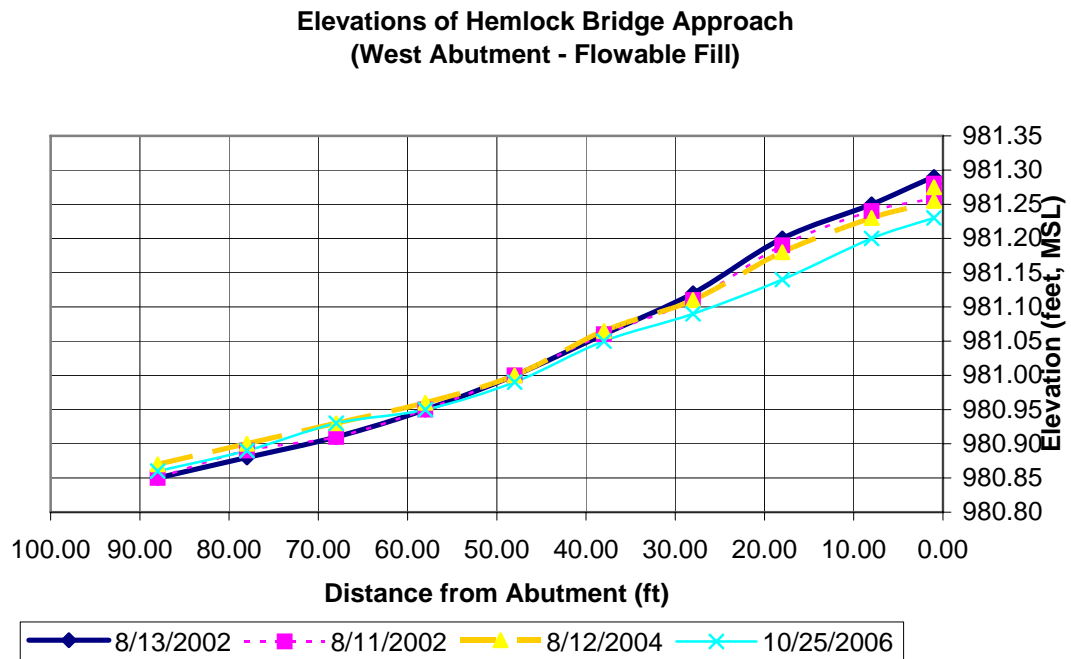
Figure 63: Elevations of Hemlock Bridge Approach at West Abutment (CLSM Fill)

Visual inspection carried out in October 2006 indicated very small differential settlements (less than 0.1 inches) at the interface between the approach fills and bridge. Survey elevations were taken over a 4-year period from the end of bridge construction on both the eastbound and westbound approaches. Survey elevations of the eastbound lanes approaching the west abutment and the westbound lanes approaching the east abutment are presented in Figures 63 and 64, respectively. The survey indicated differential settlement (see Appendix G) of about 0.3 to 0.5 inches near both abutments (within 7 feet). The differential settlement decreased further away from the abutment until the differential movement was positive. The point where the differential movement changed from negative to positive was about 27 feet from the east abutment (Structure Fill) and 47 feet from the west abutment (Flowable Fill). The transition slope (differential settlement divided by approach length) was calculated to be about 0.015 inches per foot for the westbound lanes and about 0.015 inches per foot for the eastbound lanes.

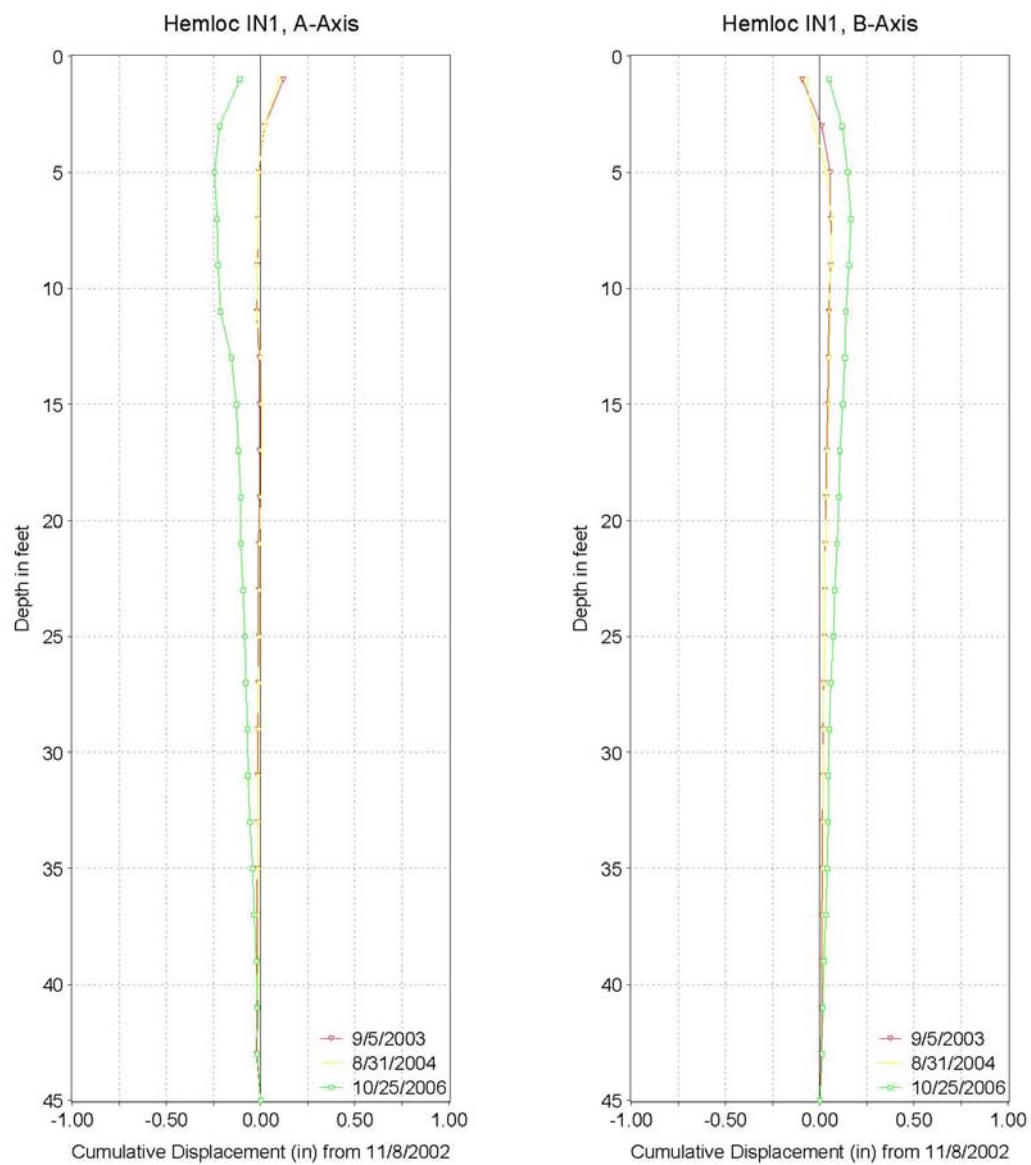
Figure 65a: Lateral Movement of IN1 at Hemlock Bridge

Inclinometer casing IN1 was installed 5 feet behind the east abutment in structure backfill as indicated in Figure 61. Note that in all inclinometer installations the A-direction (longitudinal direction) is in the traffic direction. Also, the B-direction (transverse direction) is perpendicular to the A-direction and pointing away from the center line of the roadway. Based on readings over four years, as shown in Figure 65a, the maximum movements were about 0.25 inches (away from abutment) at 5 feet below grade (bg), and in the transverse direction approximately 0.16 inches (away from the center line of the roadway) at 7 feet bg. Overall, these movements are within a quarter of an inch over four years and are perceived as insignificant.

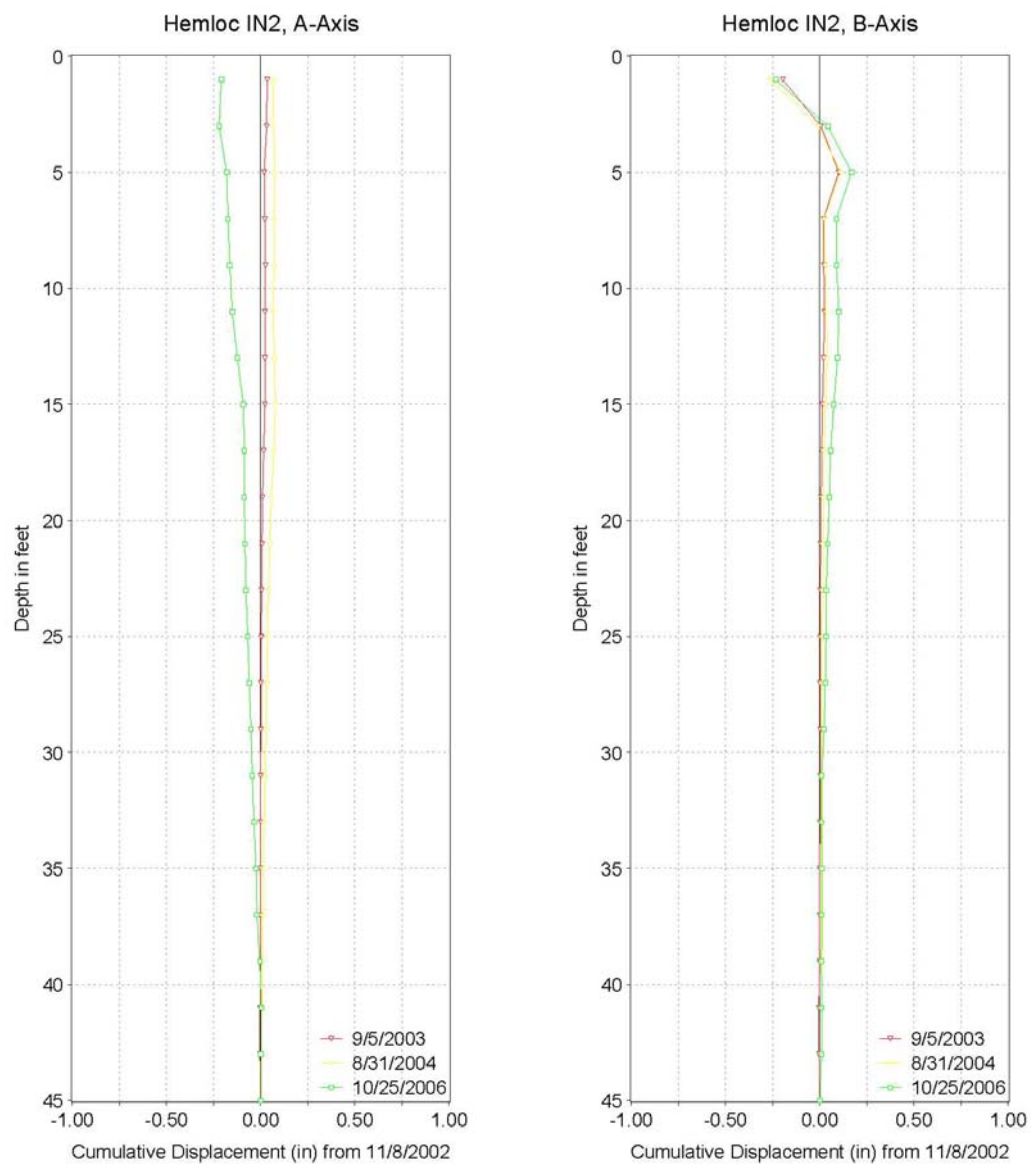
Figure 65b: Lateral Movement of IN2 at Hemlock Bridge

Inclinometer casing IN2 was installed 5 feet from the west abutment in flowable fill. The results, shown in Figure 65b, indicated a maximum of 0.22 inches (away from abutment) at 2 feet bg. Along the B-axis, the casing moved a maximum of 0.18 inches (away from the center line of the roadway) at 5 feet bg, and 0.25 inches (also away from the center line of the roadway) at 6 feet bg. Similar to the measurements in IN1, these movements are perceived as insignificant.

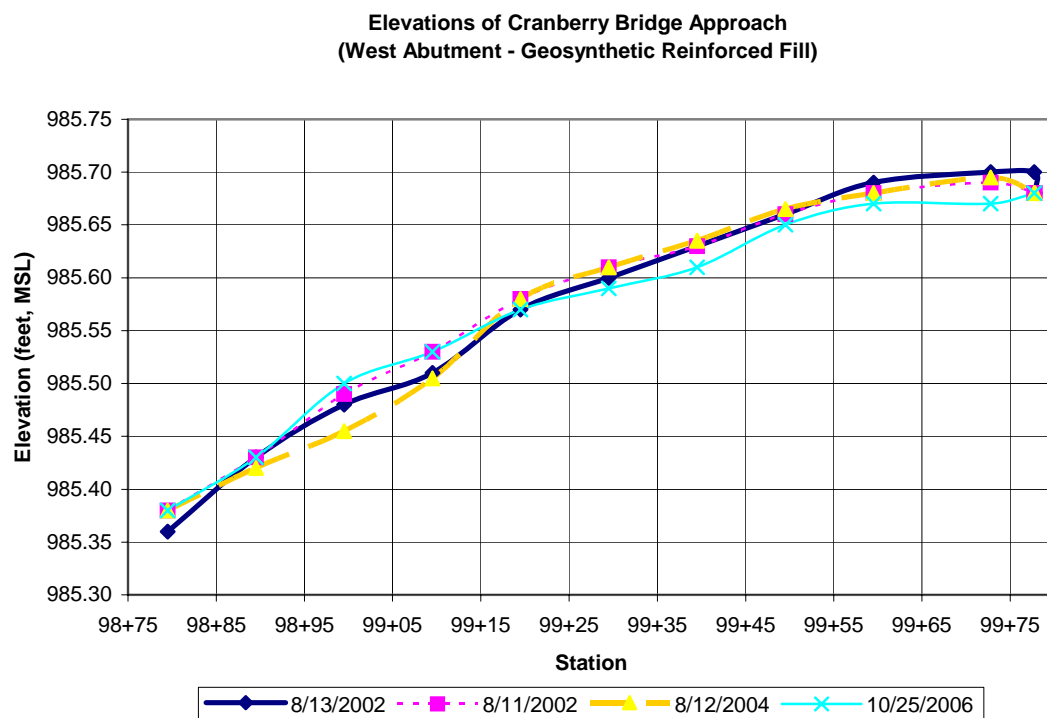
Figure 66: Survey Elevations of Cranberry Bridge at West Abutment (Geosynthetic Fill)

fills. Survey elevations of the eastbound lanes approaching the west abutment and the westbound lanes approaching the east abutment are presented in Figures 66 and 67, respectively. The survey indicated differential settlement of about 0.5 inches near the east abutments (within 7 feet) and 0.4 inches near the west abutment. The differential settlement (see Appendix H) decreased the further away from the abutment until the differential movement was positive. The point where the differential movement changed from negative to positive is about 38 feet from the east abutment (structure fill) and 58 feet from the west abutment (geosynthetic reinforced fill). A transition slope was calculated to be of about 0.013 inches per foot for the east abutment and 0.006 inches per foot for the west abutment.

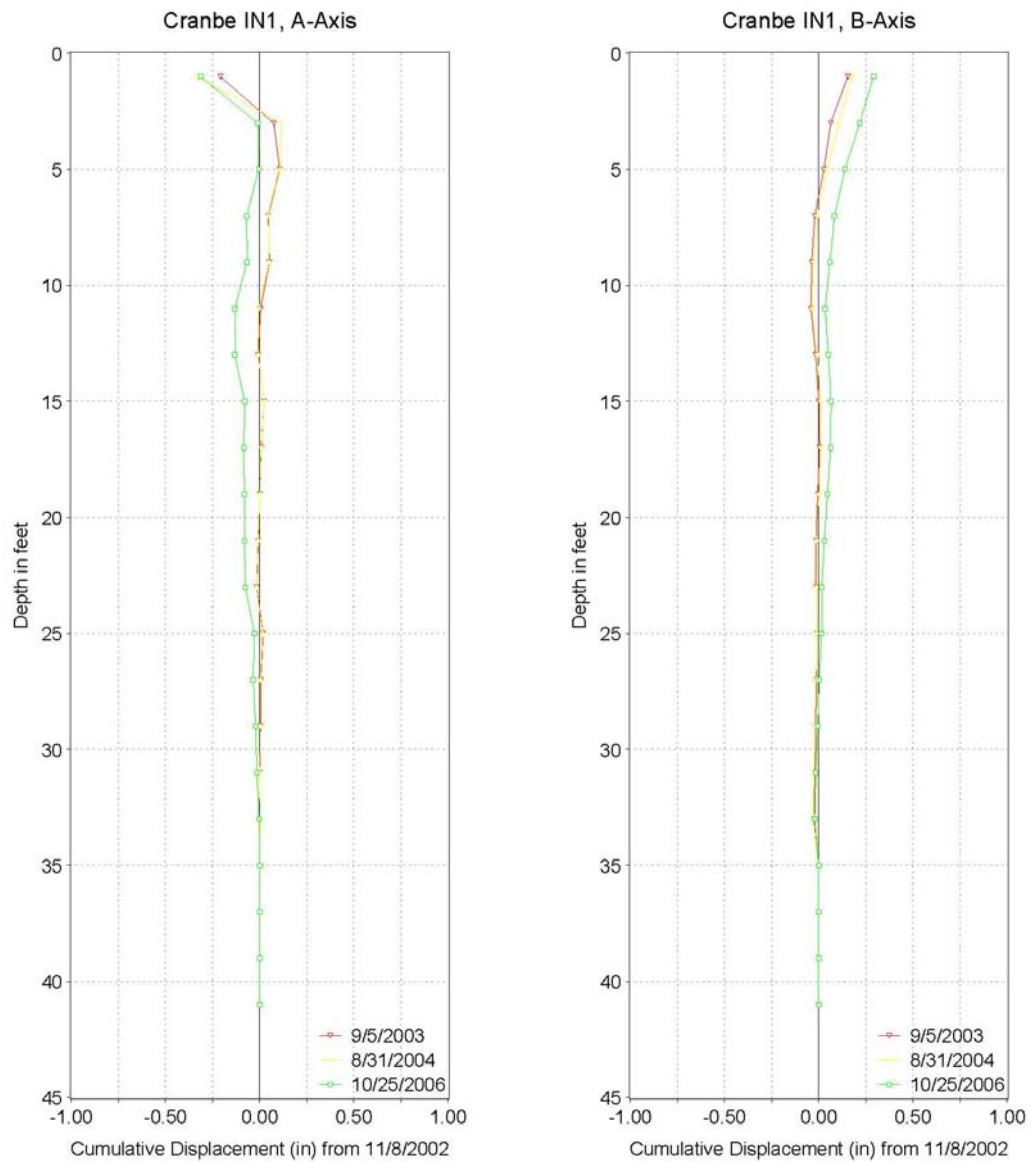
Figure 68a: Lateral Movement of IN1 at Cranberry Bridge

Inclinometer casing IN1 was installed 5 feet of the east abutment in structure backfill. Based on reading over four years, as shown in Figure 68a, the inclinometer casing moved a maximum of about 0.3 inches (away from abutment) at 2 feet bg and 0.15 inches (also away from the abutment) at 12 feet bg. In the transverse direction, the maximum lateral displacement is 0.3 inches (away from the center line of the roadway) at 2 feet bg. Overall, these movements are within a few tenths of an inch over four years and are perceived as insignificant.

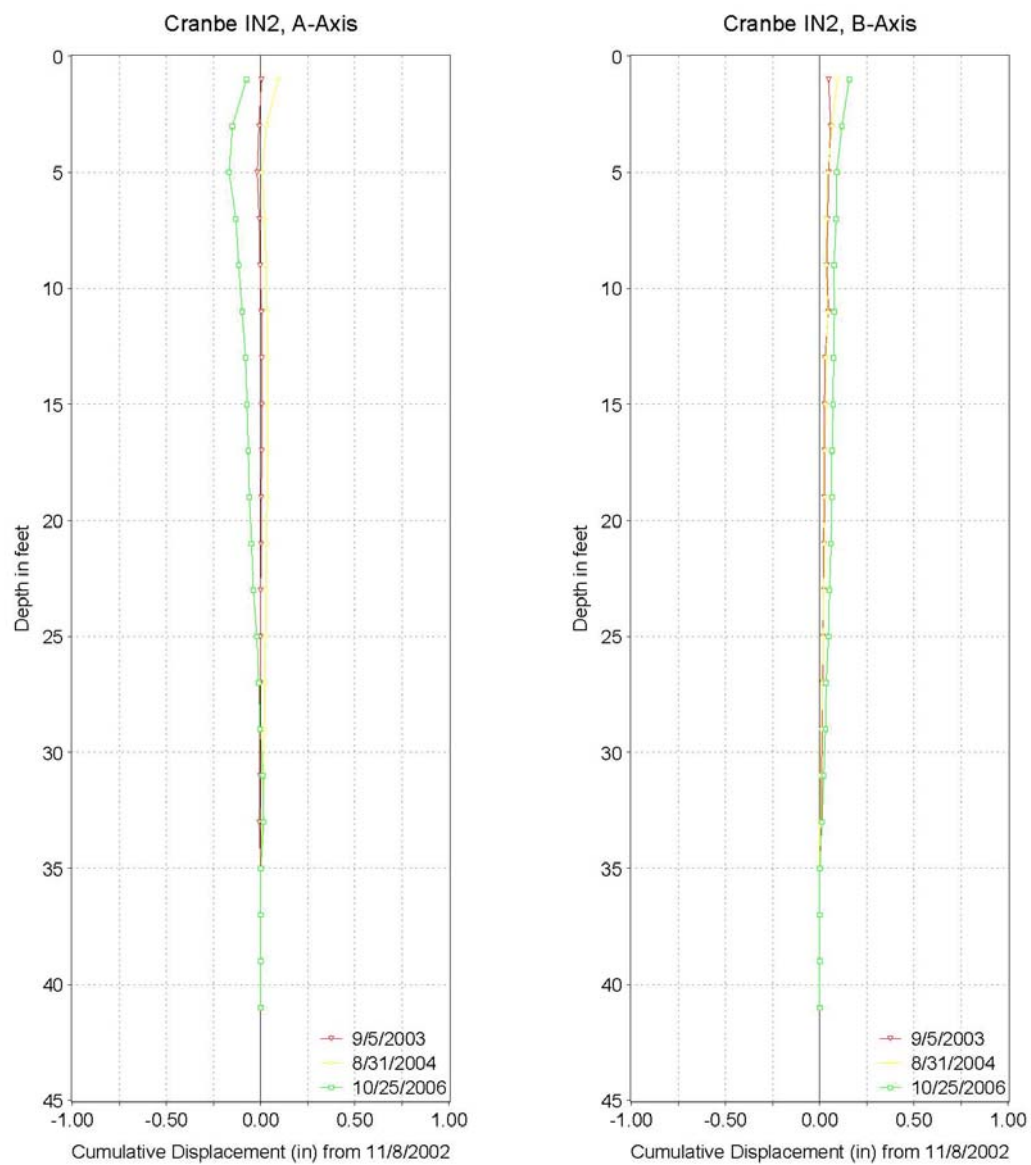
Figure 68b: Lateral Movement of IN2 at Cranberry Bridge

Inclinometer casing IN2 was installed 5 feet from the west abutment in the geosynthetic reinforced fill. The results, shown in Figure 68b, indicated a maximum of 0.16 inches (away from abutment) at 5 feet bg along the A-axis and only 0.15 inches (away from the center line of the roadway) at 2

feet bg along the B-axis. Similar to the measurements in IN1, these movements are perceived as insignificant.

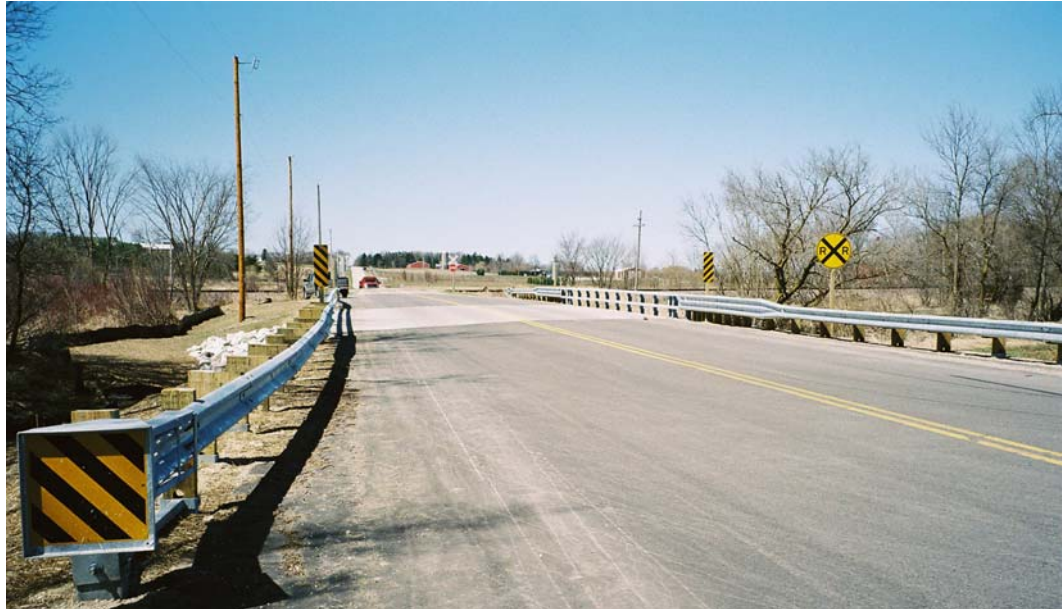
Figure 69: Looking West at Western Bridge

The last site visit to the Western Avenue bridge was carried out in September 2006. The bridge and its two approach fills appeared to be in good condition. Prior to that, on April 13, 2005, a site visit was conducted about 6 months after the construction of the bridge (Figure 69). It was observed that some of the asphalt at the interface between the roadway and back of the west

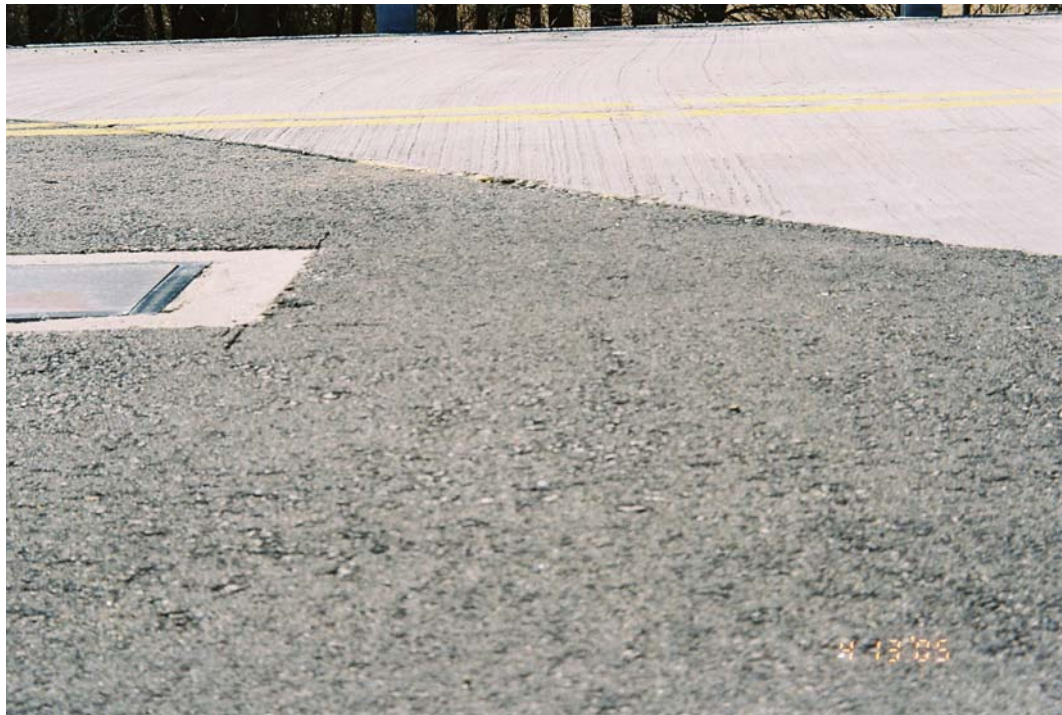
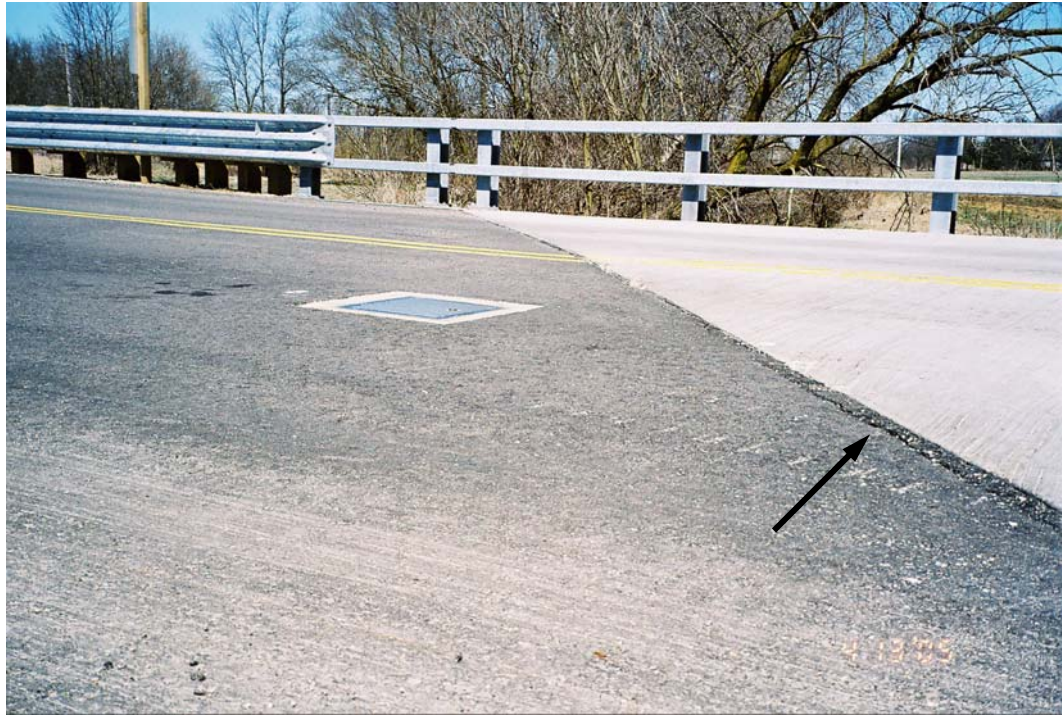
bridge deck was cracking (structure fill). The approach pavement on the westbound lanes appeared to be performing better than the eastbound lanes as shown in Figure 70 and 71. Embankment side slopes were sparsely vegetated, as grass is not grown yet. The north

Figure 70: Approach at East Abutment of Western Bridge (Geosynthetic Fill)

Figure 71: Approach at West Abutment of Western Bridge (Structure Fill)

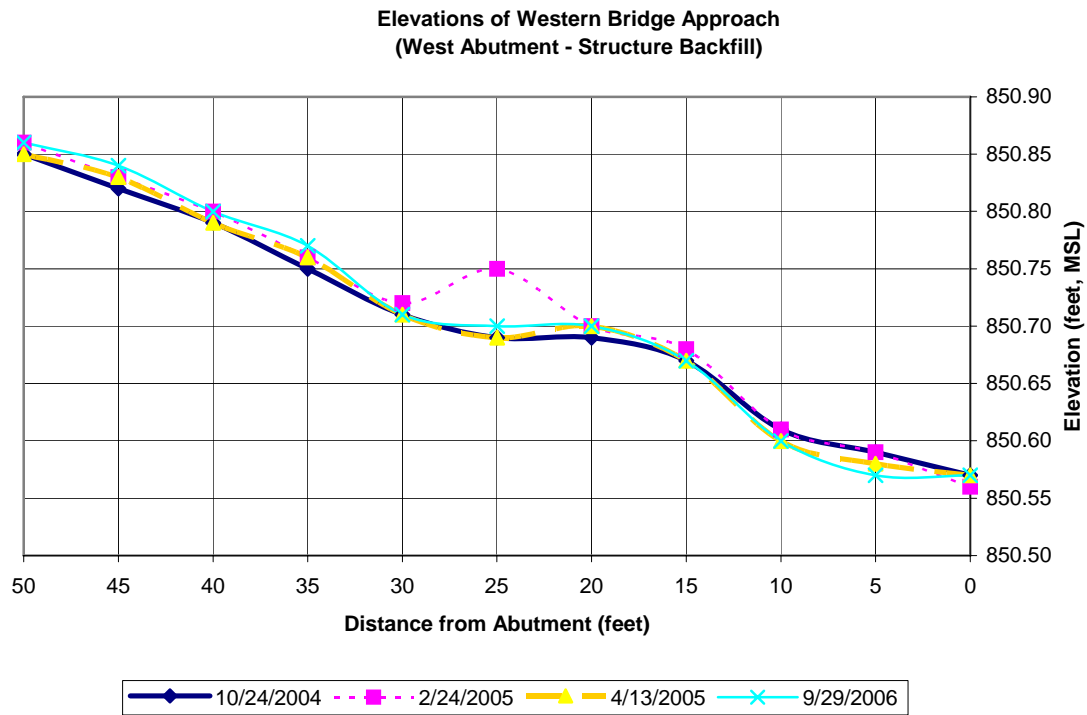
Figure 74: Survey Elevations of Western Bridge at West Abutment (Structure Fill)

Survey elevations were taken over a 2-year period from the end of bridge construction on both eastbound and westbound approaches. Figures 74 and 75 present the survey elevations at the west and east abutments, respectively. The survey indicated differential settlement (see Appendix I) of about 0.23 inches within 5 feet of the west abutment (structure fill), and only indicated positive movement at the east abutment (geosynthetic reinforced fill). The positive movement is likely due to survey, as the 2nd reading showed 0.01 inches of vertical settlement, which is considered

negligible. Along the eastbound lanes, the differential settlement decreased the further away from the abutment until the elevations showed an upward or positive movement in the pavement. The point where the differential movement changed from negative to positive is about 15 feet from the West abutment. A transition slope was calculated to be about 0.015 inches per foot.

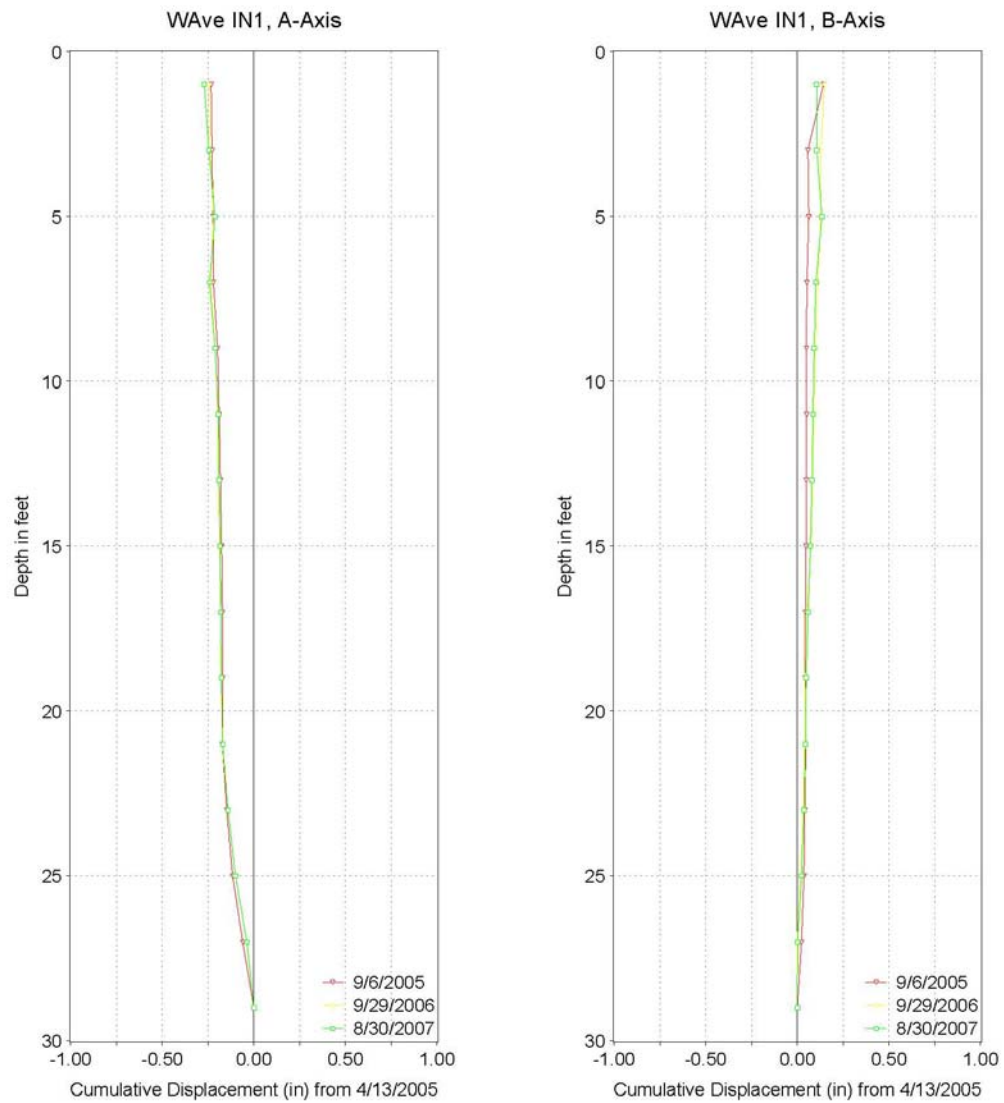
Figure 76a: Lateral Movement of IN1 at Western Bridge

Inclinometer casing IN1 was installed 5 feet behind the east abutment in geosynthetic reinforced fill. Based on readings over the past two years, as shown in Figure 76a, the inclinometer casing moved a maximum of about 0.25 inches (away from abutment) from 0 to 10 feet bg. In the transverse direction, the maximum lateral displacement is approximately 0.15 inches (away from the center line of the roadway) at 2 feet bg.

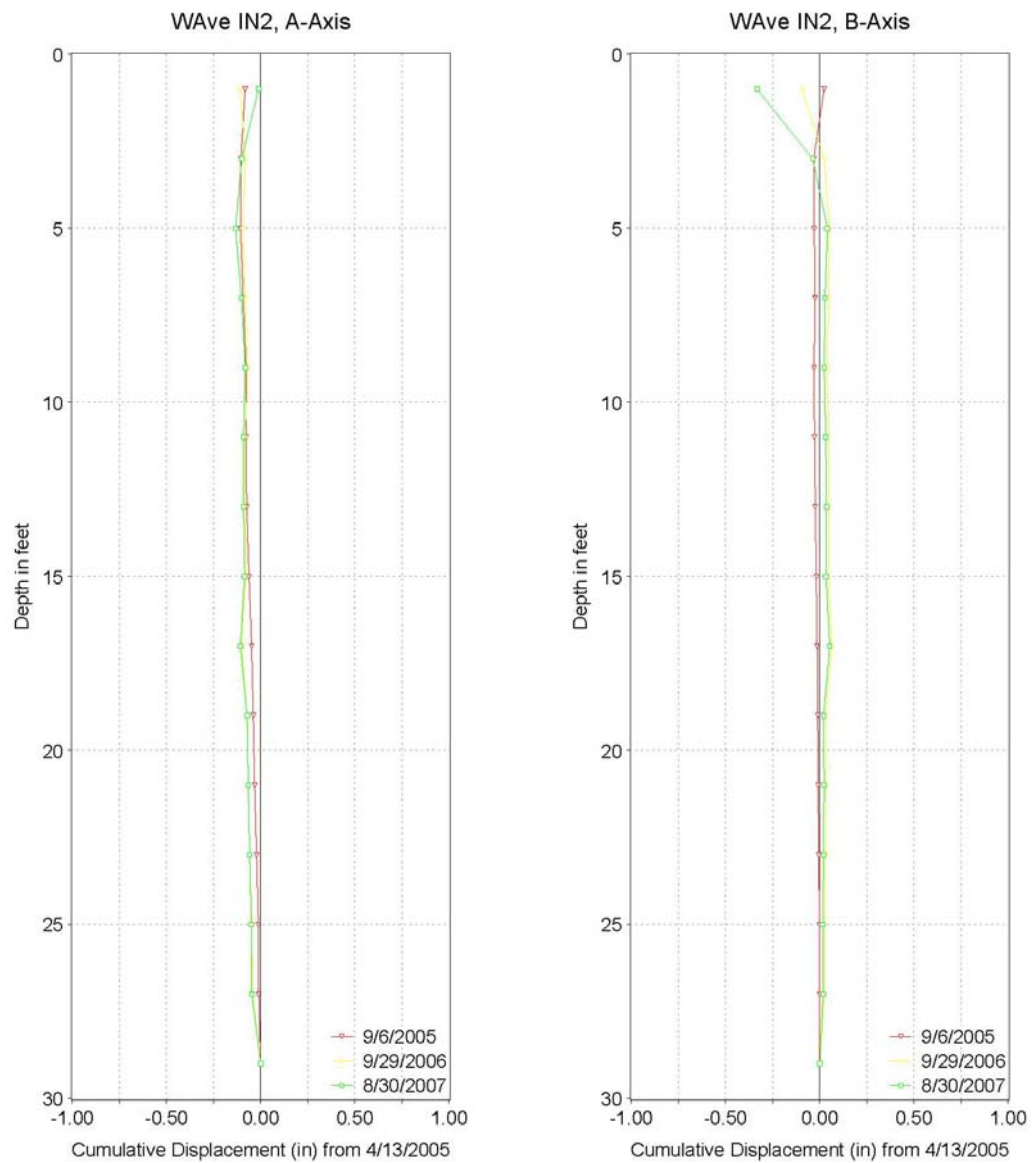
Figure 76b: Lateral Movement of IN2 at Western Bridge

Inclinometer IN2 was installed 5 feet from the west abutment in structure fill. Readings were taken over 2 years. The results, shown in Figure 76b, indicated a maximum movement of 0.12 inches (away from abutment) at 4 feet bg, and in the transverse direction about 0.1 inches (away from the center line of the roadway) at 5 feet bg. This movement is considered negligible. The net

movement appears to be towards the southwest or outside corner of the abutment where erosion is occurring.

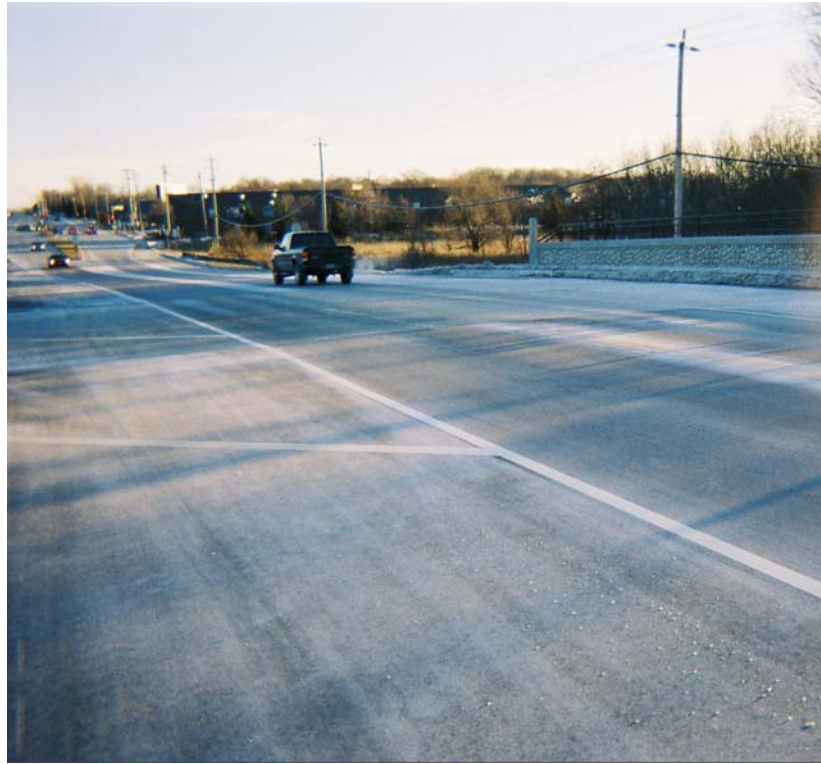
Figure 77: Looking East at Beloit Bridge

The last site visit to the west Beloit road bridge was carried out in September 2006. The bridge and its two approach fills appeared to be in good condition. On April 13, 2005, a site visit was conducted after the 3rd field measurements were taken for the bridge. An overview photograph is shown in Figure 77. The eastbound approach appeared to be in good condition with a few asphalt pieces missing near the interface with the west abutment. This is likely due to loosely placed asphalt and difficulty of compaction at the roadway-concrete deck interface. The eastbound approach (flowable fill) shown in Figure 78 appeared to be in better condition than the westbound approach (structure fill) shown in Figure 79. A noticeable dip in the asphalt was observed (westbound). It was also noted that the embankment side slopes beyond the wingwalls were settling, as noted in Figure 80, which was more prevalent on the south side than on the north. This could be attributed to the staged construction. The north side was allowed to settle before final grading and seeding. Vegetation had not yet taken, as construction was just completed in November 2004. Erosion was also observed from underneath the concrete sidewalks on the south

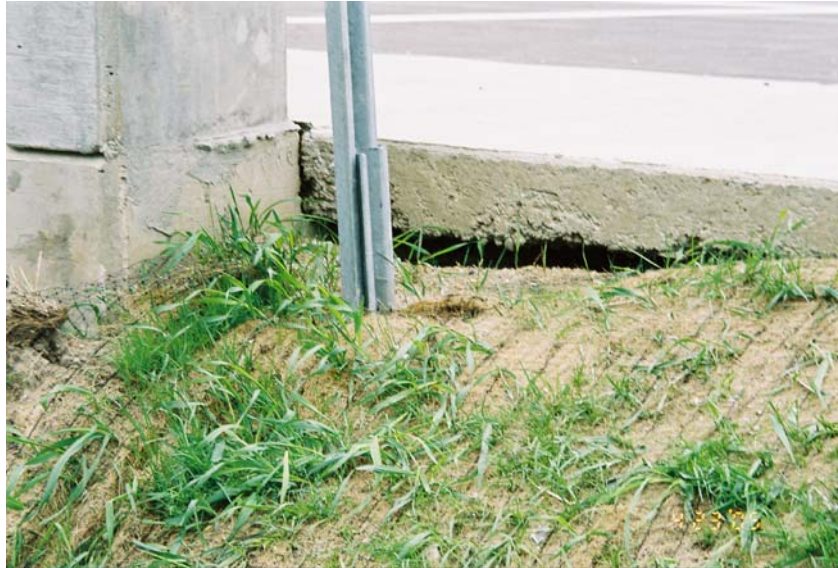
side of the bridge. A void up to 3 inches was noted and more prevalent on the southwest corner. A close up photograph of the void on the southeast corner is shown in Figure 81.

Figure 81: Void on Southeast corner of Beloit Bridge
