Wisconsin Highway Research Program

Evaluation of Bridge Approach Settlement Mitigation Methods

Final Report

October, 2007

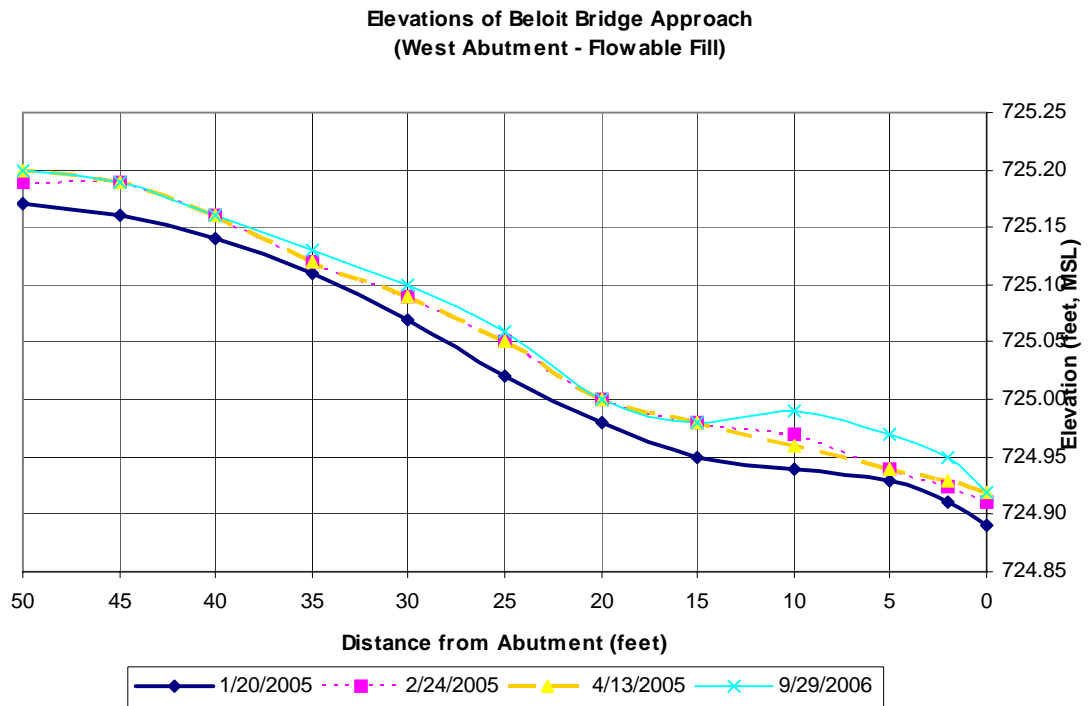
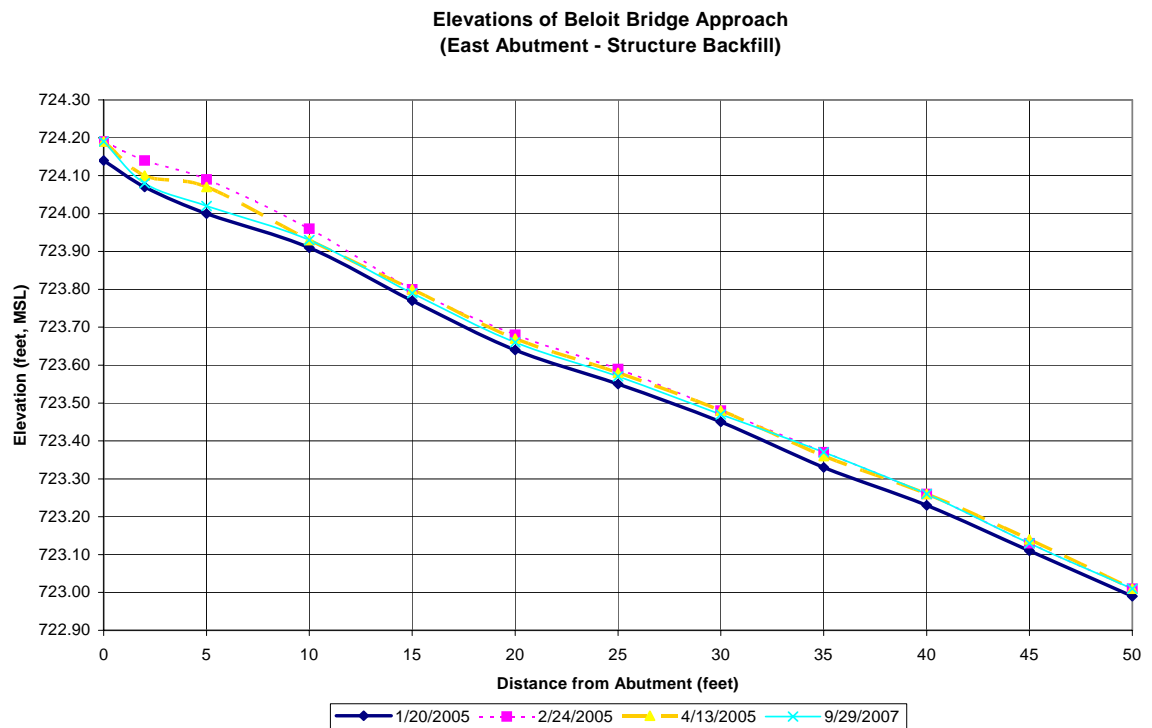
Survey elevations were taken over a 2-year period from the end of bridge construction on both eastbound and westbound approaches. Elevations for both approach lanes at the West and East Abutments are presented in Figures 82 and 83, respectively. Along both approaches, the survey measurements at 3 months, 6 months, and 2 years were higher (0.1 to 0.6 inch) than the measurements of the initial survey and could be attributed to survey error. The differential movement between the 3-month and 2-year readings showed significant movement (0.3 to 0.6 Inches) along the eastbound approach (flowable fill). Along the westbound approach (structure backfill), the survey between the 3-month and 2-year readings indicated a 0.5 inches of settlement at about 2 feet behind the abutment, which was also observed during the site visit.

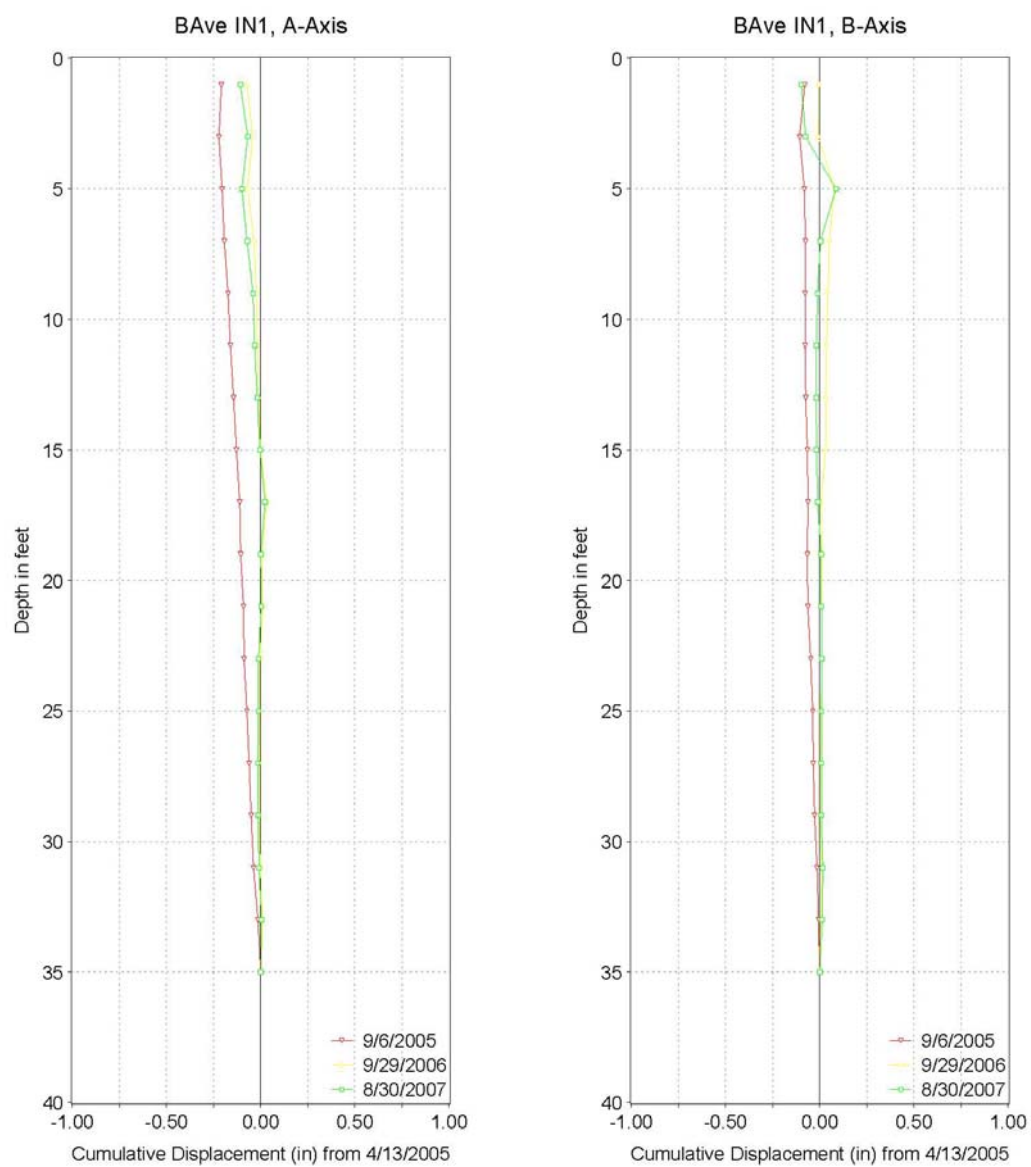
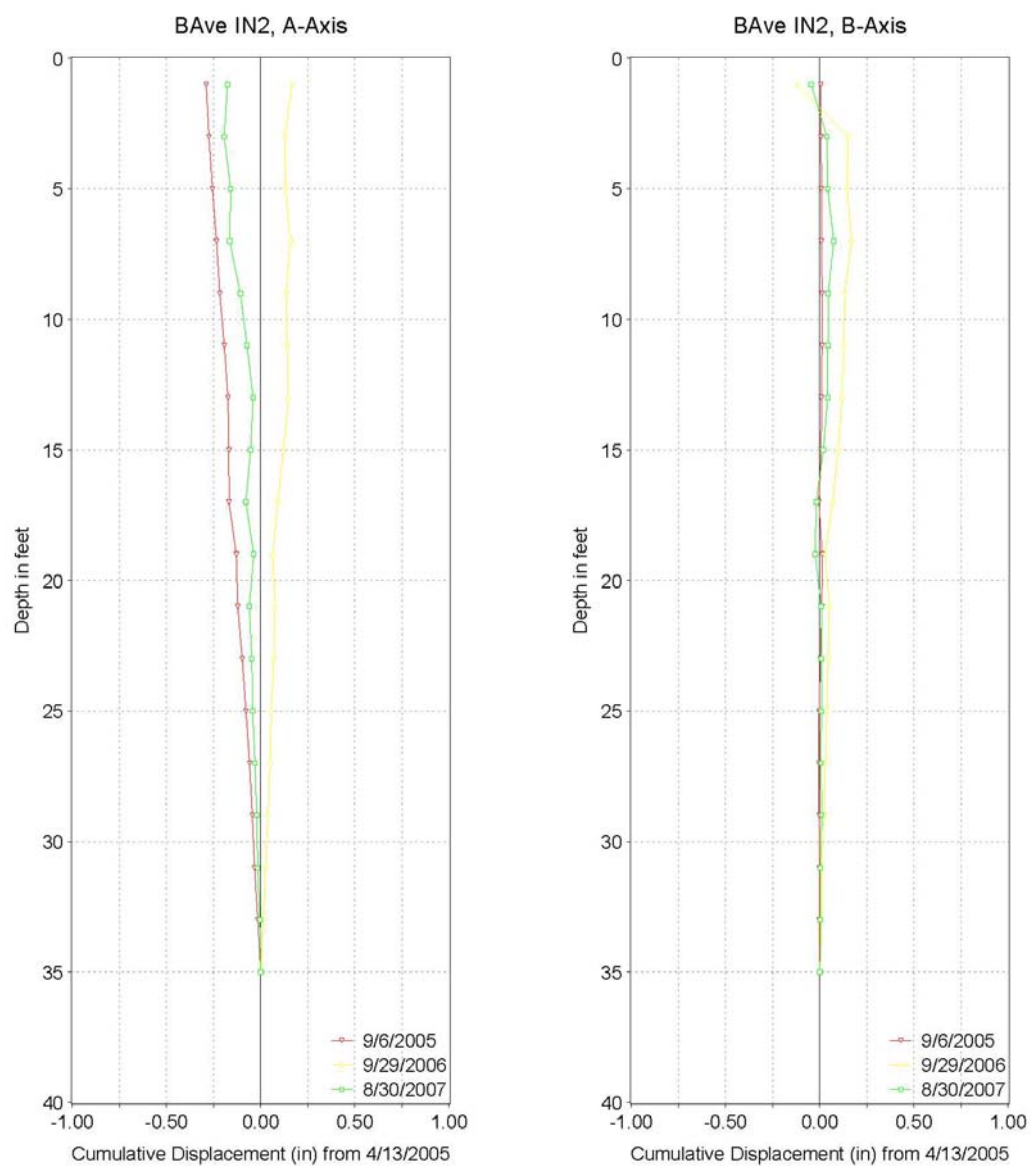
Inclinometer casing IN1 was installed 5 feet of the east abutment in structure backfill. Based on readings over the past two years, the inclinometer casing moved a maximum of about 0.1 inches (away from abutment) at 4 feet bg, as shown in Figure 84a. In the transverse direction, shown in the same figure, the maximum lateral displacement is approximately 0.1 inches (away from center line of the roadway) at 5 feet bg. The net movement appears to be towards the northeast or outside corner of the wingwall where erosion is occurring. Inclinometer casing IN2 was installed 5 feet from the west abutment in flowable fill. Readings were taken over 2 years, as shown in Figure 84b, and the results indicated negligible movement in both directions.
