Wambold Dam – Kroll Outlet Renovation

Eagle Spring Lake Management District

Kroll Outlet

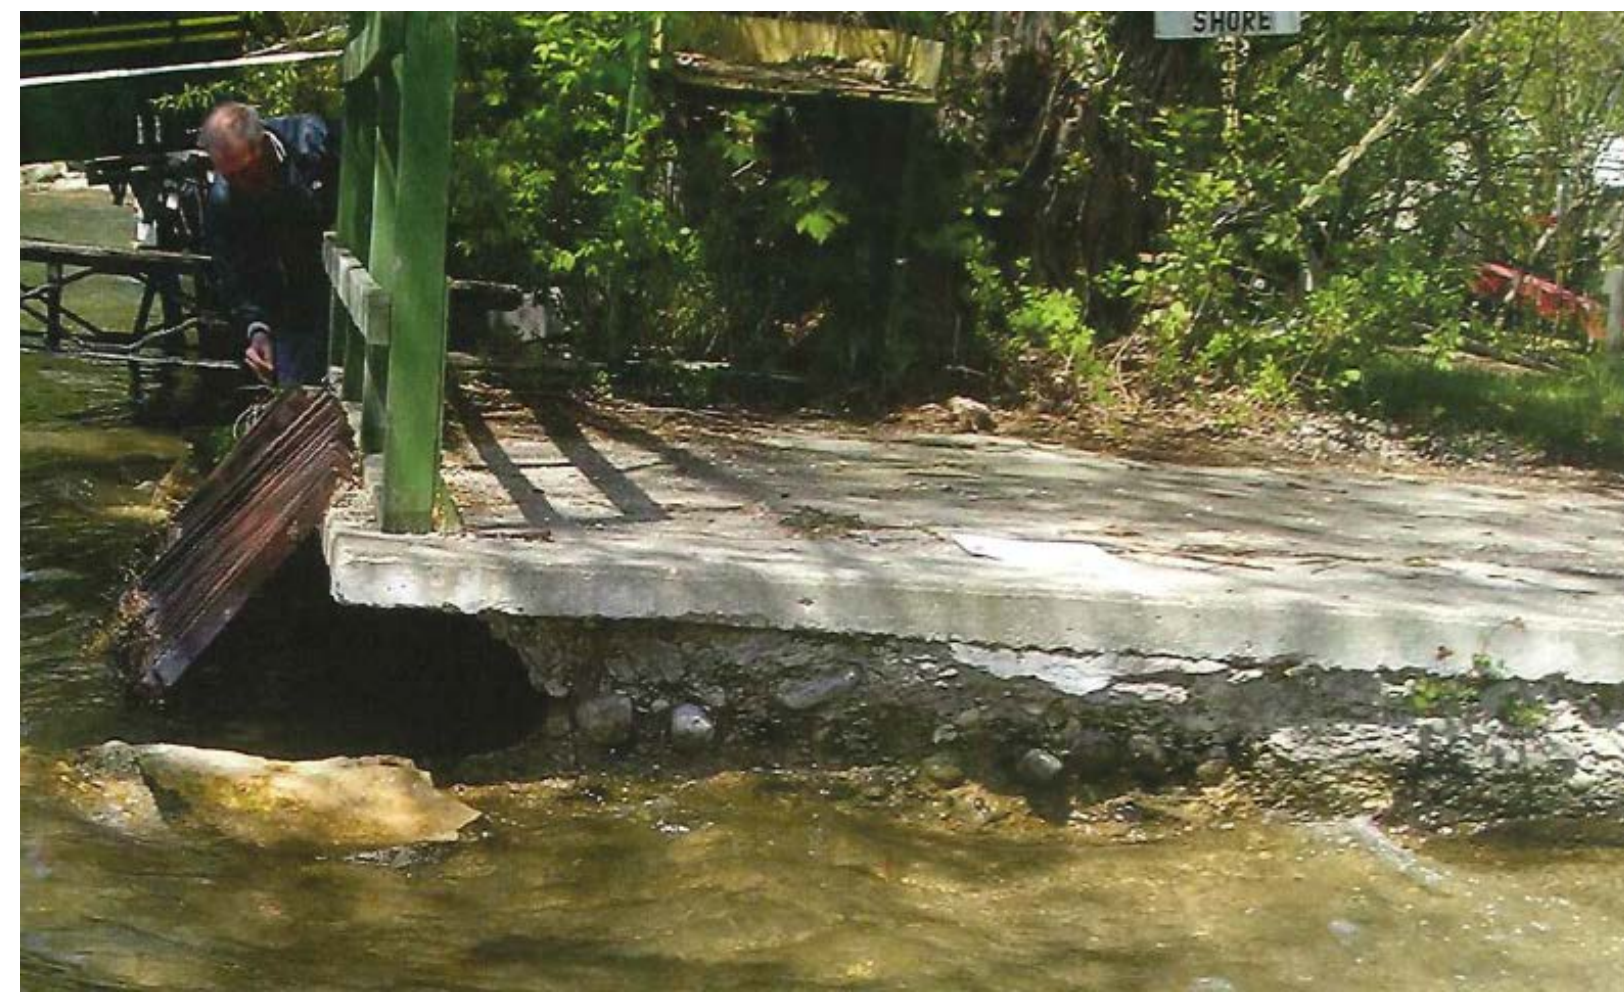
Site of the original Eagleville Mill Dam (1838). Previously housed one of the last known specimens of the McCormick – Holyoke Turbine (Donated to Old World Wisconsin Historical Society for eventual display).

Major deterioration of the intake was noted and the control mechanism for water flow was wood stop boards which did not provide a reliable water control mechanism.

Last major construction and repair at the site was in 1935 as a WPA Project.
